Pasadena
Elementary
School

Pasadena, MD

Catherine Neiderer
Architectural Engineering
Construction
Management Thesis

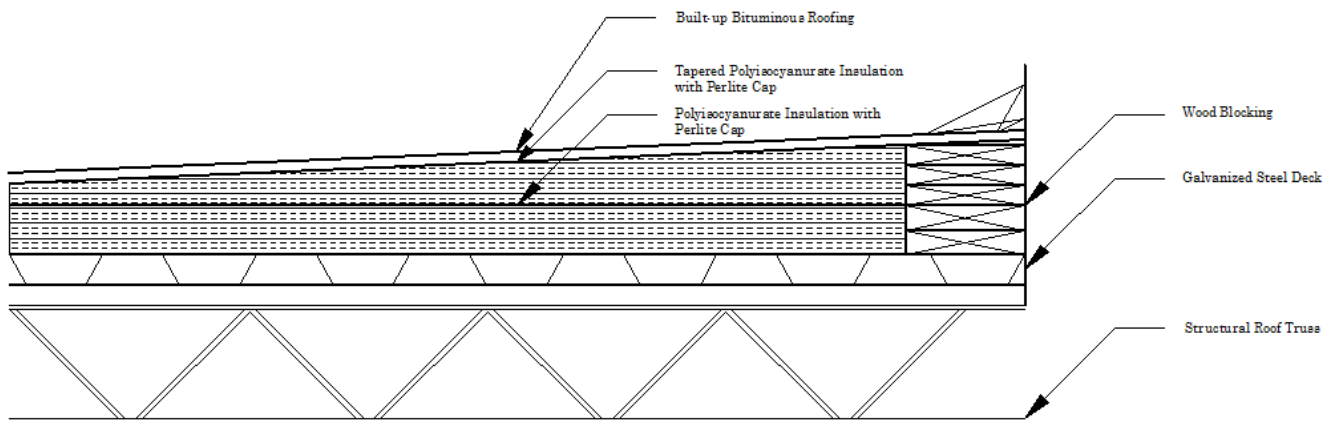
Existing Roof Section

The original design of the school was a basic roofing system that mirrored today's standards. A 1-1/2", 20 gauge acoustic steel decking with tapered insulation that sits on top of steel roof trusses. There is cap flashing and thru-wall flashing below a bituminous membrane that serves as moisture protection. A section of the original design is shown below.

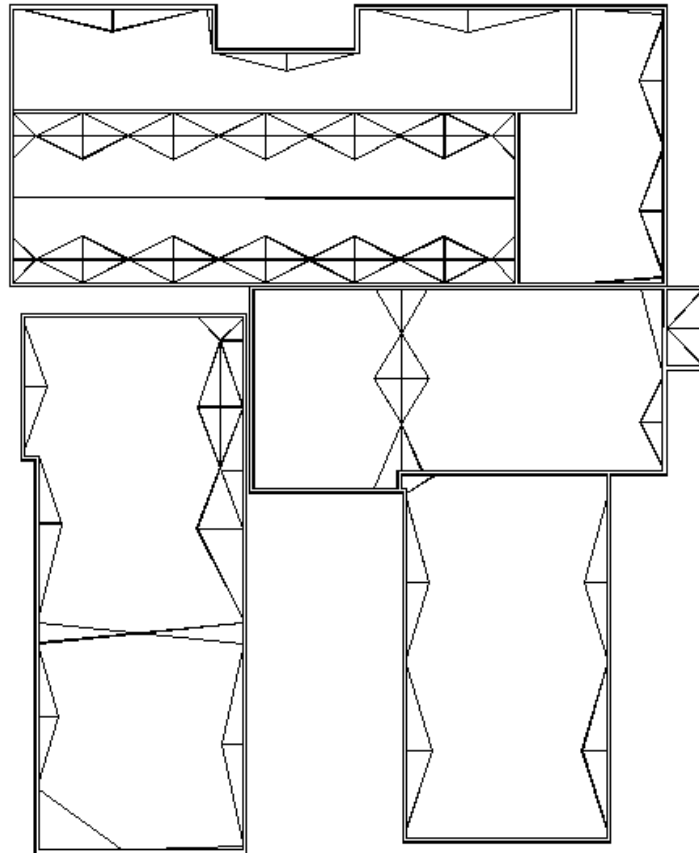
Existing Roof Plan

Below is the original design for the roof plan for Pasadena Elementary School. Note that all slopes for tapered insulation shown on the plan are 25"/12".

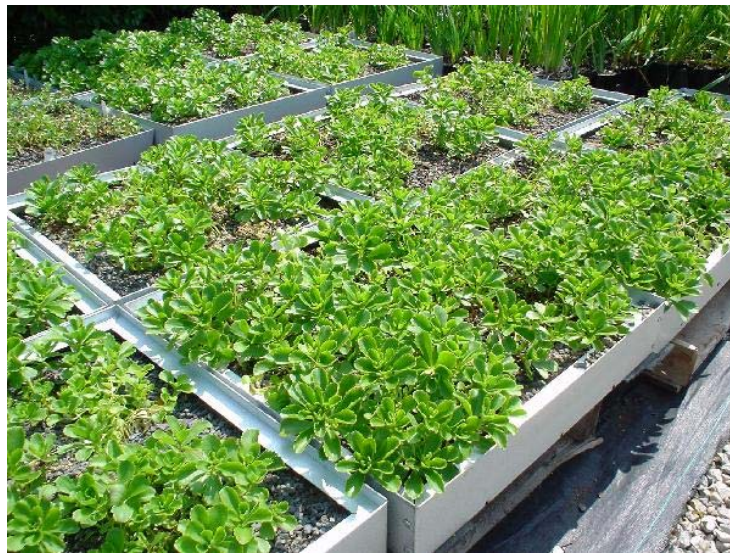
Green Roof Blocks

A unique alternative to what most people think of greenroofs are Green Roof Blocks. They consist of 24" x 24" heavy gauge aluminum containers and are portable units that can be rearranged. They contain durable and drought resistant sedums that stand in 4" of growing medium. The lifetimes of the sedums are 100 years in length. The sedums sit on a 3/8" thick walk pad material that protects the roof from any moisture that the sedums might cause and in addition helps with roof drainage.

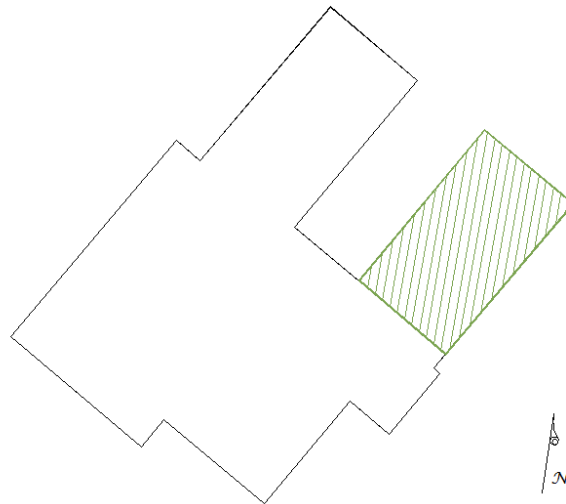
Footprint of Building with Shading of Location of Area Green Blocks to be Added

An amount of \$111,125 is much less than that of \$616,000 and would be easier to convince the owner of its value and that it is worth purchasing. Compared to a total project cost of \$14,042,006, the amount to add green roof blocks is not that much and would be a great impact on the energy efficiency of the building.

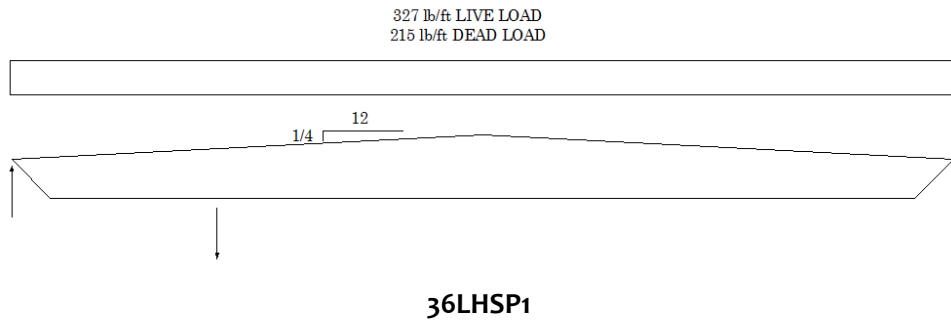
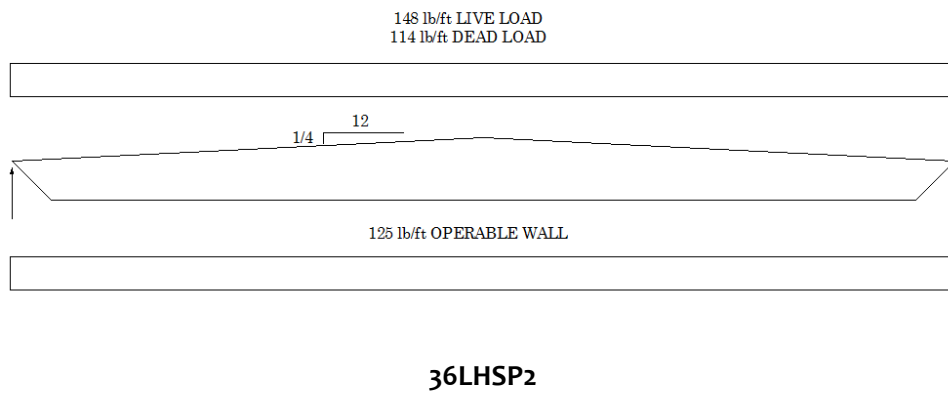
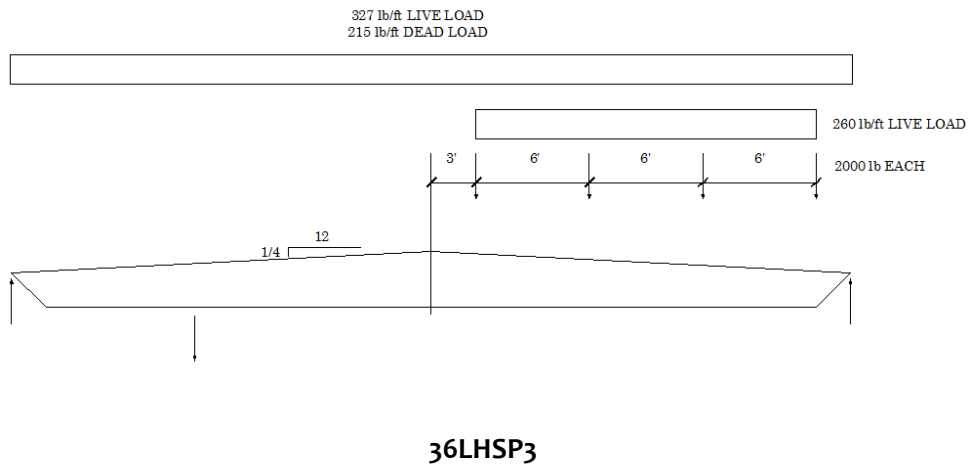
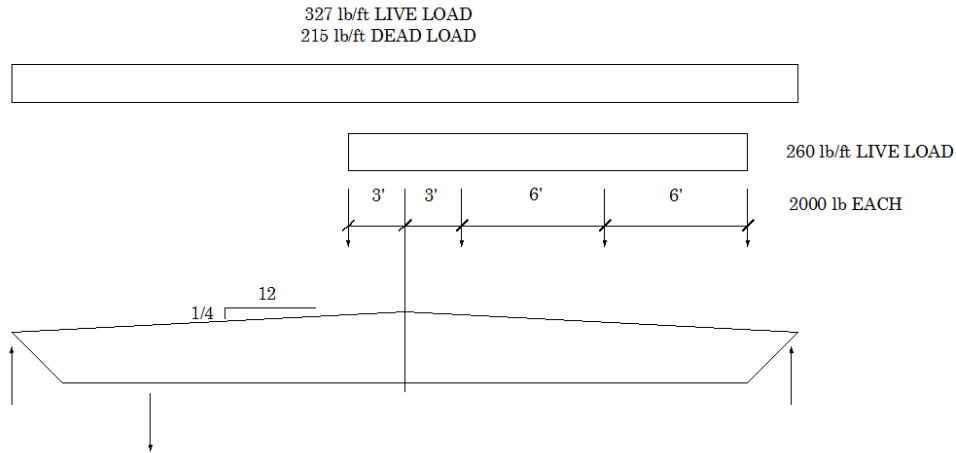
The original design loads (lb/ft) for the four structural trusses used in the building for support of the roof are below:

Note: For trusses 36LHSP1, 3 and 4 1000 lb live load at any location bottom chord shall be designed to transfer load to the adjacent panel points.

There are four types of trusses used in the building as noted above. When first beginning to look into the green roof blocks a weight of such magnitude was not anticipated. The trusses original to the building's design are not capable of holding such a weight and therefore would need to be redesigned by the structural engineer.

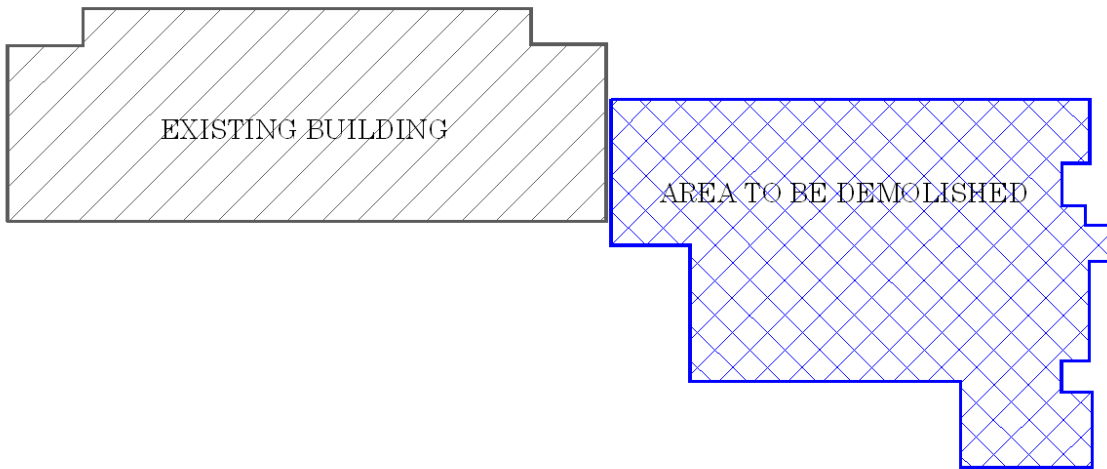
Existing Building Layout

During the feasibility study the architect came up with a proposal for what could have been the elementary school had they chosen the renovation option. Notice on the next page both the existing building including the area to be demolished and the proposed new addition followed by the original floorplans of the building.
