VIMS Seawater Research Laboratory

Dan DiCriscio
AE Senior Thesis
Mechanical Option
2007

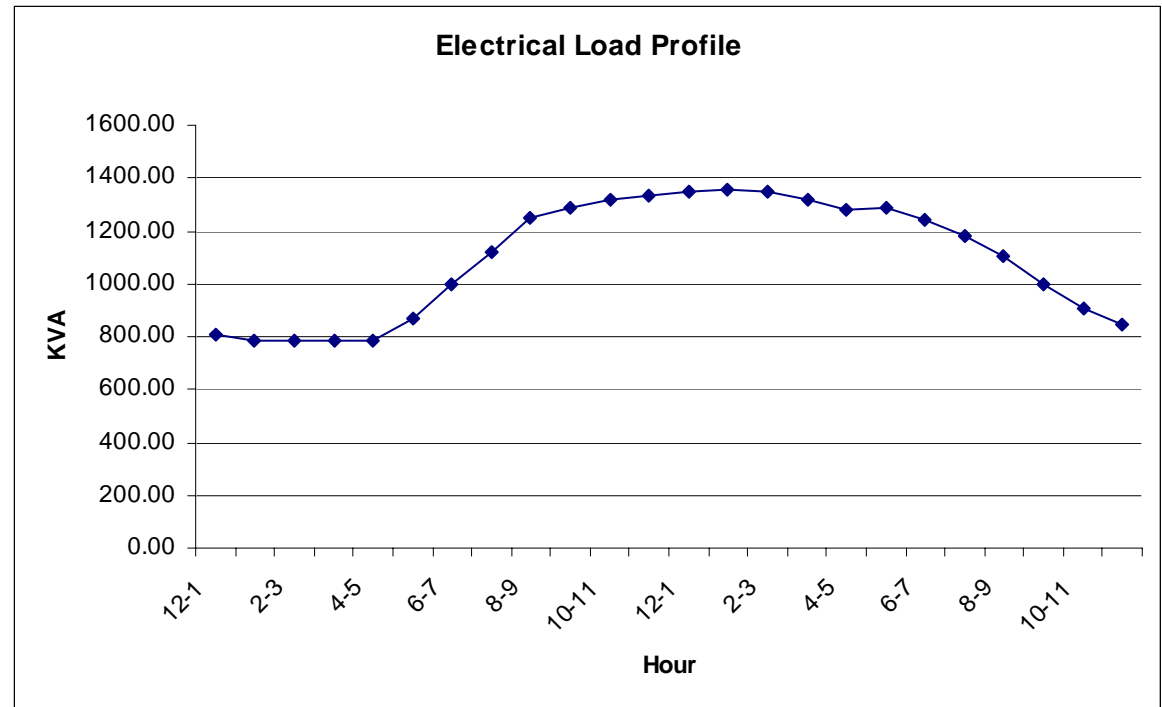
Calculated Building Loads & Load Profile

(based on typical medium commercial load profile data from Pacific Electric & Gas Company)
