Executive Summary

Federated Department Stores is constructing a new Bloomingdales in Chevy Chase, Maryland. It is 180,000 square feet of retail space. The project is being delivered as a design-bid-build of 18.86 million in 21 months, from November 2005 to August 2007.

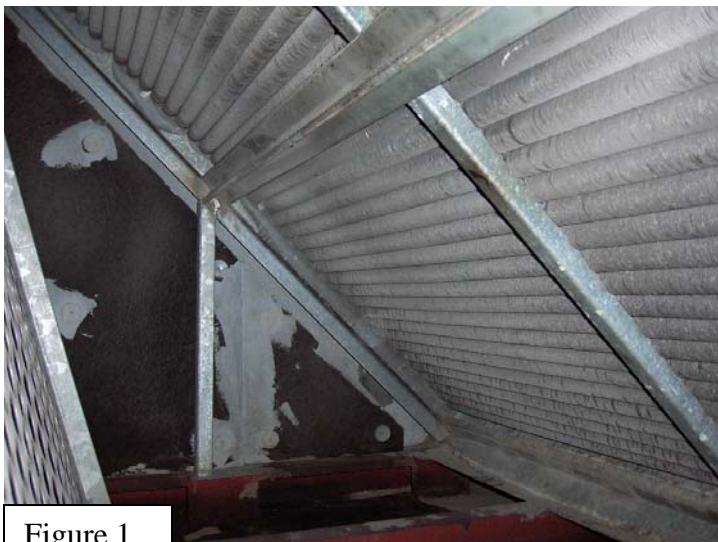
Figure 1

When trying to understand UVGI devices it is helpful to try to understand the causes of SBS. The main contributors to SBS are the high levels of pathogens, allergens, and the existence of microbes. The main contributors to these are the naturally damp cooling coils that are an ideal space for breeding of molds and bacteria, as seen

in Figure 1. These growths cause the efficiency of the HVAC systems to drop drastically causing a larger use of energy to condition the air. Without proper filtering these spores can become airborne, becoming circulated into the air. Further causes can be that of volatile organic compounds, or VOCs. Many building materials release these VOCs into the air; new carpet, wall coverings, glues, adhesives, paints, etc. All of these contributors added to the symptoms of SBS.

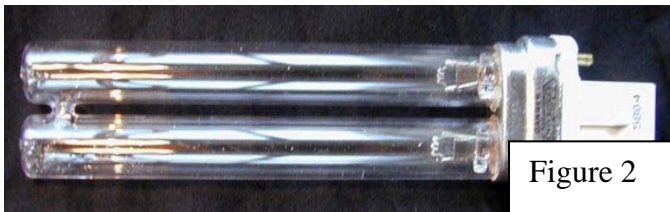
ensure effectiveness. The lifetime of germicidal UV bulbs varies depending on design. A typical bulb is shown in the above Figure 2

A separate problem that will affect UVGI is dust or other substances that create a film coating the bulb, which can lower UV output. Therefore bulbs require annual replacement and scheduled cleaning to

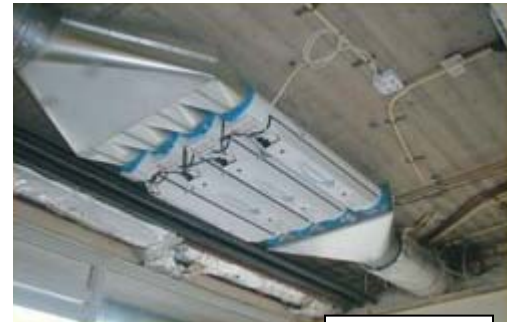
Costs for installed UVGI systems can vary widely, depending on the building and the HVAC system. The expense is more than offset by energy cost savings and the economic benefits of reduced absenteeism and increased productivity of healthy workers. These systems easily fit into standard air conductors, with 'plug and play systems it allows for easy access and maintenance which is important to the maintenance of the system. Typical installation shown at the right in Figure 3

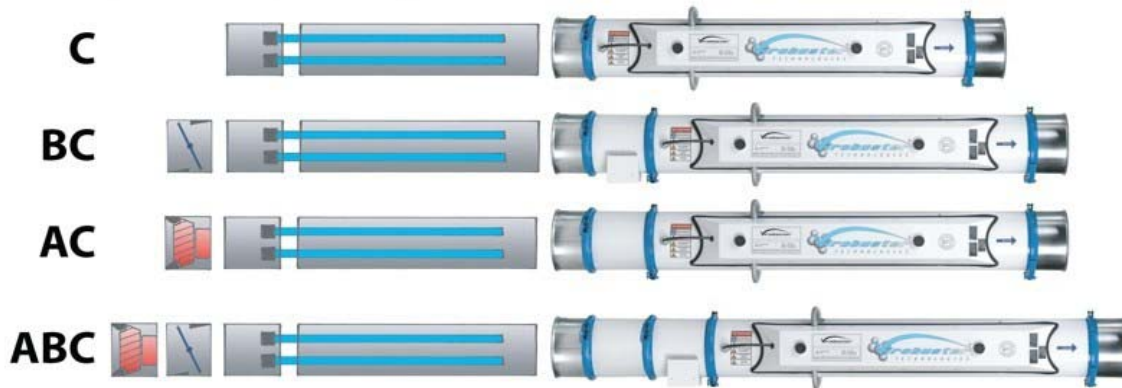
Virobuster® Steritube

Proven to eliminate up to 100% of all airborne molds, bacteria and viruses with an one pass-through: also SARS, TBC, Influenza, MRSA, and Anthrax

Steryltubes are designed to 180 cubic feet per minute with almost 100% effectiveness. The advantage over other systems such as the Ozone generators is that they do not emit harmful byproducts such as ozone. Ozone at the atmospheric level is known to cause symptoms in those that are using them for the original problem. Issues such as chronic lung illnesses, allergens, and other respiratory problems are only instigated by ozone, which can also cause permanent damage with high doses of long term exposure. Though Ozone generators usually produce 2% ozone this can be enough. Below in figure 4 is a comparison of Steryltubes to other popularly used sterilization systems.

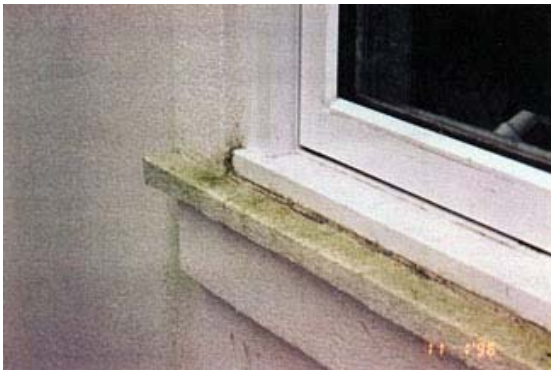
Cracking on window joints (above)

Failures usually occur at joint areas, specifically expansion joints, and joints between other façade materials. Minimizing these possibilities is critical to the success of the system. Utilizing the input of the architectural group, and providing detailed joint construction is only the starting component of a successful system. This allows for a sealant contractor that is experienced in EIFS construction, to properly install the panels. Sealants are just as important as any other aspect of construction, as it must allow for proper expansion and contraction, as well as provide the proper seal between materials such as

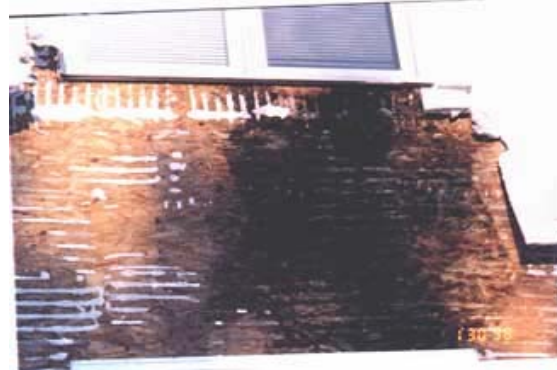
Resulting water damage from failure (above)
