Tyler Swartzwelder  
Construction Management  
Faculty Advisor: Dr. Messner  
Canton Crossing Tower  
1501 S. Highland Avenue  
Baltimore, Maryland 21224

# Technical Assignment 1: Construction Project Management

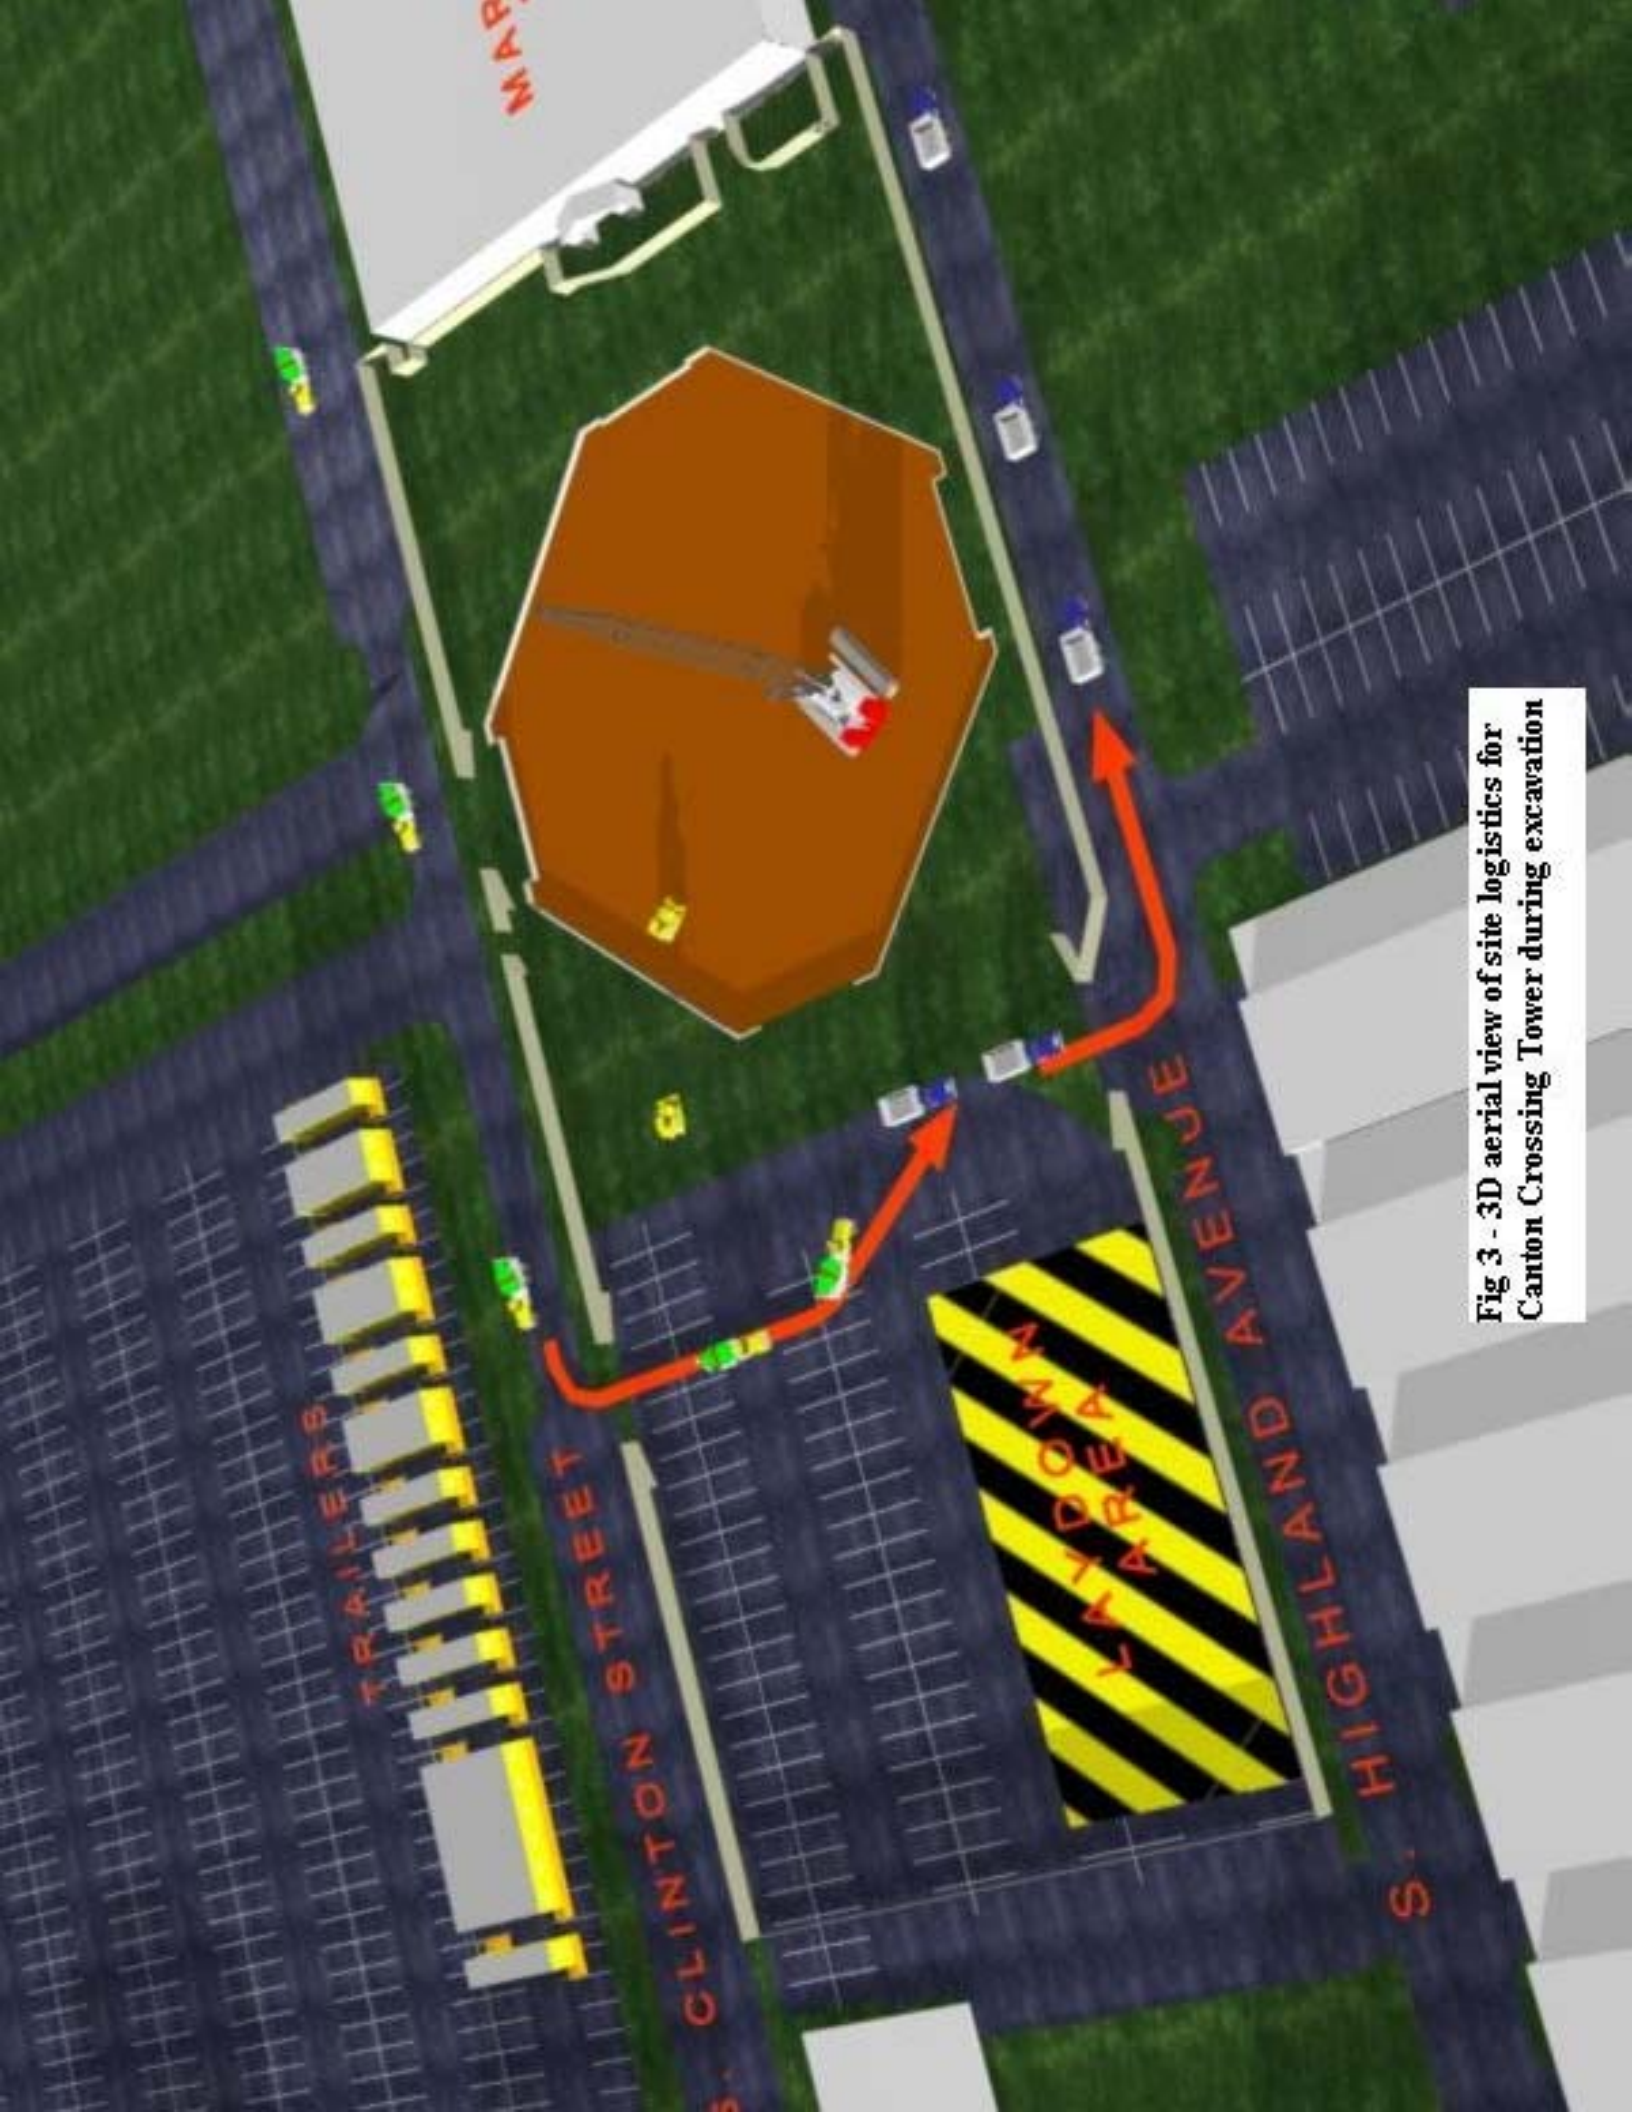
Fig 3 - 3D aerial view of site logistics for Canton Crossing Tower during excavation

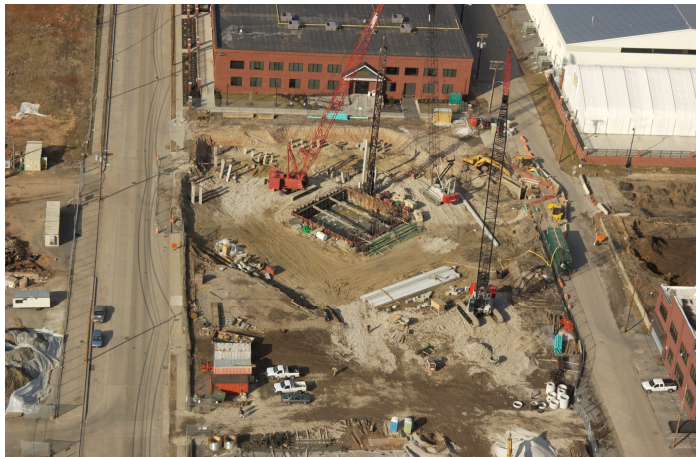
**Fig 4–** Aerial view of existing site conditions

The site logistics plan for construction of the tower was favorable to the General Contractor. There is no demolition required onsite before construction, and the existing active utilities are water main and overhead electric. The lot the building sits on is roughly 1.23 acres. Directly adjacent to this lot is a 1.47 acre lot that is available for trailers, steel staging and laydown areas, and dumpsters. Across the street from these lots is a 3+ acre empty lot that can easily hold more trailers, as well as the construction parking for the project. On the opposite side of

the street, an existing 2 story warehouse building (also owned by Hale Properties), is the location of the General Contractor's office.

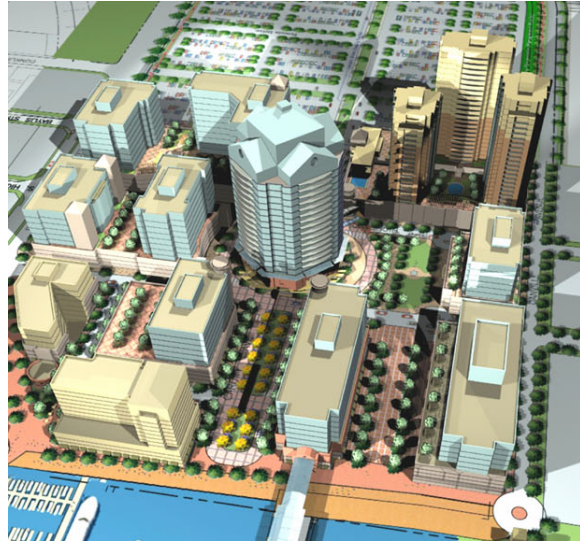
**Fig 5–** 3D aerial of the Planned Unit Development (PUD)
