# Techinical Assignment I: Lighting Existing Conditions and Design Criteria Report Advisor: Dr. Moeck 5 October 2005

The following Lighting Existing Conditions and Design Criteria Report analysis the lighting system being considered for the renovation and addition of the Franklin Care Facility. It is important to note that the information for this report was gathered from 80% design development documents. This is not a report of the actual lighting conditions of the Franklin Care Facility. Many assumptions have been made regarding issues that have not been finalized.

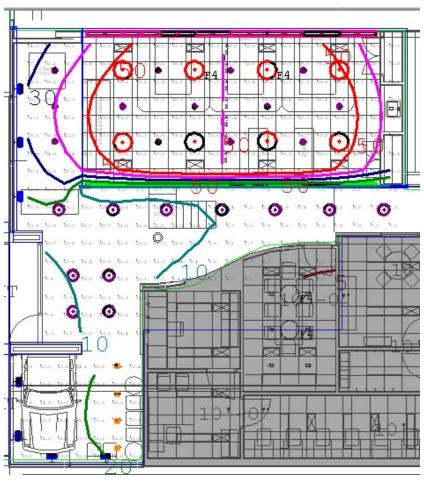
# Illuminance Values of Electric Lighting

Waiting area	ghting Only Rehabilitaion Illuminance (FC) at floor	Vertical Illumination (FC) In rehab area
Average	18.53	26.68	32.32
Maximum	28.6	58.2	66.2
Minimum	10.9	4.6	23.3
Avg/Min	1.7	6.23	1.39
Max/Min	2.62	12.65	2.84

Power Density = 1.90 W/sqft

The power density for the physical therapy suite is 1.9 W/sqft, while maximum power density using the space by space method according to ASHRAE 90.1 is 0.9 W/sqft. The actual power density is 111% above the value set by ASHRAE. The power density needs to be greatly reduced to meet ASHRAE, and should be further reduced to earn LEED credit as a green building.

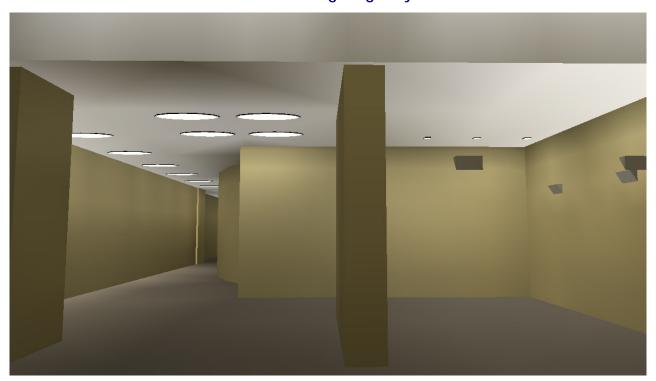
Waiting Area and Corridor

# AGI32 Renderings of Physical Therapy Suite Electric Lighting Only

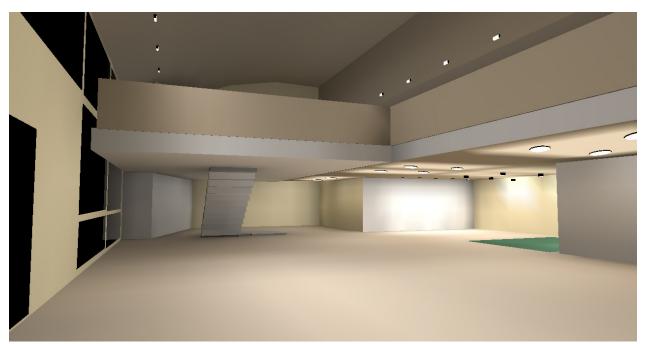
Lobby and Visitor's Lounge

## AGI32 Renderings Main Entrance Lobby Electric Lighting Only

Aesthetically the electric lighting in the main entrance lobby is very nice. The high reflectance vaulted wood ceiling is illuminated from beneath, enhancing the architecture of the lobby. The pendants used in the lobby and visitor's lounge are decorative and create a residential feel. The lobby lighting does not have an institutional feel, and you feel like you are entering a home community and not a health facility. However, the levels of lighting are very low. 10fc is recommended at night, but the electric lighting only provides an average of 3.73fc at the floor. The 15 – 150W quartz lamp fixtures do not provide enough light on the ceiling to reflect 10fc. To use a purely uplighting technique either more fixtures or fluorescent fixture should be used. The reception desk is only illuminated with the ambient light, providing 2.4fc, well below the suggested 50fc. Although she is located directly next to the window, task lighting is necessary for the receptionist to read and use her computer when daylight is not may not be adequate because the ratio of task to surroundings will be greater than the recommended 1:10. The pendants in the visitors lounge provide adequate ambient light, however the 14.28 illumination level is a little low for reading.

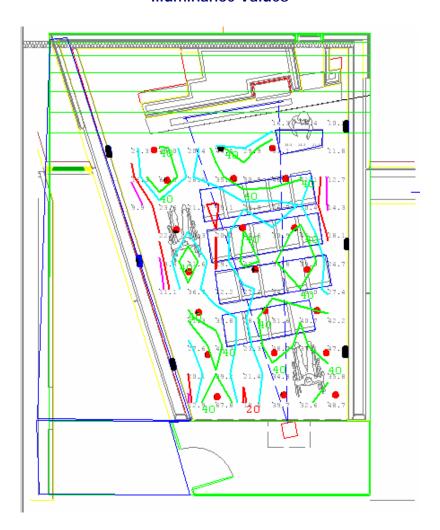
# **Illuminance Values**

Congregational Illuminance (FC) at 2.5'	Vertical Illumination (FC) in congregation	Leadership Illuminance (FC) at 3.5'	Vertical Illumination (FC) at leadership
Average	31.93	11.31	28.03	6.55
Maximum	67.8	15.3	38.5	7.5
Minimum	9.9	8.6	21.3	5.6
Avg/Min	3.23	1.32	1.32	1.17
Max/Min	6.85	1.78	1.81	1.34

Power Density = 3.42 W/sqft

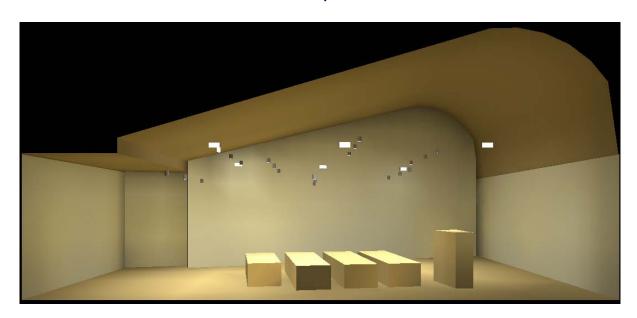
## AGI32 Renderings Chapel

The suspended halogen fixtures aesthetically enhance the chapel. Halogen was a good source to choose because of the good color rendering, and ability to be dimmed from the moment of installation. A dimming control system allows the illumination level to be changed for different uses of the chapel as well as during the service. It would be inconvenient to use fluorescent sources that must be burned at full output for 100 hours before dimming. The uplights along the perimeter of the church enhance the architecture of the wood ceiling, and the reflected light provides vertical illumination throughout the chapel. Adequate light levels are provided in both the congregation and leadership area. However, there is no difference in lighting between the two different areas of the church. Perhaps more illumination should be used to enhance the leadership area and call attention to the front of the church. Accent lighting would be a good choice to distinguish the leadership area from the congregational area.
