Technical Assignment 1 Table of Contents

The Rockville Library

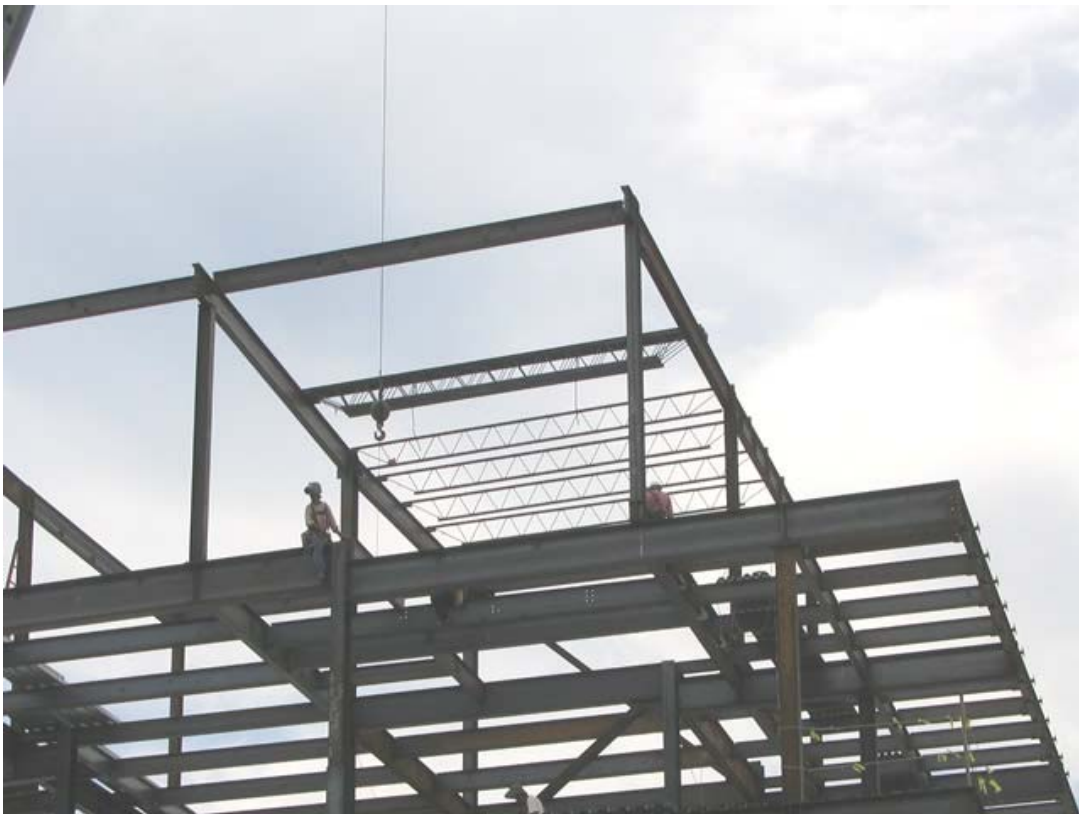
The Rockville Library is supported by a system of structural steel columns, beams, and girders. This steel skeleton consists of beams sizes mainly being W 16x26, 18x35, and 12x16, while girder sizes are mostly W 21x57 and 24x62. Steel columns normally rise through all three building stories and are typically sized at 24"x36" piers with 9'x9' footings. Lateral bracing is used to support frame columns, connected by full penetration welds. Steel beams are aligned uniformly at 8 feet apart, running east/west along the narrower length of the building. Girders run through along the wider length and are spaced based on the required loading of the area. Where more support is needed like in mechanical rooms and computer labs, girders and beams are spaced closer together to handle the load. For the majority of the library, which are office spaces and reading rooms, less support is needed and more spacing can be given to steel beams and girders. In order to erect the steel a single truck mounted, hydraulic, with a 100 ton capacity crane is used. This type of crane fits the job since the structure is not too tall for a truck crane, there are no overly heavy objects to lift, and the site is small enough for the crane to move and reach every area of the building. The truck crane is affordable and can be moved to neighboring sites to aid in the construction of the entire building complex.

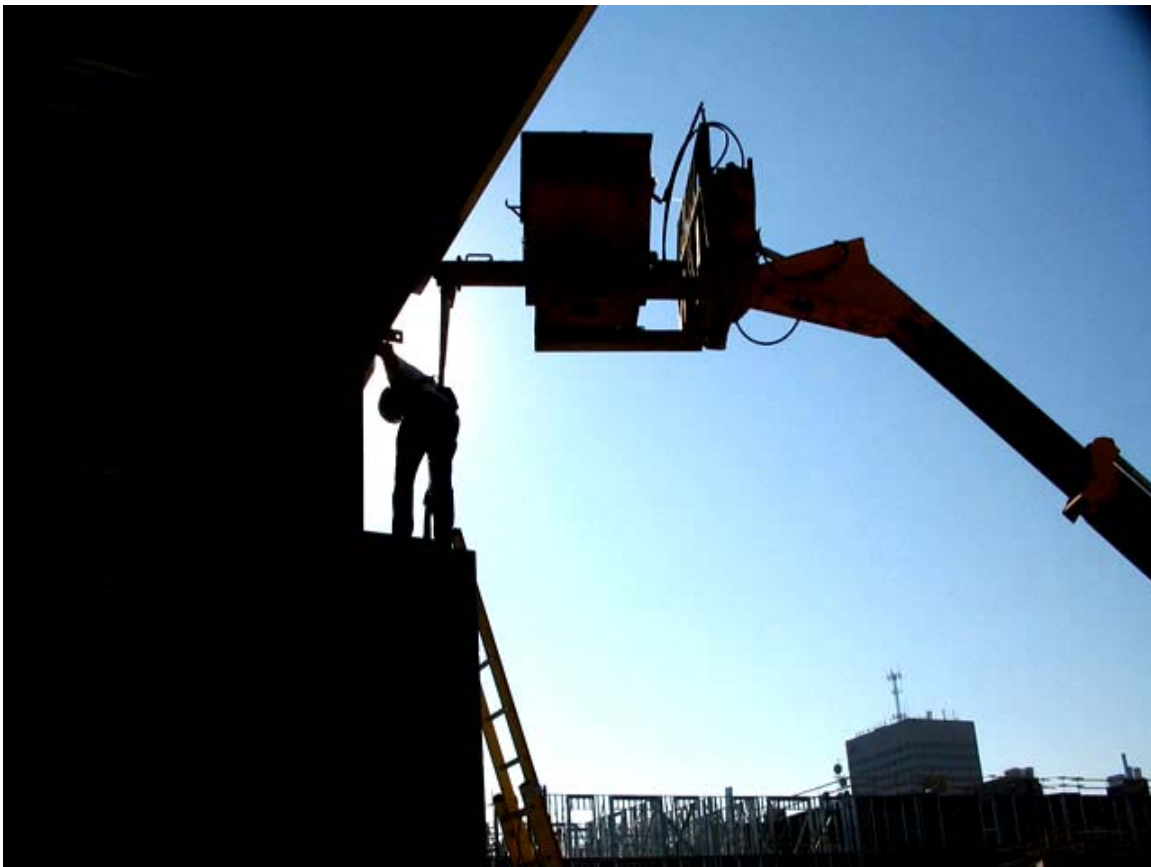
The Rockville Library makes use of both load bearing and veneer masonry. Concrete masonry units enclose the building supported by steel reinforcement bars and concrete formwork. 4" interior layers and 12" exterior layers are grouted into the building walls on the western and northern building elevations. Freestanding CMU units are bonded with steel #5 rebar to concrete footings on parts on the southern and western building ends. Brick veneer decorates the building exterior around the southern and eastern curtainwall areas and are placed by steel tubular scaffolding.

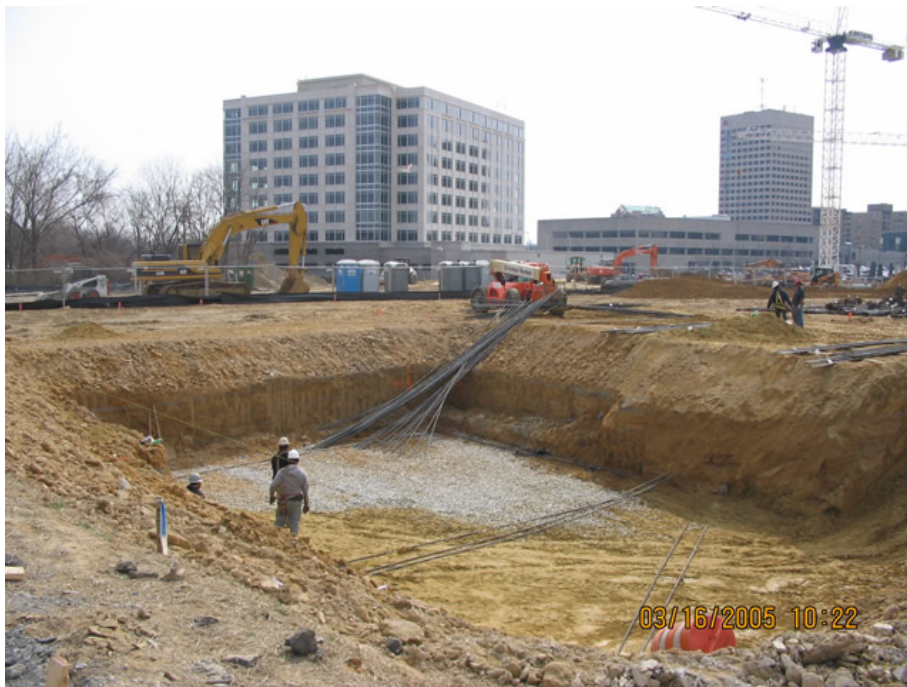
Previous to building construction the site was a parking lot for a local mall. The mall was demolished before building construction and the site was prepared for building construction as part of the town center development. Soil was analyzed and determined that shallow excavation and little to no dewatering was required due to previous development on site. The main concern was realizing where existing utilities were located and how to properly tie-in these resources to the site. Excavation is sloped since it is considered to be shallow enough not to require shoring. There is enough room on site to allow for slope excavation and grouting protects foundation footings from any water that still exists on site.
