Tyler Swartzwelder Construction Management Faculty Advisor: Dr. Messner Canton Crossing Tower 1501 S. Highland Avenue Baltimore, Maryland 21224

Existing Construction Conditions

Technical Assignment 1: Construction Project Management

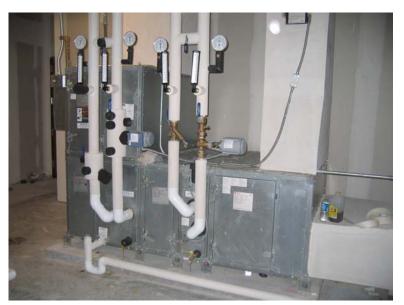
The mechanical design in the tower is based on two air handling units located on each floor. The units are constant volume vertical air units (8500 cfm), each consisting of mixing box, chilled water cooling coil

and fan. The feeds from these units are predominantly run down each corridor in the ceiling space of the tower's core. The ducts from the corridor also branch out to the shell area.

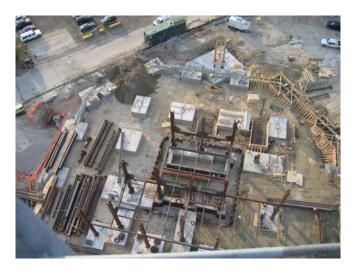
The structural system in the Canton Crossing Tower starts with a foundation comprised of precast, prestressed concrete piles. The 20" square piles, which use 7000 psi concrete, are situated underneath pile caps.

These pile caps are located on the column grid and each covers roughly 4-10 piles.

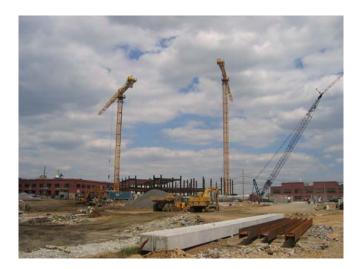
perimeter. The height of the tower cranes were 340 ft & 380 ft respectively. They have a concrete foundation with eight precast piles under each. The pieces of the cranes, known as "towers", were each approximately 20' tall. To remain structurally safe, the max free standing towers are nine or 180'. Once the cranes were above the 180' height limit, they

had to be tied into the building structure.
