MONONGALIA GENERAL HOSPITAL

THESIS REPORT

CARMEN A. BRUTICO III

MONONGALIA GENERAL HOSPITAL'S HAZEL RUBY MCQUAIN TOWER

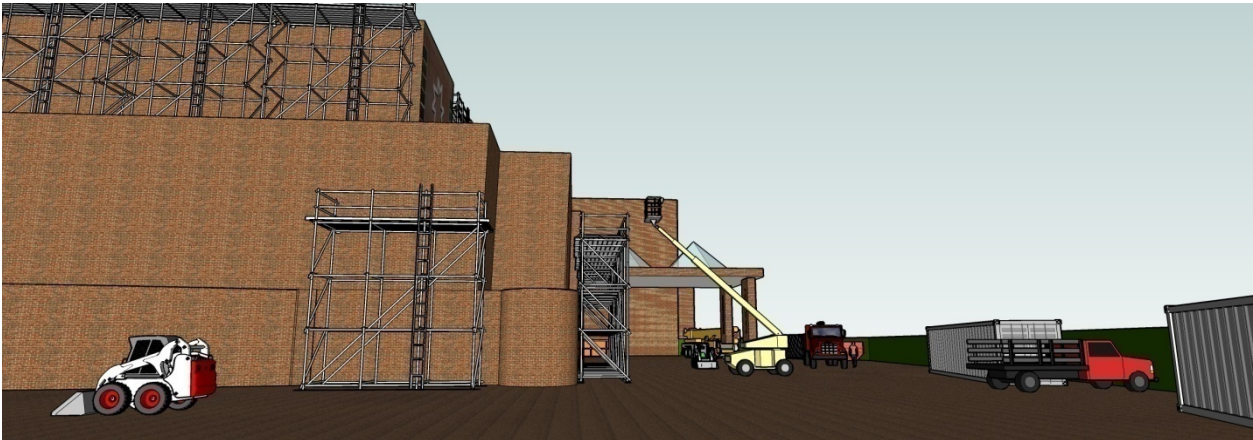
Figure 5 – View of Southeast corner

Three site layout plans for the exterior enclosures and façade are located in Appendix B. Two of the three are 3-D views of the site with labeling of important site items. The third is a plan view also labeled, clearly indicating the locations of key areas and items. Additional 3-D site views are provided below to better visualize and understand the site layout.

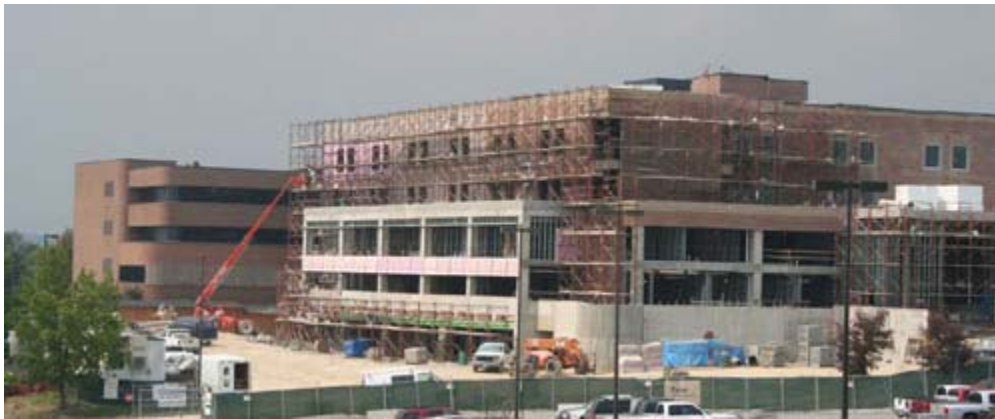
The exterior façade on the new Monongalia General Hospital Tower consists of a brick veneer system with metal stud backing. Most of the exterior fenestrations are punch out windows to allow natural light into the working spaces and patient rooms, while public areas such as lobbies use a curtain wall glazing system to accent the aesthetics from both interior and exterior. The brick exterior was chosen to match the existing building's red brick and allow for a seamless and continuous look along the entire exterior.

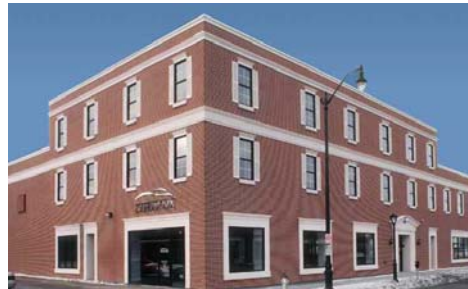
Similarly to the matching of clay brick, Dryvit can match any brick color, maintaining the continuous color and pattern of the existing building’s exterior red brick veneer. The simplicity of the EIFS allows it to be used on an unlimited amount of building design combinations. This versatility allows for compatibility with the Monongalia General Hospital Tower Addition design. The construction of the EIFS allows for the same metal stud backup, requiring no changes to the design of the building. The EIFS can be directly applied to the Fiberlock Aqua Tough Sheathing Panels used on the exterior backup wall.

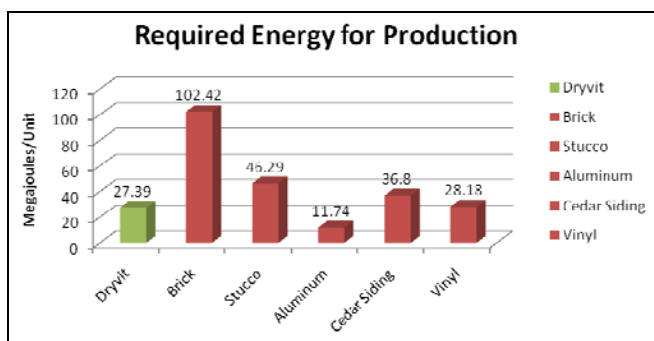
Figure 23 – Required Energy for Production

Dryvit’s systems require lower than average amount energy to produce then other typical exterior cladding systems. Figure 23 shows the resources needed to extract and create the materials used to make the Dryvit outsulation systems including the expanded polystyrene, compared to some other exterior cladding systems.
