Consolidation of Slab Penetrations Study

(Depth, Breadth-Structural)

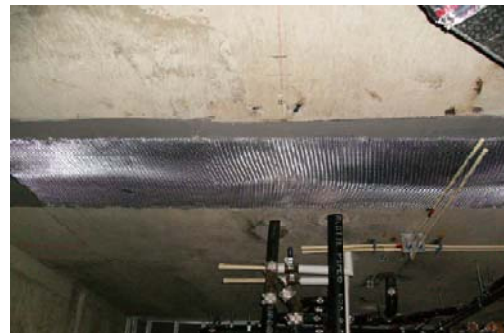
Figure 24 Fire proofed CRFP panel on underside of

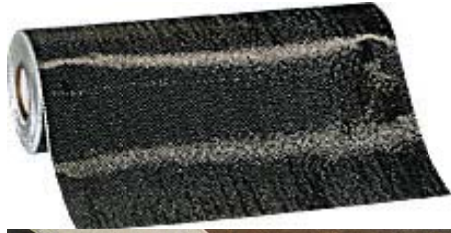
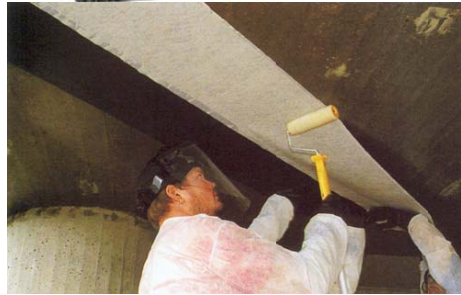
Figure 27 A roll of CFRP (top), CFRP installation (bottom)

The material used in this project is carbon fiber reinforced polymer (CFRP). The material has many applications outside of the construction world including automobiles, high end sports equipment, and in the aerospace industry. The primary reason is the materials high strength and light weight. However, its use in the construction industry is primarily structural and is cost effective in strengthening concrete, masonry, steel, and other structural members. (Carbon Fiber Reinforced Polymer, 2009) Although CFRP can be used as an alternative to steel in reinforcing, its primary use is in renovations, as is the case at Crystal Plaza II.

Typically applied to concrete structures, the CFRP reinforces the column or slab for flexure. The added strength can sometimes exceed twice the strength of the unreinforced section, however, only small gains are made in stiffness. CFRP

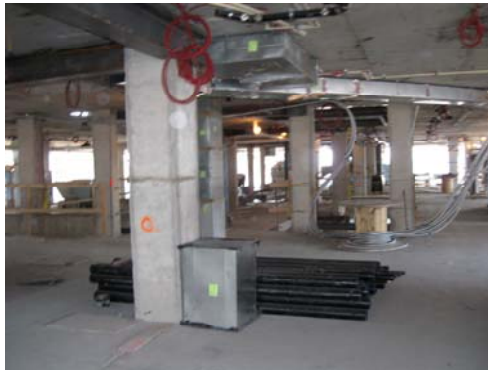
Figure 28 Typical installed material requiring

As stated earlier, much of the area requiring the CFRP is already complete in terms of rough in of the primary systems (mechanical, plumbing, framing). This requires the installed material to be removed by the subcontractor responsible, stored during the installation process of the CFRP, and then reinstalled, essentially doing the work twice. Not only does this impact the schedule, but the quality of work and product as it runs the risk of damage during removal and reinstallation. Luckily the installation process was started prior to the close in of the walls, requiring no drywall to be removed and little framing.

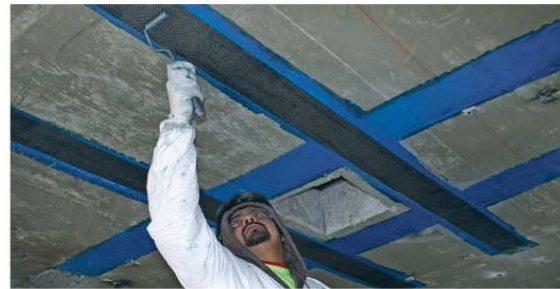
Figure 29 Installation of CFRP

The installation process for CFRP requires a large lay down area and somewhat dangerous chemicals to adhere the carbon fiber to the slab. Initially the slab was cleaned and prepped for the installation; the CFRP was then applied, allowed to dry, and then covered with a protective resin. This process takes anywhere from 2-7 days per floor and requires the work on the floor of other trades to basically stop. The ability for the trades to work on other floors, such as above or below, allows the project to stay on schedule overall, but adds about a 3 week delay to any given floor as the CFRP process is completed. However, since the project was proceeding ahead of schedule, there are no problems with this delay as it becomes even less on the upper floors where fewer strips of CFRP are needed.

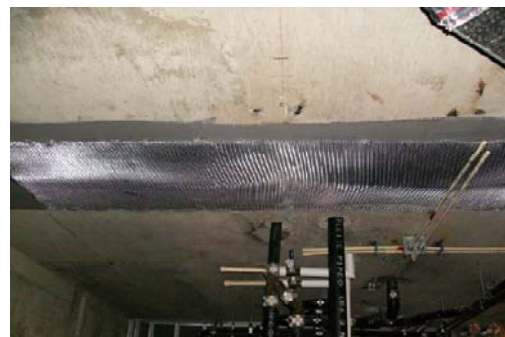
Figure 30 Installed CFRP with 2 hour fire proofing

The next issue with the schedule occurred when the overlooked task of fireproofing was noticed. The requirement did not arise until after drywall had been installed on the lower floors. To further complicate the situation, local inspectors would not continue close in inspections until the issue was resolved. This caused the drywall schedule to be extended by 2 weeks, however, not being on the critical path, did little to the overall project schedule.
