LAFAYETTE TOWER  
WASHINGTON, DC  
JUSTIN WINGENFIELD  
CONSTRUCTION MANAGEMENT

Justin Wingenfield  
Construction Management

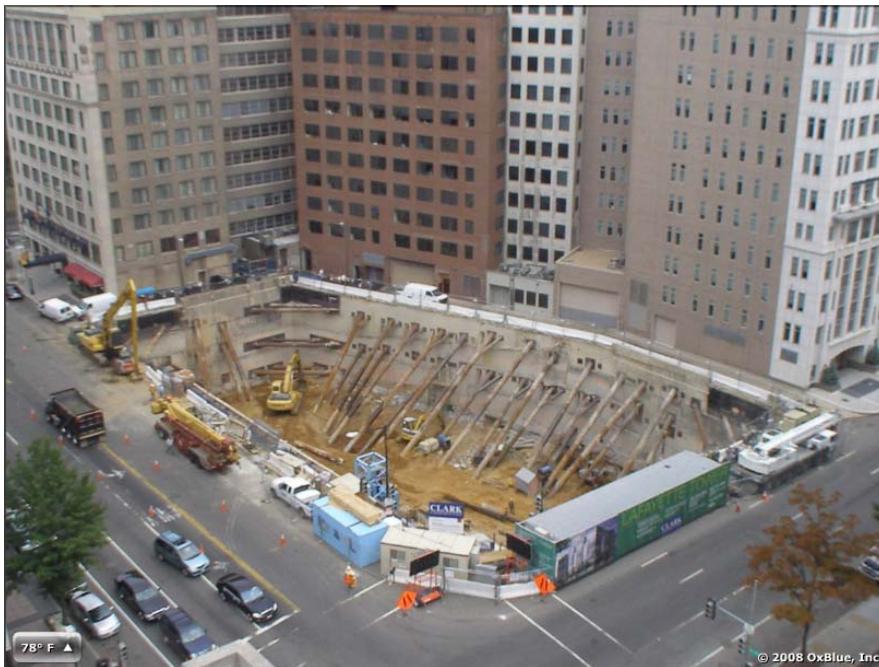
Figure 1 - Demolition Site Picture

The first phase that took place was the demolition of the existing building. The picture below illustrates what the site looked like once the demolition was complete. It gives a great view of all of the support of the foundation walls in place. You can also see Clark's site trailer, storage sheds, and various pieces of equipment around the site.

The only problems that I noticed with Clark's site layout is that the south-west corner of the site was extremely congested which would make it hard for equipment and materials to be moved around in that area and also occasionally when materials were being hauled from site, extra lanes of traffic had to be shut down. This could potentially cause some problems with the local authorities especially considering the White House is a few blocks away.

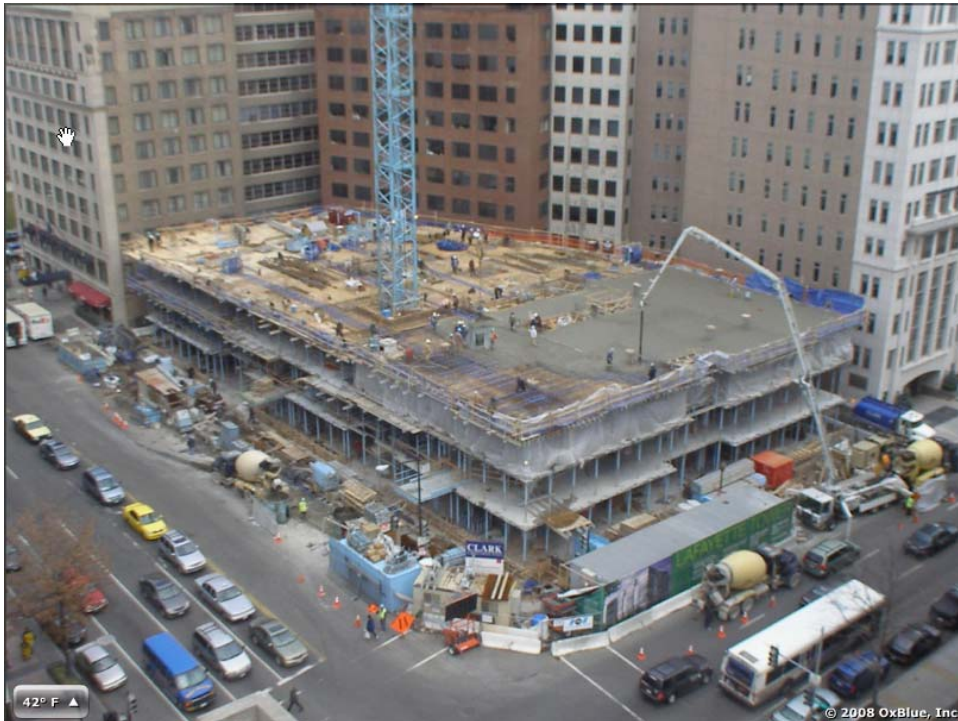
**Figure 2 - Superstructure Site Picture**

The second key phase to be analyzed was the layout while the superstructure was being constructed. Below, you can see what the site looked like while concrete was being placed. In the picture, you can see the pump truck distributing concrete for 4<sup>th</sup> floor deck. Along with that, you can see three concrete trucks either fueling or waiting to fuel the pump truck and the crane which won't be used for placing concrete until the building reaches its upper floors.

I think Clark's site layout is very functional for this stage of construction. Site cleanliness is somewhat of an issue in the above picture and needs to be kept under control better.

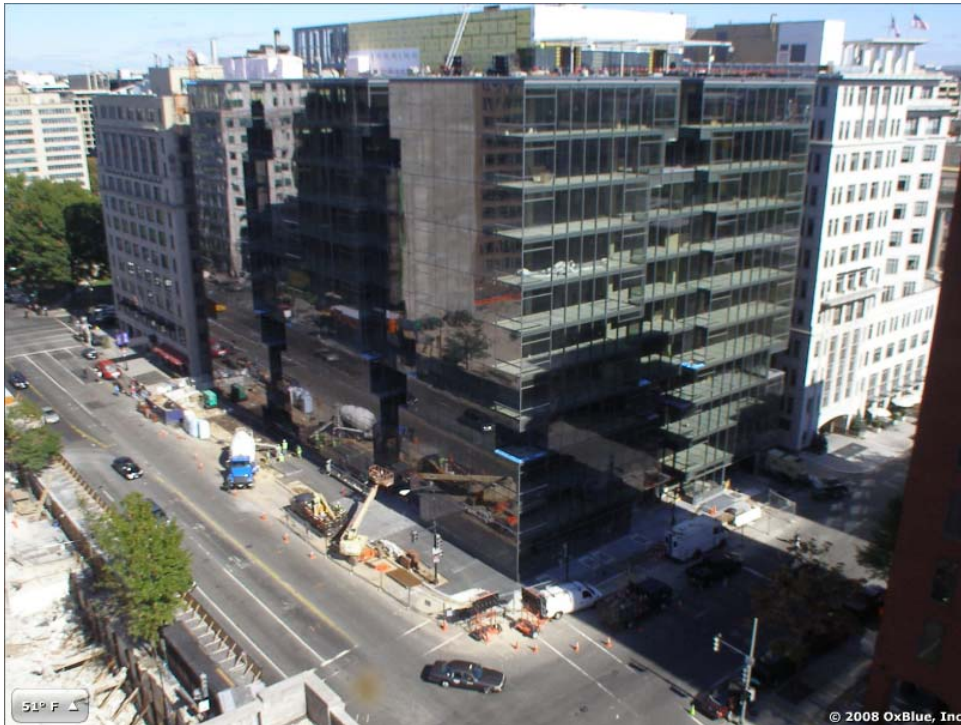
**Figure 3 - Finishes Site Picture**

The final phase examined was the finishes layout which shows what the site will look like after the building becomes water tight and interiors are the main concern. This is presently the current phase the project is in. As you can see in the picture below, the façade is entirely erected and there is a very minimal amount of activity going on outside of the building. Once the superstructure reached about the 8<sup>th</sup> or 9<sup>th</sup> floor, Clark's office was moved inside so there was no need for a trailer outside.

The only thing that surprises me about the current state of the site is that there is still a lift and a concrete truck on the premise in this picture. Other than that, everything seems to be in order.
