LAFAYETTE TOWER
WASHINGTON, DC
JUSTIN WINGENFIELD
CONSTRUCTION MANAGEMENT

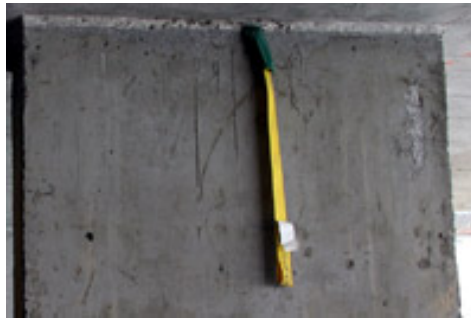
The in-deck anchors were cast into the columns during the concrete pours. Two anchors were placed in each column to accommodate for activities that required more than one person.

Figure 2 - In-deck anchor set in column

In order to go outside of the cables, workers had to be wearing full body harnesses and be attached to the anchors with retractable cable fall arresters. This increased the amount of time it took to complete any activity and also caused frustration for the workers as they completed their day-to-day tasks but was a necessary evil to ensure safety which is always the #1 priority.

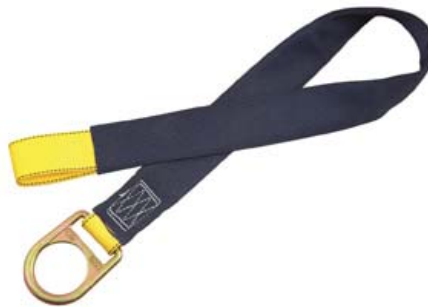
Figure 3 - In-deck wall anchor
