# UPMC Passavant Pavilion

## Technical Assignment 2

Jeremy McGrath | Construction Management | Consultant: Dr. Chimay Anumba

24 October 2008

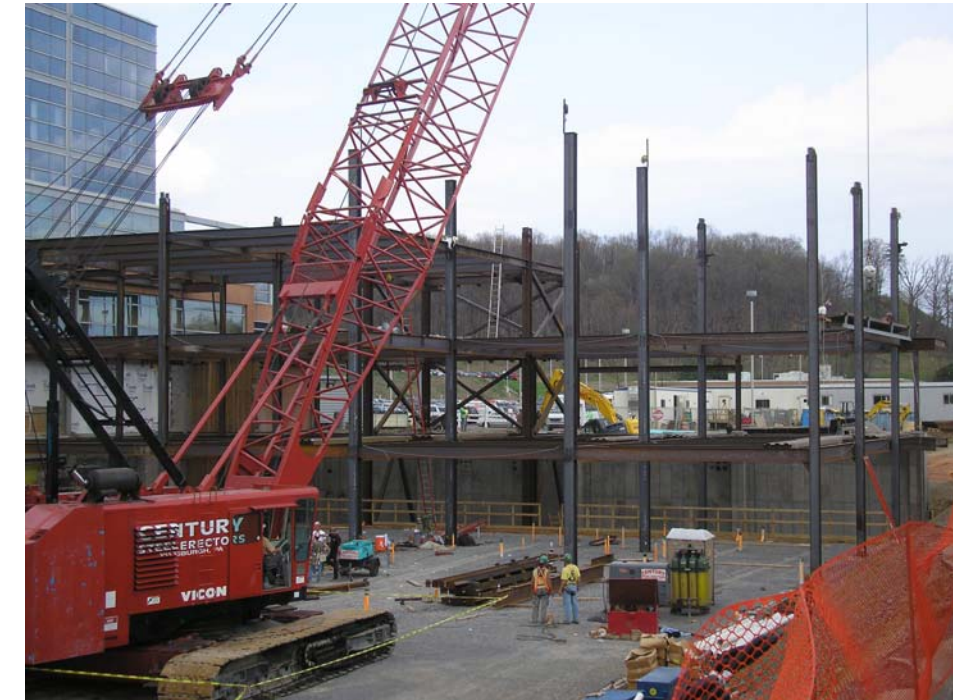
Figure 3. Steel Erection Site Plan – Early Sequences

Figure 3 , Steel Erection Site Plan – Early Sequences, shows the site logistics of the phases of steel erection that occur at the eastern portion of the building footprint. The driving factor of the layout of the staging and storage areas during this phase of construction is the working radius of the steel erection crane. For this project Century Steel Erectors utilized a Manitowoc 4100w crawler crane with a 160' boom and a 40' jib at a 15<sup>0</sup> offset which allows the crane to have a maximum radius of 125'.

The crane's working radius determined its placement within the footprint of the building. As shown below in Figure 3 the crane was positioned at roughly the location of column line 6 of the Pavilion. This location allows the crane to reach all areas within the footprint to the east of column line 6 during the erection of Zones 1 and 2 and the majority of the footprint to the west. With the crane being able to pick from the majority of the western portion of the Pavilion footprint it allows these areas to be utilized as staging areas for the steel members prior to erection.

Staging areas were placed within the footprint of the building, as well as, along the southern most extent of the construction site along Cumberland Rd. A storage area near the western construction entrance was utilized for the staging of trailer loads of steel that had yet to be unloaded and shook out.

When the steel members were delivered to the site the trucks were to arrive from the east by way of Cumberland Rd. This allowed for the minimal amount of interaction between the heavy truck traffic and the patrons of the hospital. As the deliveries arrived the trucks would back into the site using the western construction entrance and then proceed down the ramp into the subgrade level of the Pavilion. At this time the trucks would be unloaded and the shakeout of the steel would occur. Once unloaded the trucks would then exit in the same direction in which they entered and proceed east on Cumberland Rd.

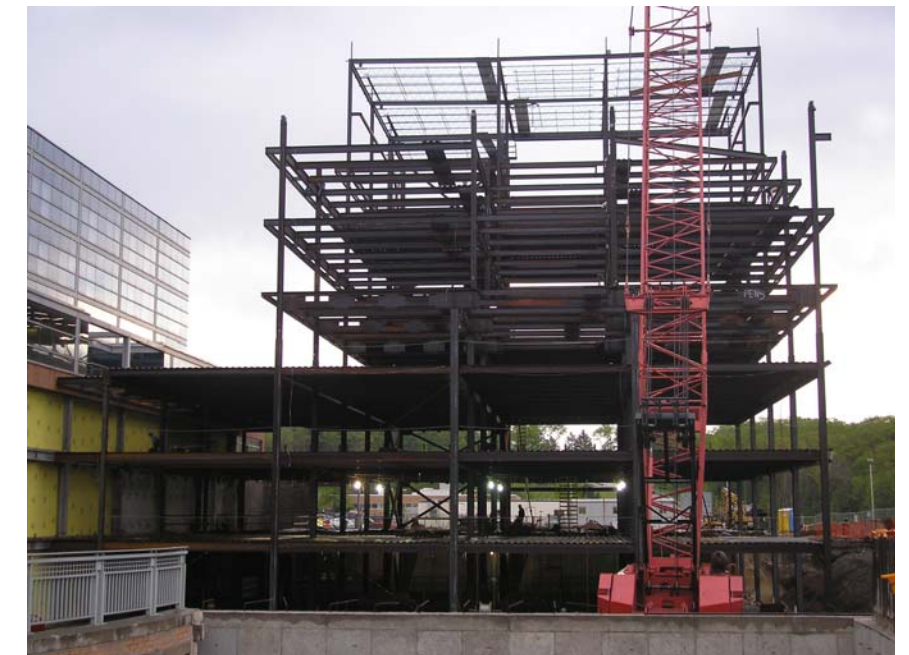
Figure 4. Steel Erection Site Plan – Late Sequences

Once Zones 1 and 2 of the Pavilion Addition were erected it became necessary for the crane to be relocated so that the erection of Zones 3 and 4 could begin. This relocation required the realignment and benching of the ramp entering the excavation so that the crane could be safely during picks.

Since the footprint of the building was now becoming filled with the superstructure of the building the staging areas also needed to be relocated. The optimal locations for the new staging areas were to expand the one located along Cumberland Rd. further to the west and to utilize the area that was previously used as storage area for steel deliveries. These staging areas were well within the picking range of the crane and conveniently located for off loading and shakeout.

The steel deliveries for this phase of the project followed the same path as the earlier phases as they entered and exited the site. This continuity of site access allows for timely deliveries and less confusion among the delivery drivers as they will be familiar with the site and less likely to make wrong turns and enter the site from the wrong direction.

As the steel erection began to near completion and the final pieces were being erected within Zone 4 of the building the crane was working its way out of the excavation. This natural progression out of the hole allowed the crane to be located at its final location on the site. After the erection was complete the crane was laid down along the south staging area near the western construction entrance where it was demobilized and removed from the site.

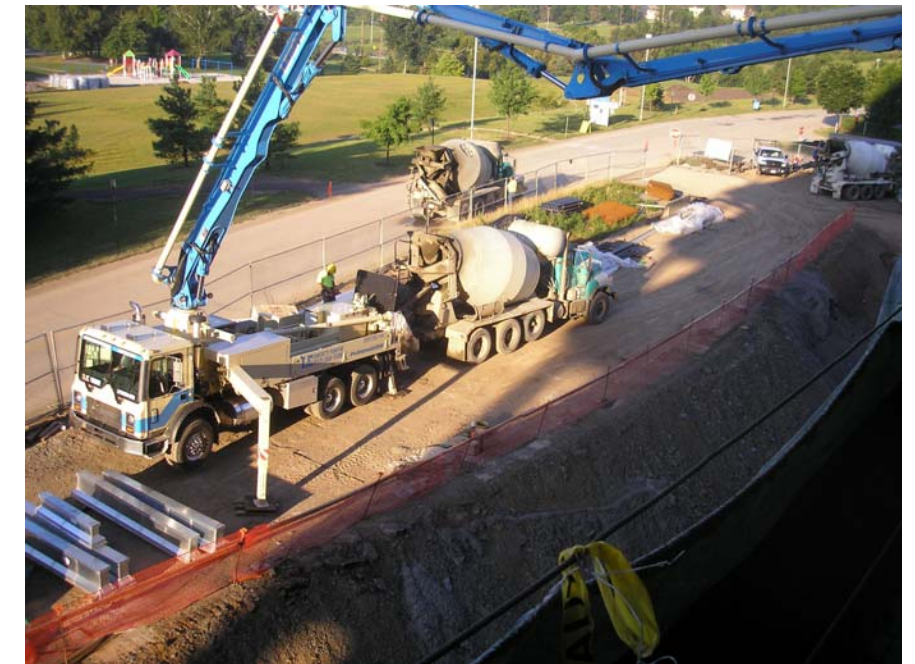
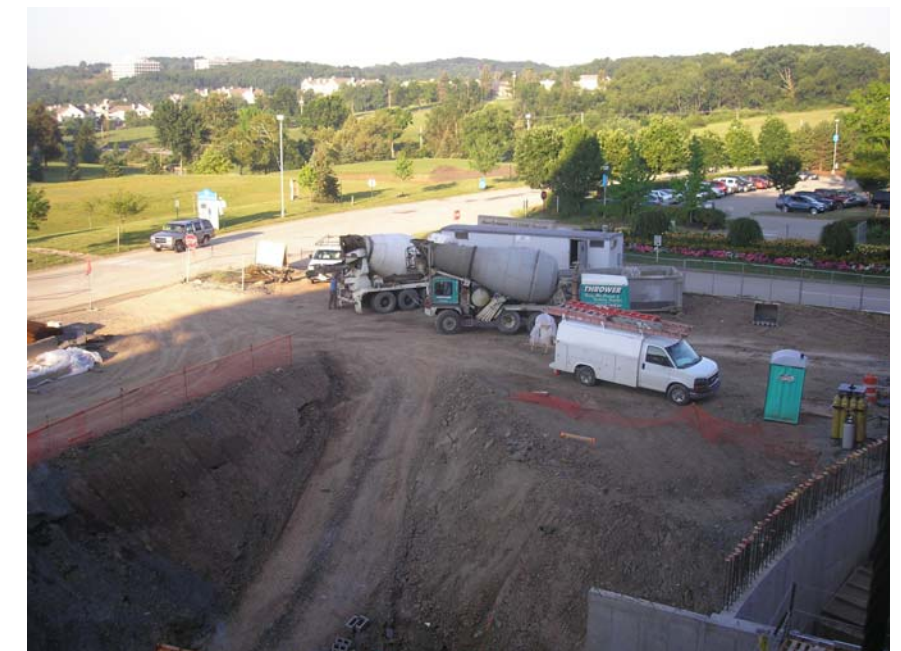
Figure 5. Site Logistics Plan - Overall

As the structural steel frame of the building was progressing towards the east and Zones 1 and 2 were completely decked and detailed the concrete contractor could then begin to place the slabs on deck and the slab on grade in the Pavilion. Again following the general east to west path the concrete placement began at the eastern portion of the building. This allowed the concrete to follow the steel out of the building.

The concrete pump was staged near the ramp which enters the subgrade level of the Pavilion from the east. From this location the pump could easily reach all of the floors of the building. Special care needed to be taken when determining the best place to stage the pump not only for site sequencing reasons but also because of an existing air shaft at the southeast corner of the existing hospital. If the concrete pump was placed too close to the air shaft there was a potential for exhaust fumes to migrate into the shaft and then throughout the hospital.

As the concrete progressed up the eastern zones of the building and the steel began to near completion on the western zones of the building, concrete pours were needed to be made in the west. While the crane was still on site the concrete pumping operation was staged near the south steel shakeout area as shown on Figure 5 below. This required coordination between the steel erector and the concrete contractor so that all operations ran smoothly since they were in such close proximity to one another and to ensure the safety of all the workers as steel was still being raised at these locations.

At this time many other trades began to arrive on site as more of the superstructure began to take shape. This necessitated more site logistics planning as the available real estate within the confines of the construction site began to become occupied. The MEP contractors were onsite as the steel and concrete began to work through the building but the majority of their staging occurred within the building on the floors where the materials were needed.

Masonry, on the other hand, required a great deal of space within the site as they needed staging areas for their materials and scaffolding, as well as, the crane which would lift materials up to the floors of the building. The masonry staging area was positioned directly behind the Wayne Crouse field office and between the emergency access road which allowed it to have minimal impact on the other operations. The mason's crane was positioned near the northeast corner of the Pavilion Addition which enabled it to access all floors at the east stair tower where CMU backup walls and brick veneer were being installed.

All concrete deliveries arrived to the site from the east along Cumberland following the same path as the steel deliveries. Once arriving on site they would enter the eastern construction site entrance and back into position behind the concrete pump. This area was wide enough to enable two concrete trucks to be located at the pump so that as one was emptied the next truck could begin to service the pump and keep a continuous flow of concrete moving into the building.

The masonry deliveries to the building followed the same path to the building as described above for the concrete deliveries. Small tools and smaller deliveries were also made to the site and were able to follow the path around the Emergency Department Parking area as shown on Figure 5.

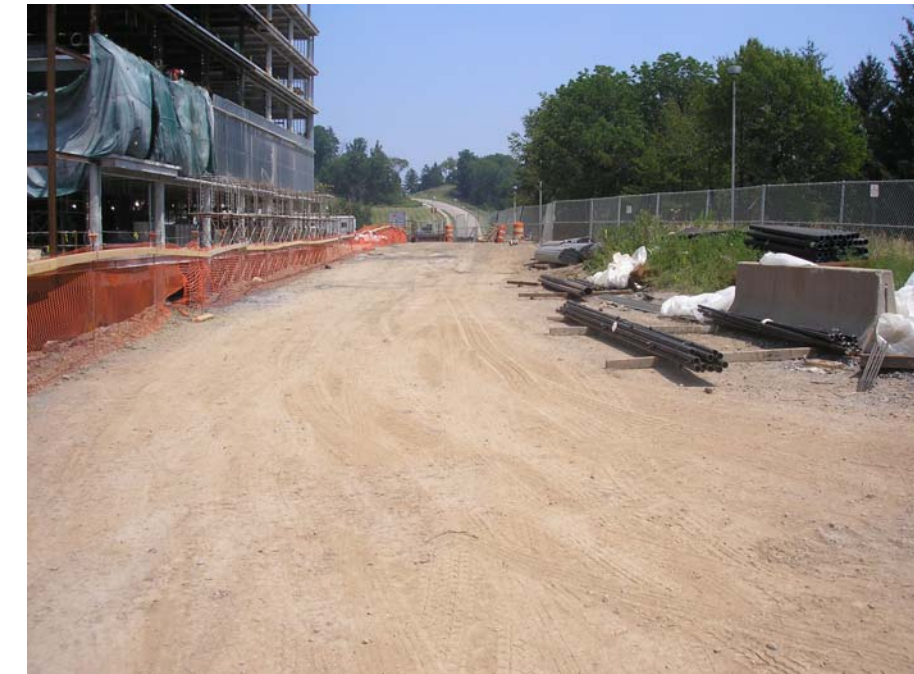
Figure 6. Interior/MEP Deliveries Site Plan

As the superstructure was complete and the interior trades began to finish installing hangers and sleeves within the slabs on deck of the Pavilion deliveries of larger materials were needed to be made to the site. While steel erection was still in progress the deliveries were made at the southern portion of the site and the materials placed on the lower floors by a Lull. This process required that a lane of traffic be restricted along Cumberland Rd. as the deliveries were being made. The restriction of traffic along this road was not appealing to the owner and as more and more frequent deliveries began to be made it necessitated the need for a permanent delivery area along the south elevation of the building.

After the steel erection and detailing was complete the south elevation was free from steel shakeout areas and this allowed this area to be utilized as the main site delivery point. Due to the height of the building all materials above the 3<sup>rd</sup> Floor needed to be lifted with a crane. Lifting platforms were placed on the exterior of the 4<sup>th</sup> through 7<sup>th</sup> Floors which enabled the crane to lift the items to the proper floor. The cranes used for this process were operated by the subcontractors responsible for the delivery and were often shared among the different subcontractors. These cranes were placed along the south elevation where they would be able to remove the materials from the trucks and place them on the lifting platforms.

The trucks making deliveries to the site again followed Cumberland Rd. from the east and then would enter the site near the crane. There was no permanent entrance at this location so the temporary fencing was needed to be moved and then repositioned so that the entire truck would be within the confines of the site. If the need arose two delivery trucks could be positioned on either side of the crane so that a continuous flow of material to the building could be sustained.
