Technical Assignment 3

Alternative Methods Analysis

Integrated Science Center

College of William & Mary

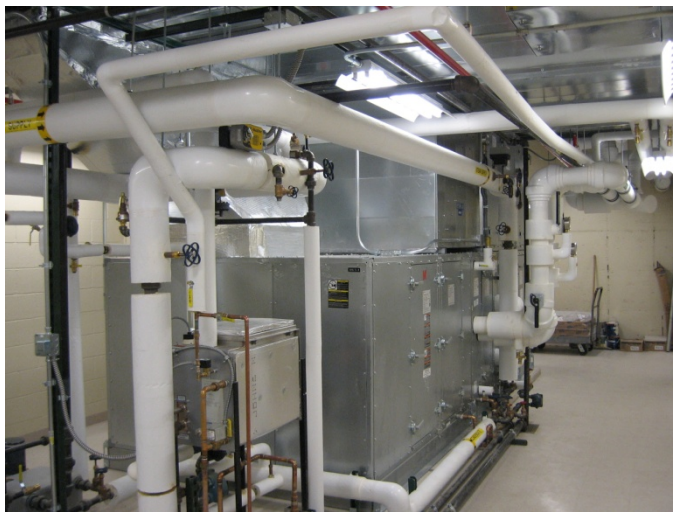
Figure 1.2 – Air Handler Unit

The Integrated Science Center is a state of the art facility which contains over 40 fume hoods. All of the ambient air in the building must be exchanged with external air several times per day. Recirculation of air is not permitted, as the fume hoods are integral to the building exhaust system. Unfortunately, the engineer who specified the air handler units did not take into consideration the massive amount of condensation that would form when operating the system at 100% external air exchange in the humid summer months, and as such, moisture began to overflow the small drain pans and flood the penthouse floor. After consulting with the design engineer, manufacturer, and mechanical contractor, the following measures were implemented.

1. Operate the system at less than maximum airflow. The system was designed for each unit to draw 43,000 CFM; however, they were originally operating at 48,000 CFM per the Owner's specifications. After additional modifications were made to the air distribution system, the airflow at each unit was lowered back to the 43,000 CFM, which helped to mitigate, but not eliminate the problem.
2. Addition of moisture eliminators and larger drain pans finally resolved this issue. The moisture eliminators effectively contained the excess moisture being blown off of the coils and deposited the condensation into the larger drain pans which were capable of handling the excess capacity. Please see Appendix A for moisture eliminator product sheet.

- *Moisture Carry Over at AHU*
As discussed previously, the engineer who specified the AHUs did not take into consideration the massive amount of condensation that would form when operating the system at 100% external air exchange in the humid summer months. As a result, moisture began to overflow the drain pans and flood the penthouse floor. The system was designed for each unit to draw 43,000 CFM; however they were operating at 48,000 CFM per the Owner's specifications. To fix this problem, the airflow at each unit was lowered back to 43,000 CFM, moisture eliminators were added and larger drain pans were installed. This situation could have been avoided if the proper AHU was specified initially. With the help of mechanical professionals, a new AHU system could be proposed. What would be the difference in cost be compared to the original system?

The Integrated Science Center is a state-of-the-art laboratory facility and it requires an elaborate mechanical system. The humid summer months caused an excessive amount of condensation to form when operating the system at 100% external air exchange. As a result, moisture began to overflow the drain pans and flood the penthouse floor. I would like to propose a new AHU system that could handle the building demands during Williamsburg's humid summers. The estimated new system cost could then be compared to current system plus the added expenses for larger drain pans and moisture eliminators.

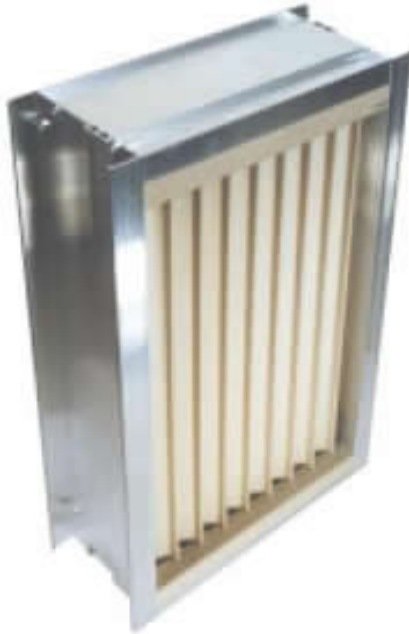
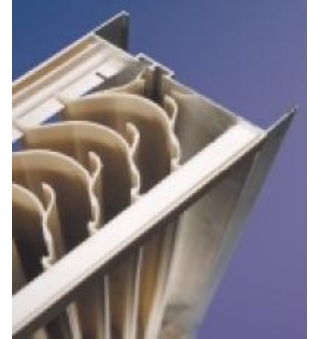
AHU COMPONENT - MOISTURE ELIMINATORS

Modular, flexible and made of different materials, the Arosio Moisture Eliminators represent the most effective system to remove humidity. Thanks to their blade profile made of polypropylene they ensure a constant efficiency.

The polypropylene-bladed moisture eliminators are specially designed to meet many requirements in air treatment. The screwed extruded aluminium frame is extremely solid and gives sturdiness to the whole system. Also available with/without bottom drains.

- **BLADES** polypropylene + talc / extruded aluminium
- **DISTANCE-SETTING PROFILE** polypropylene, pitch 25 mm and 33 mm
- **VERTICAL CLOSING PROFILE** polypropylene
- **FRAME** extruded aluminium
