ANALYSIS 4: PEDESTRIAN SAFETY

Critical Issue Research Method

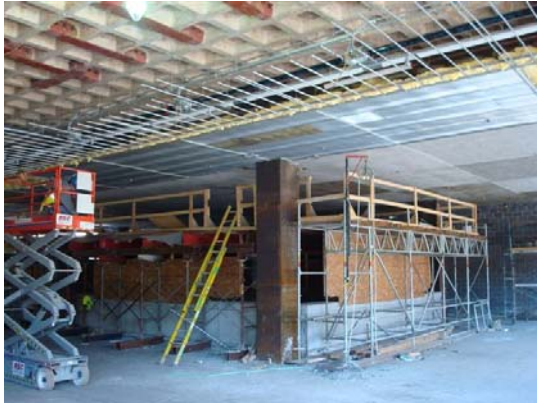
Figure 24: Photo showing the escalator ceiling work.

down and the curtain wall installation took place along D Street and the ceiling work directly above the escalators was completed. Figure 24 shows the ceiling work taking place over the metro escalator. From the start of the project, overhead protection was in place in order to protect pedestrians while demolition was taking place. Finally, the metro entrance was reopened on July 1, 2008 and overhead protection was eliminated since all overhead work was complete. Additionally, special measures were implemented to protect pedestrians while the remaining work along the streetscape and lobby are being completed.

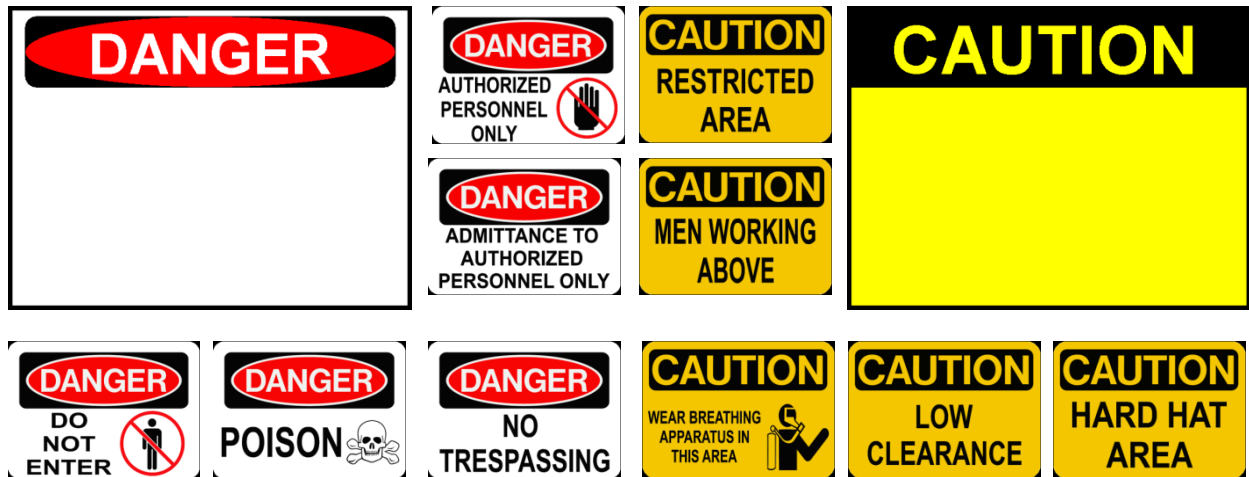
Figure 26: Examples of the Danger and Caution signs used according to Subpart G

After learning about DAVIS' safety techniques, it was researched the OSHA requirements that are the same for every project. It is necessary that the employer must initiate and maintain accident prevention both on and around the site. In order to do so, there should be an established safety training and education program. Additionally, general housekeeping must be followed in order to keep everyone safety, including pedestrians that would be passing by. Since the construction site was shutting down one of the entrances to the metro, there had to be an established plan with the metro in case of an emergency would occur in the tunnel. This plan was then documented and hung around both the construction site and the metro area to make everyone aware of what to do in case of an emergency. Subpart G of the OSHA Standard for the Construction Industry outline the sign and barricade requirements. Figure 26 provides examples of what the signs should look like.
