ANALYSIS 2: STRUCTURAL INTEGRITY OF THE PARKING GARAGE WAFFLE SLABS

Structural Breadth

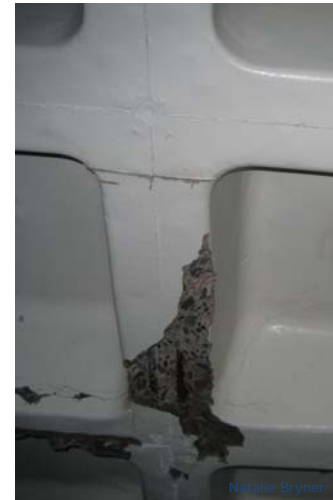
Figure 17: Section of the waffle slab that was contained spalling concrete with rebar exposure.

Throughout the three levels of the parking garage, there were sections that needed to be updated structural in order to insure they would not only hold the weight of the parking garage, but also support the floors above, including the additional of a Pent House level. In order to determine if a section needed to be updated, there were several tests that were preformed. First, a few occasions were recommendations of the engineers, even when the concrete looked sound. One type of test that was completed was using “sounding” to test every area of the garage to see if it was sound. This test consisted of listening to the tones of the reverberations caused by dragging heavy chains over the concrete. To know if an “area (contained) bad concrete, the sound became hollow.”²⁰ The second type of test that was performed was using a hammer or pole to check the overhead parts of the waffle slab. This test produced the same hollow sounds if a section contained bad concrete. Additionally, manual inspection was complete in order to replace exposed and/or corroded rebar, along with visual spalled sections. Figure 17 provides an example of a spalled section.

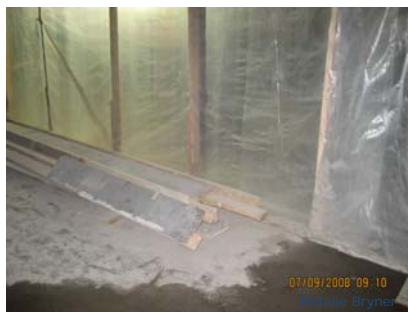
Figure 18: Photo showing the poly-wall used in the parking garage

While all of the above steps were taking place, the area of the parking garage that they were repairing would be completely sectioned off. This meant that no other construction could take place in the area. Poly-walls (Figure 18) were used to contain the dust created in this area and prevent people from walking on a weakened section. The areas were also sectioned off due to the risk of falling debris, open holes, dust, and sound controlled. A safety requirement for the CRS employees is that respirators were required and that the shoring had to remain in place until the concrete was at 100% strength.

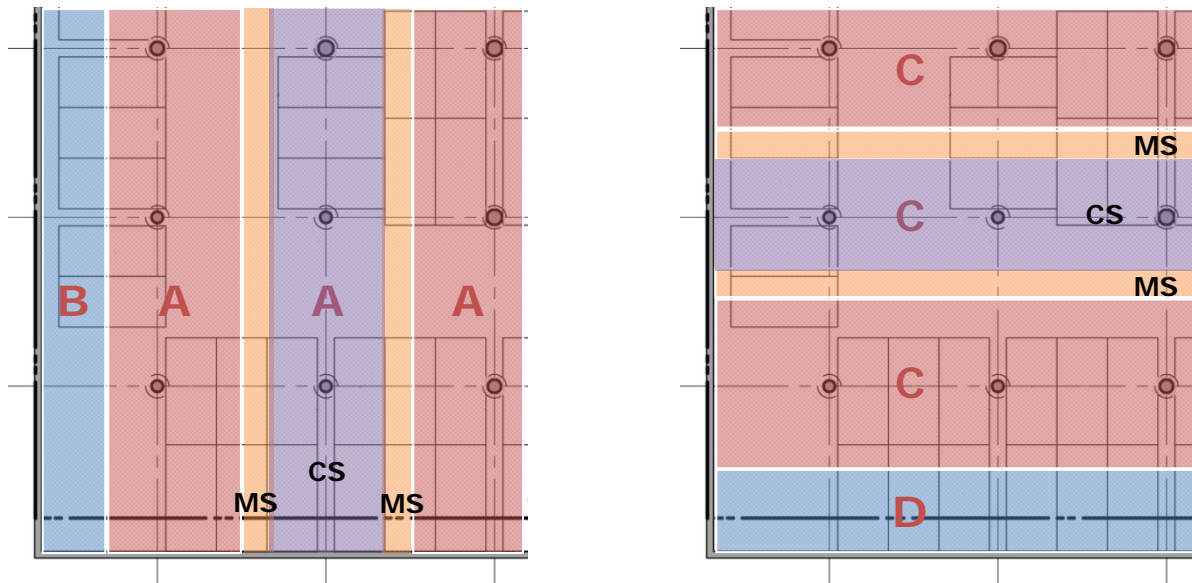
Figure 19: Diagram showing the frames used for the calculations

First the parking garage was broken up into 4 sections. The four sections are Frame A, Frame B, Frame C, and Frame D. Frames A and C are interior frames, which Frames B and D are end frames. Please see Figure 19 for a visual representation of the areas that the frames cover. After determining the frames, we know that each of the bays are 30' by 30' and the columns are 26" by 26". The other given information can be found in Appendix F. After all the given information was determined, the values were imported into an excel spreadsheet made to calculate the number of rebar needed for each frame. These spreadsheets can also be found in Appendix F. Table 7 is a summary of the tables, which shows how many pieces of #8 rebar are needed.
