Waynesburg Central High School

Technical Assignment #3

Robert O. Brennan
Construction Management
Adviser: Dr. Riley

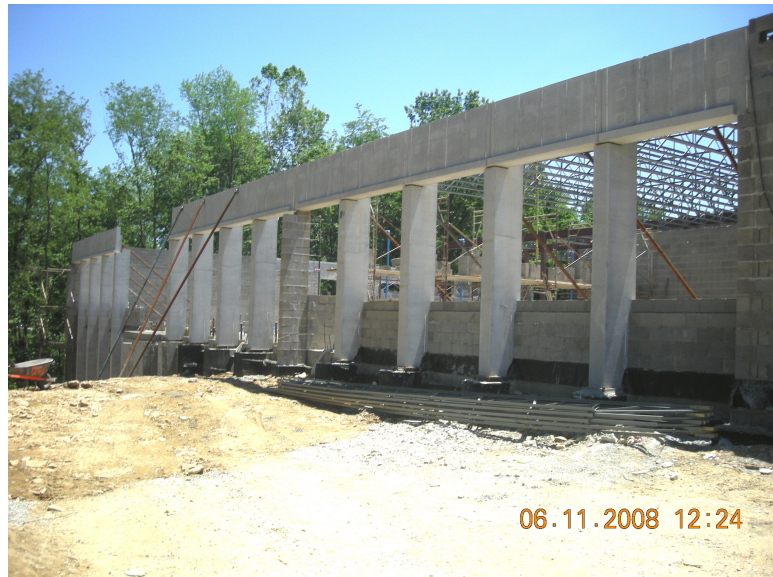
Figure 2: Precast concrete at building G

Congestion on a construction site is something that is to be avoided at all cost; it lowers productivity and also creates an environment that is less safe. Precast concrete did not alleviate any congestion on the site but actually caused increased congestion because of the dead men that needed to stay in place till the structure was stabilized. The dead men pictured in figure 2 and figure 3, show the amount of congestion caused. Scaffolding had to be built around the dead men in

order for the masons to lay the block, which was completed before any of the dead men were removed. The dead men did not allow for easy movement through the building and only left the middle corridor for transportation.

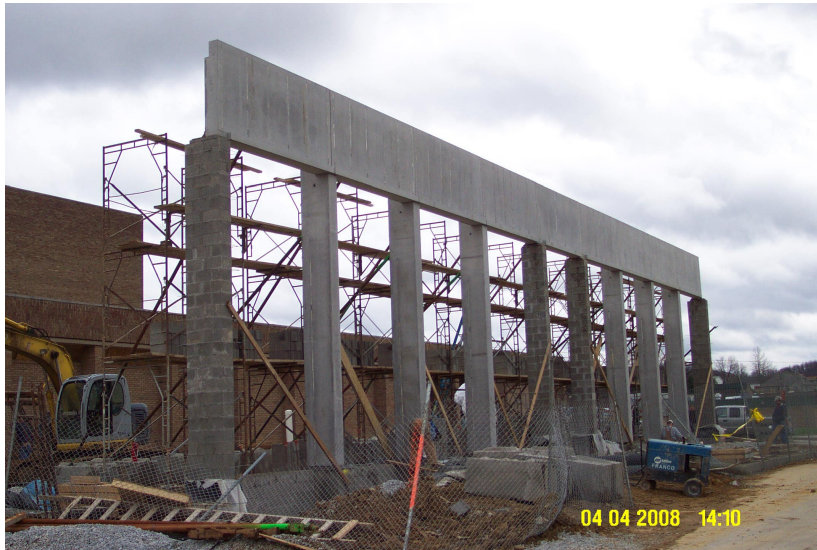
Figure 3: Precast concrete at building F

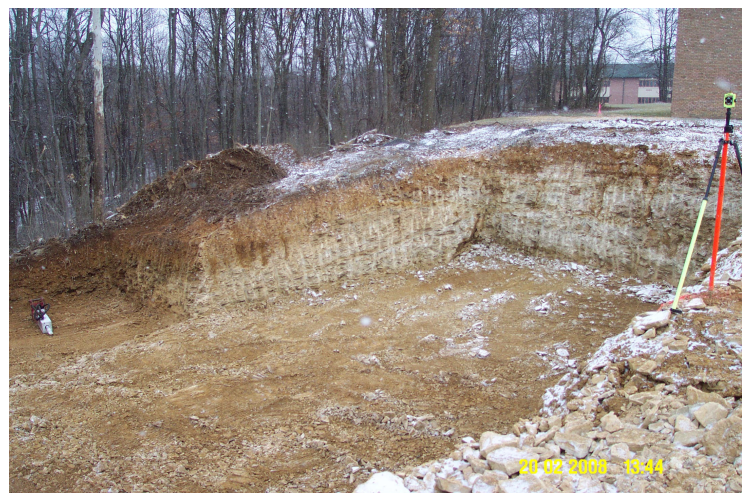
Figure 4: Excavation on building G

On any construction project the most critical phase to ensure completion on time is the excavation and getting the building out of the ground, this is where the most unknowns lie. At Waynesburg Central High School the project was no different except for the actual implementation of the drawings. Plans and specifications for Waynesburg Central High School called for spread footings 7' to 8' deep. During the excavation rock was

encountered at a depth of 3 feet. All geotechnical reports showed that rock did not exist till much deeper and that is why the foundations were originally designed at 7' to 8'. Another geotechnical report was done to find the bearing capacity of the soils at a depth of 3' to 4'. When the bearing capacities came back the foundations were then redesigned and elevated to the shallower depth. By having the engineers take another look at soil conditions and ultimately redesign the foundations it saved the excavator from having to hammer 4' or more of rock and saved an estimated two weeks.

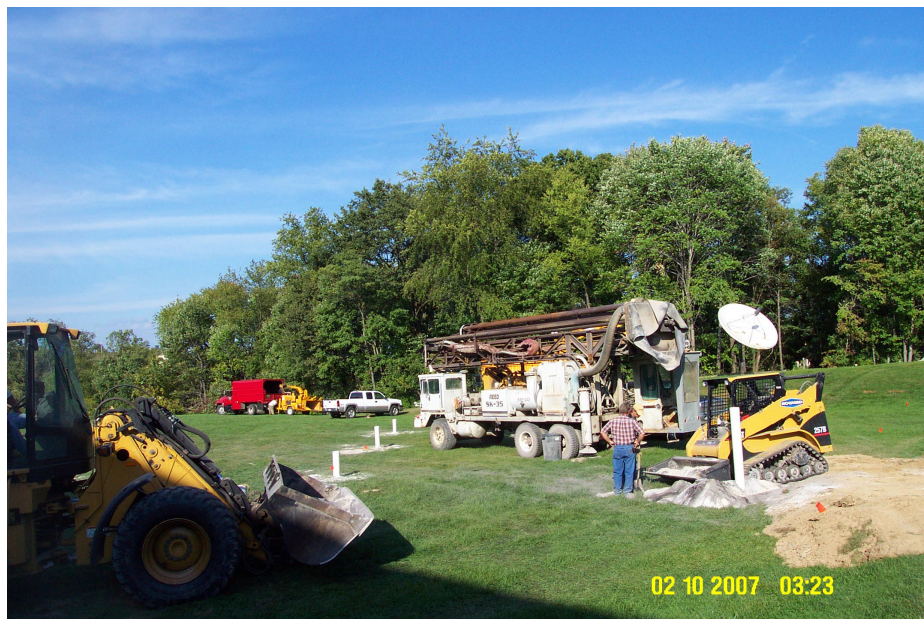
Figure 5: Mine grouting

Western Pennsylvania has several regions that were mined in the past and the site of Central Greene School District has some underground mines that needed to be stabilized. This part of the package was actually opted to be taken out and completed under a separate contract. For constructability reasons mine grouting needed to be taken as a factor. Mine subsidence is something that could cause serious damage to a building. Mines need to be stabilized to ensure that differential settlement does not occur in the foundation. Differential settlement can cause serious problem in a building and to the structural stability. Mines on the site at Waynesburg Central High School were stabilized before other construction began to ensure the structural integrity of the building. In the section titled Schedule Acceleration Scenarios explains the reason that the mine grouting was removed from the contract before bid.

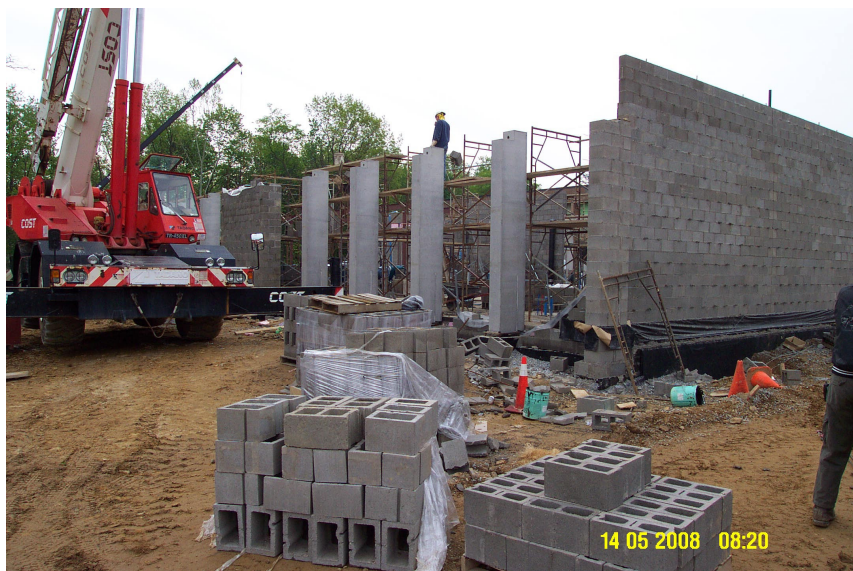
Figure 6: Precast concrete erection

concrete for a structural system caused for a longer schedule and less productive worksite. Since the precast concrete was simply a performance spec this caused for an allowance of time to be left in the schedule for the manufacturer to produce shop drawings that were then submitted for approval. Pieces of the precast concrete system then began to be manufactured. Pieces were stored at the manufacturer's site until the delivery date at

which time they were delivered by tractor trailer. Precast concrete members were erected directly from the truck by a 40-ton mobile crane. The process for erecting precast structural concrete in and of itself is

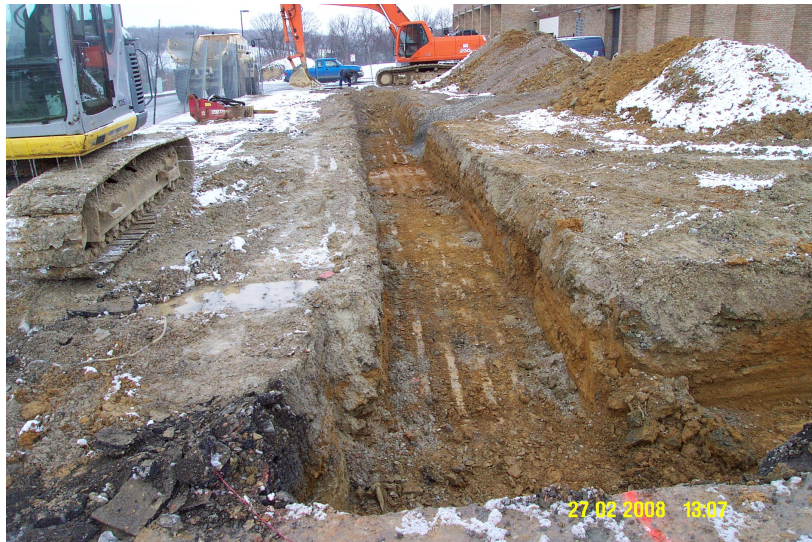
Figure 7: Shallow foundations of building F

Reducing the depth of the foundations created less material to be excavated which always leads to a time savings. In excavation the amount of time it takes to remove a given quantity of material is directly correlated to the properties of that material. In the case at Waynesburg Central High School the material that was encountered was rock, which is one of the most challenging materials to remove. Removing rock requires hammering which is very costly and time consuming. By reducing the depth of the foundation by approximately 4' as much as two weeks of hammering were cut off the excavation process.

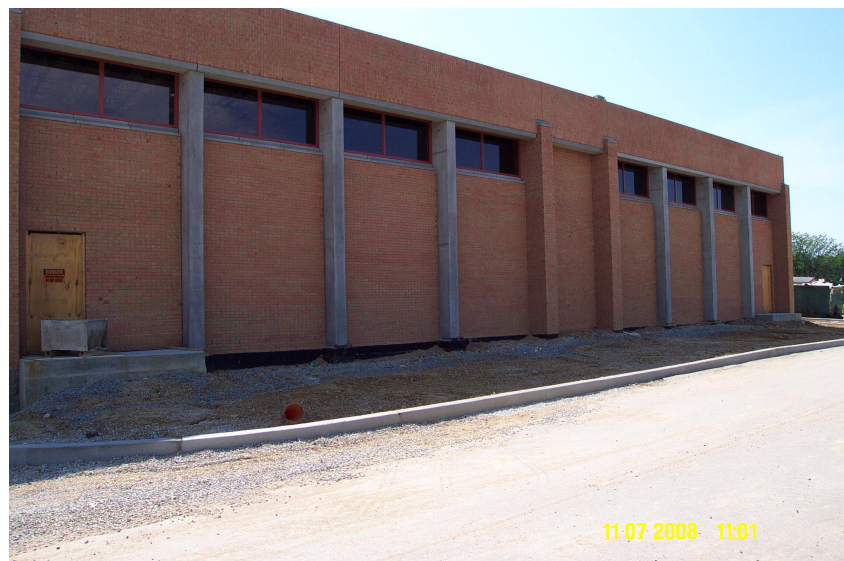
Figure 8: Finished exterior of new music suites

High School by the architect primarily to achieve a specific aesthetic, which is shown in figure 8. Vertical concrete columns and the horizontal concrete lintels were the desired goal of the architect. If this system had been further analyzed it could have been found that the same look could be achieved by utilizing structural steel members and then wrapping the columns with a nonstructural concrete component. With the construction manager coming

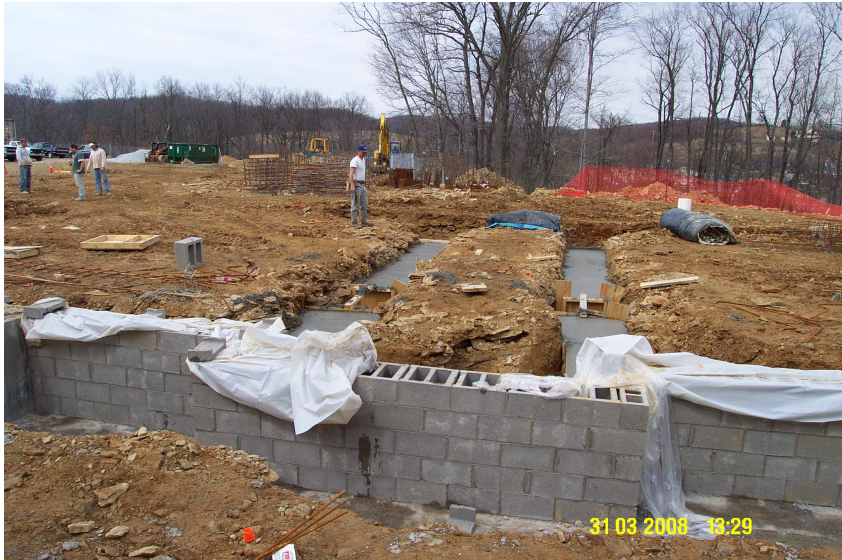
Figure 9: Shallow foundations of building G

Foundations at Waynesburg Central High School are a great example of value engineering because there was foresight of cost savings. During excavation rock was encountered at a much shallower depth than originally assumed. Since foundations were already designed and planned for a depth 4' deeper, a decision was made to reengineer the foundations and explore the potential savings. When it was determined that the soil encountered was suitable for a foundation to be placed it was decided to decrease the foundation depth by approximately 4'. Reducing the foundation depth eliminated an average of six courses of block saving a large amount in material and labor.

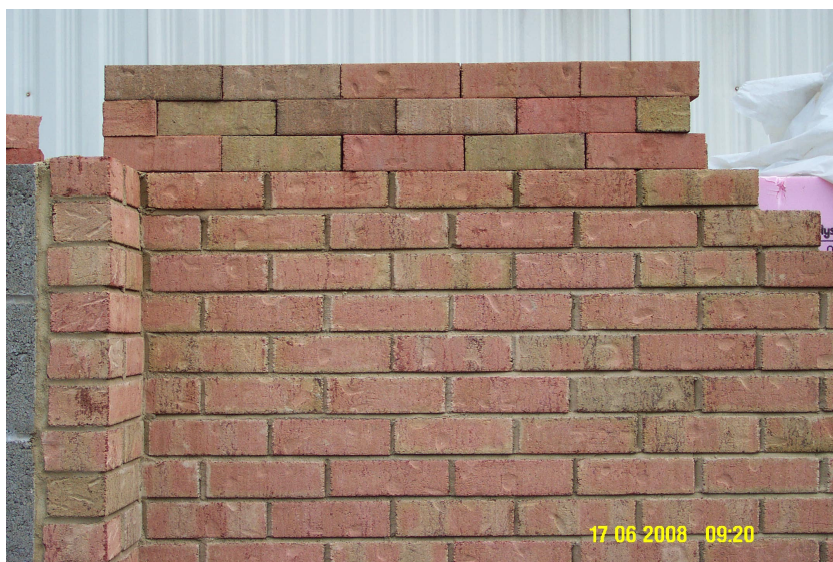
Figure 10: Top 3 courses new brick, bottom courses on building F

Waynesburg Central High School has done this well. There have however been points due to contractor errors when areas could not be worked in because a product was late or the wrong product was delivered or ordered. Waynesburg Central High School is a masonry building with exterior face brick which was tried to be matched for the additions so they would not stand out. There are two additions on Waynesburg Central High School in opposite sides of the building. Each addition had a different completion date and therefore similar activities on each would commence a little over a month apart. Since there was a difference in schedule brick for building F was ordered and delivered separate to the brick for building G. When the brick for building G arrived later it did not match that which was already installed on building F, this is shown in figure 10.

Through a series of meetings the issue was resolved and new brick was fired and delivered to site for installation. This process

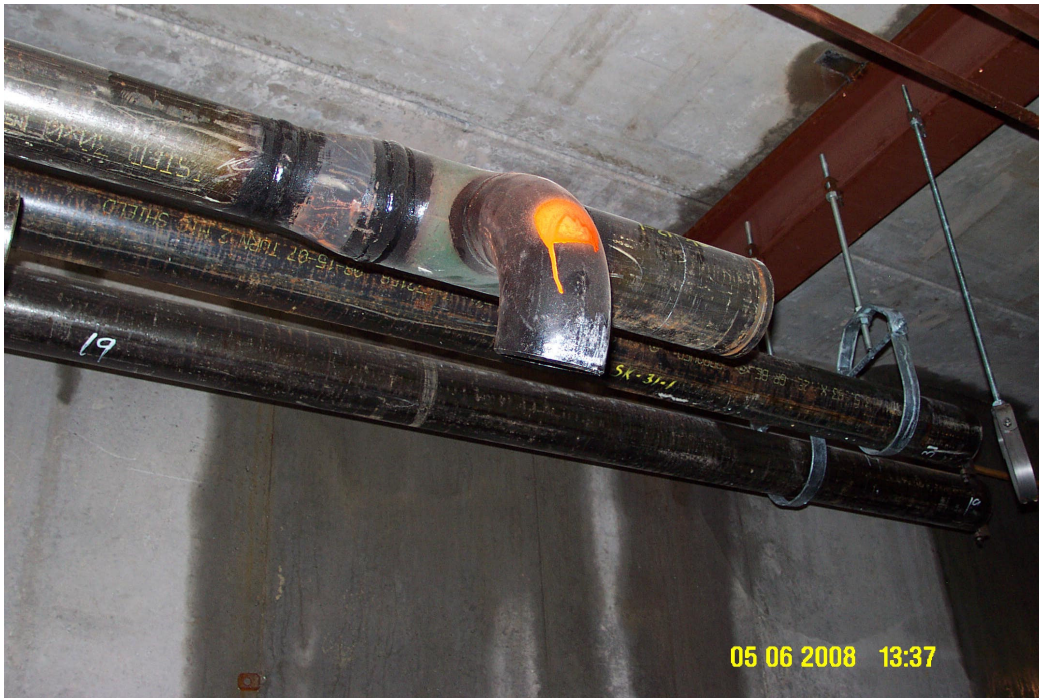
Figure 11: Foreign pipe marked in orange

drawings. The construction manager addressed the situation with the contractor who did not feel they were necessary because the equipment the lines were feeding already had shut off valves. Over 20 valves that are clearly marked and called for on the drawings were not placed in the system. The same contractor also had problems with not providing the same product that was approved in a submittal. Public project do not allow foreign piping to be installed, this contractor however installed foreign pipe on the project and when approached about it chose not to remove and replace the pipes with American made material. Figure 11 shows the foreign pipe that was not removed marked with orange spray paint. These are only a few of the problems that have come up due to a lack of performance by contractors and the increasing use of the legal system to settle disputes.

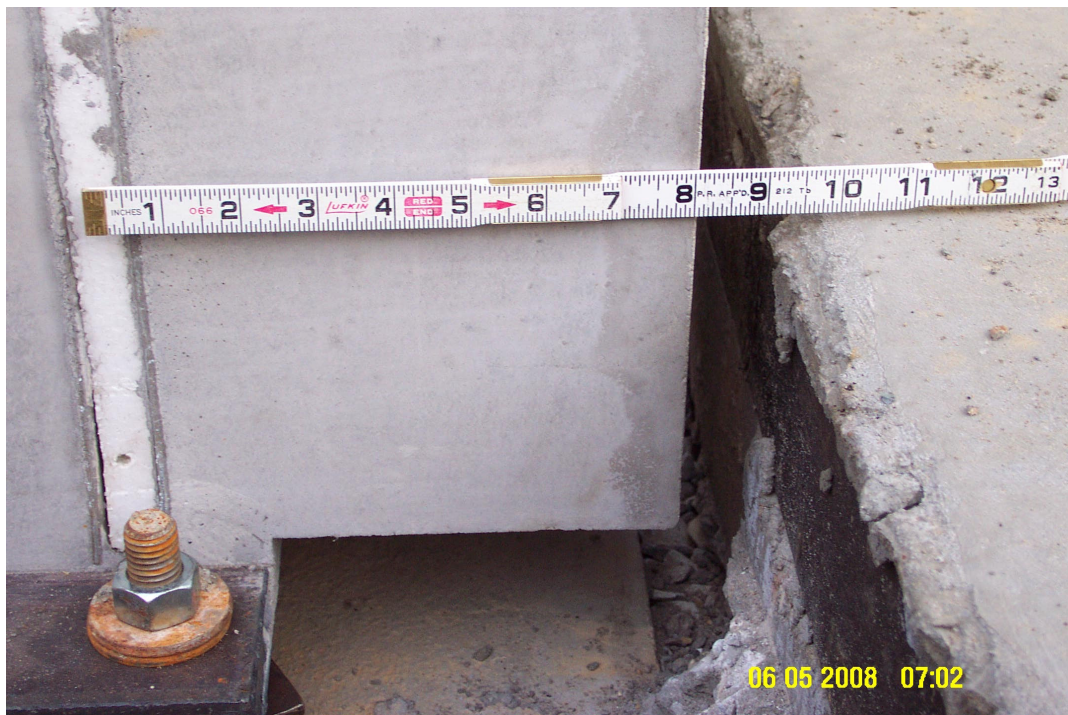
Figure 12: Offset precast concrete column

Precast concrete at Waynesburg Central High School caused several problems. One problem that came as a result of the precast concrete was the columns being set in the wrong location. The precast concrete columns were set 4 inches in from where drawings showed. This resulted in several changes being made. With the column set into the building it no longer allowed for the white vertical strip shown in figure 12 to be used to tie brick into as initially designed. Figure 12 shows the base of the precast column and the edge of the concrete slab with a ruler showing the distance to the white groove. Since the groove is only 9 inches from the edge of the concrete slab there is not adequate space to install

concrete masonry units and still be able to tie brick into the groove. Concrete masonry units with face brick were still used as infill between the columns. As a result of the offset a different method of tieback was used at the edges butting a column. The offset in the precast concrete columns not only resulted in the changing connection between brick and column but also effected the connection to the open web joists resting on the beams. Since the bottom cord on open web joists always has extra that does not
