Technical Assignment #3

Scott Earley
Construction Management
Consultant: Dr. Riley
11/21/2008

The Washington County Regional Medical Center

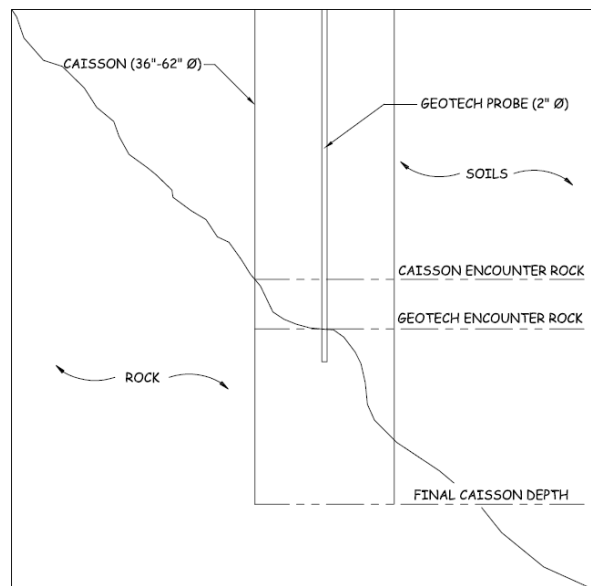
Figure 1: Caisson Diagram

The main issue with the caissons is the ability to reach sufficient bearing rock. This issue is not directly related to the caisson operation. The subsurface conditions show the rock sloping on the site at about a forty-five degree angle with areas sloping even more severely. The rock on site, when encountered, was also fractured at the surface. When the geotechnical report was performed to show the depth of adequate bearing rock, a two inch probe was used. The caissons vary in diameter, but the smallest size is thirty-six inches. When the caisson drilling apparatus was used to drill the caissons and it reached the depth at which the geotechnical report determined suitable bearing rock, only a portion of the diameter of the drill was on the rock. Consequently, satisfactory bearing pressure could not be reached. Please see Figure 1 for a diagrammatic view of the situation. The caisson contractor had to drill through the rock until the whole caisson was bearing on rock. As mentioned previously, the rock was at a steep angle which meant some of the caissons had to be drilled twenty more feet. This posed numerous issues related to the schedule and cost of the caisson operation and how it would greatly impact the remaining activities.

Figure 1 is for diagrammatic purposes only and was drawn by the author, not to scale.

As discussed in the previous two technical assignments, the medical center has three bed towers that are supported by a deep foundation system. The system chosen for the project was caissons. There are 150 caissons divided among the three bed towers. The depth varies from approximately six feet to about fifty feet; nevertheless, all of the caissons must reach an adequate rock surface with bearing pressure of 80,000 pounds per square foot.

The project team overcame this issue by adding more manpower and extra equipment. Since the site is fairly large and open and the project is in early stages of construction, space for extra equipment and men was not an issue. The original plan for the caisson operation included two drilling rigs and two crews working eight hour days. Since this delay in schedule, the plan now consists of six drilling rigs and six crews working ten hour days and every other Saturday.
