Thames St. Wharf Office Building

Technical Assignment III

Author: Chris Bell

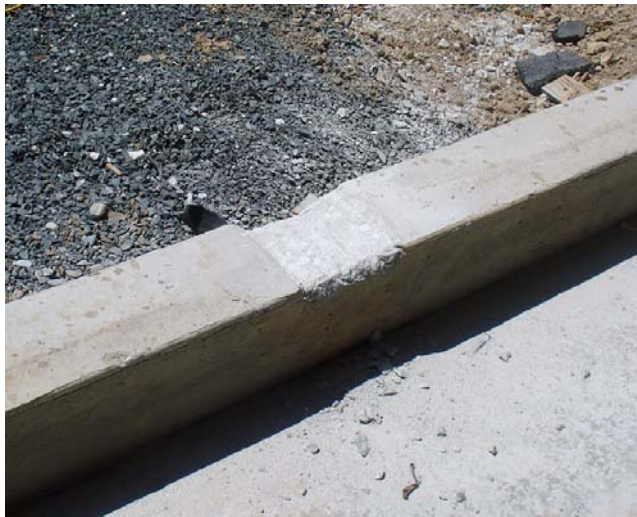
Concrete Curb Chip-Out Ground Floor

The concrete structure was built larger than the design had originally intended. It was built correctly per the contract drawings issued to the concrete subcontractor, but those drawings differed from the drawings issued to the other subcontractors. This had the biggest affect on the curtain wall. Multiple beams were poured two (2) inches to long and are now in conflict with the aluminum supports for the curtain wall. Additionally the concrete curbs that support the curtain wall on the ground floor were two (2) inches to tall causing the supports not to fit.

This was a problem that Armada Hoffler inherited and had no control over. They were completely unaware of this issue until they walked onto the site and found it when the curtain wall contractor came to install the curtain wall but was unable to. To remedy the situation the concrete curbs needed to be chipped out the two inches necessary where the window supports would be located. Where the curtain wall intersects the beams the curtain wall will be trimmed around the beam. The beam cannot be chipped away for fear of possibly exposing the rebar. Additionally all of the door openings were too small for the doors and frames that had been ordered and needed to be chipped out to allow the frames to fit. It is still being determined who will pay for the added costs associated with the concrete chipping though it is known that SBER had to pay the concrete subcontractor to demobilize and then remobilize.

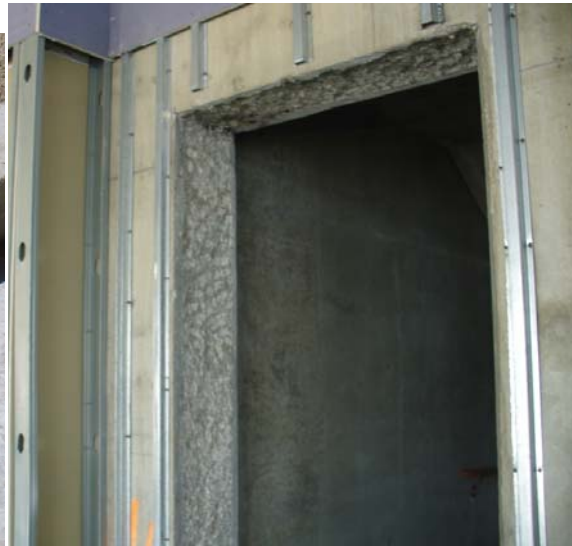
Concrete Door Chip-Out
