**TECH REPORT 3
SANTA ROSA JUNIOR
COLLEGE STUDENT
CENTER**

Alternative Methods Analysis

**Dan Vallimont
2009 SENIOR THESIS**

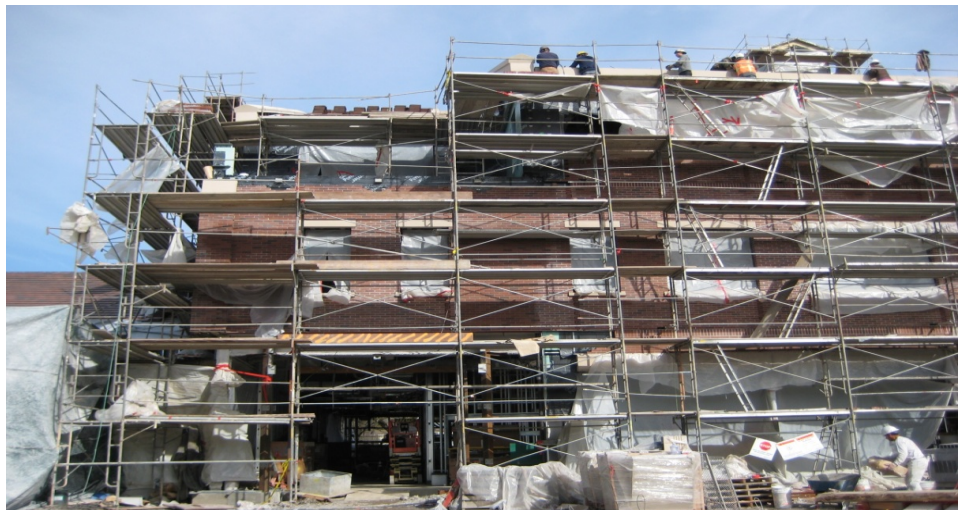
Right: Installation of brick veneer façade.

As mentioned several times before, the problem of having such small tolerances for the installation of the brick veneer façade created numerous headaches on the job site. The small ledger angles that were welded to metal studs were not as much of a problem as the WT's. The WT's were much more difficult to work with because it is much harder to install structural steel to small tolerances than it is to install metal studs. Also, the fact that the steel subcontractor attached the WT's to the bent plates in the shop rather than doing so in the field only added to the problem. Finding a more efficient way of supporting the brick veneer would more than likely have saved both time and money.

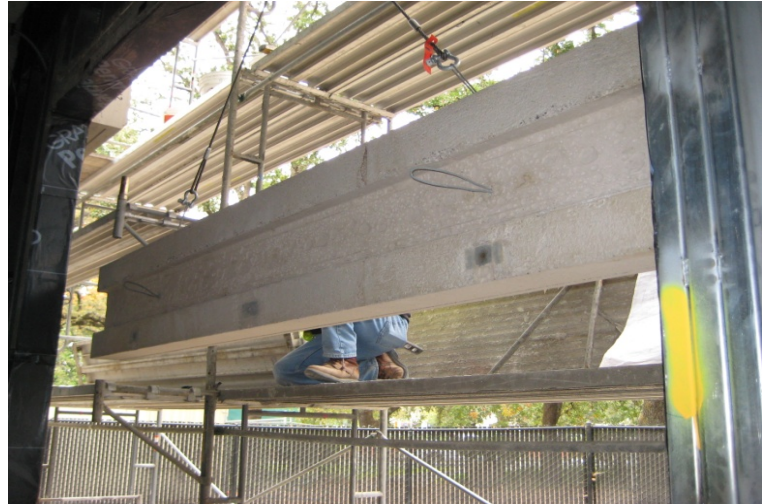
Top Right: A precast member is lifted into place with the help of a winch.

Another big problem area on the project revolved around the precast concrete elements. Several things contributed to this. First of all the elements were fabricated long before the building had been constructed enough to field measure and therefore many pieces did not fit properly at first. Finding these problems in the field rather than earlier on made it much more difficult to make changes. Also, the concrete was prefabricated in Mexico, very far away from the construction site, making things all the more tedious. Finding a better way to go about the prefabrication process on this portion of the project would have saved a lot of problems and delays down the road.

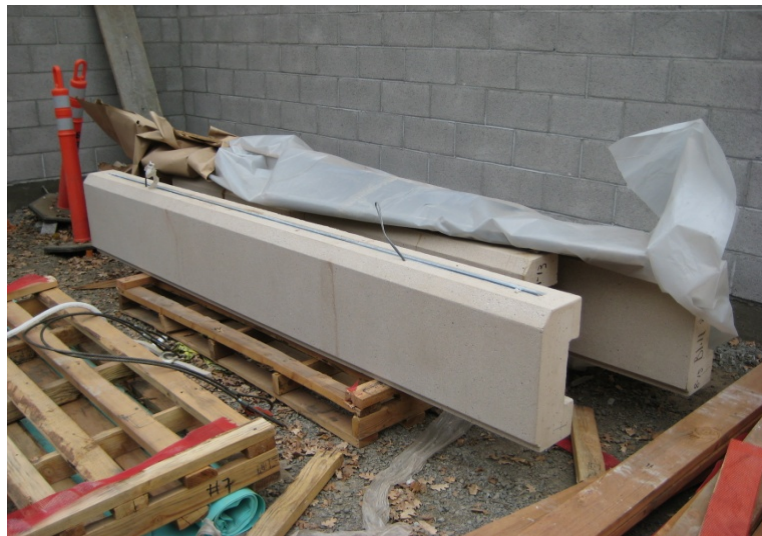
Middle Right: Newly delivered precast concrete panels are stored and covered until it is time to place them.

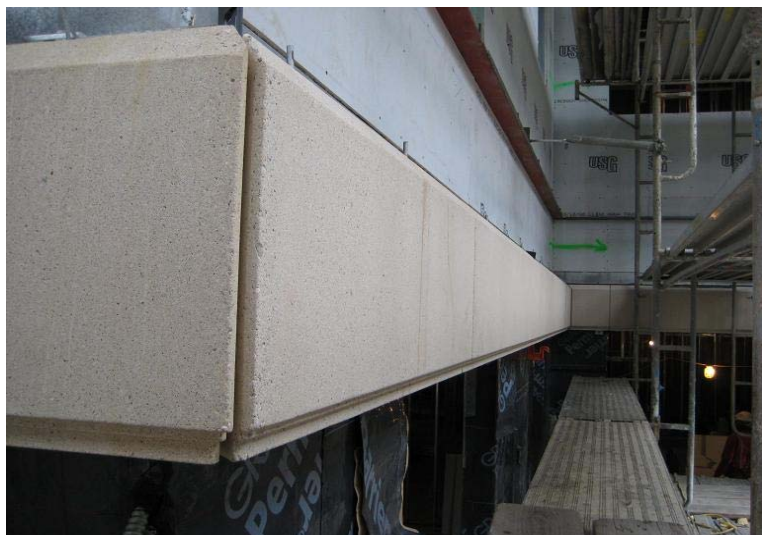
Bottom Right: Several installed precast panels that form a “band” around the building. The small room for error in size can be seen at the small end joint where two panels meet.

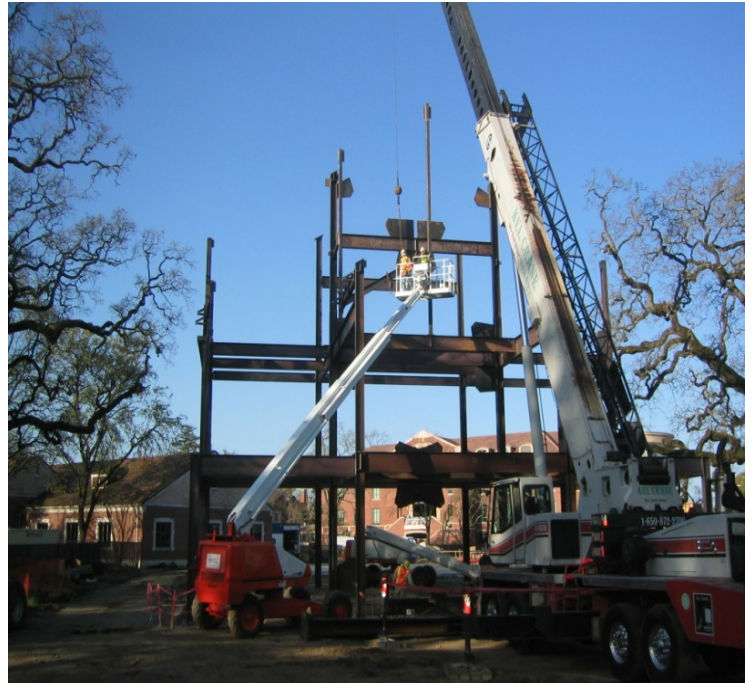
Above: Single crane and crew at work during erection

Another problem that attributed to schedule delays was that caused by the installation of the structural steel. As stated earlier the steel shop drawings were completed on time but the start of the steel erection was a month late and the completion of the erection and welding of the steel ended up being several months late resulting in the need to be granted a 72 day extension to the original schedule. Finding a way to keep the steel on schedule would have resulted in eliminating other delays on the project that ended up occurring as a result of the steel erection process and would have ultimately caused the project to be completed on time for its original completion date.

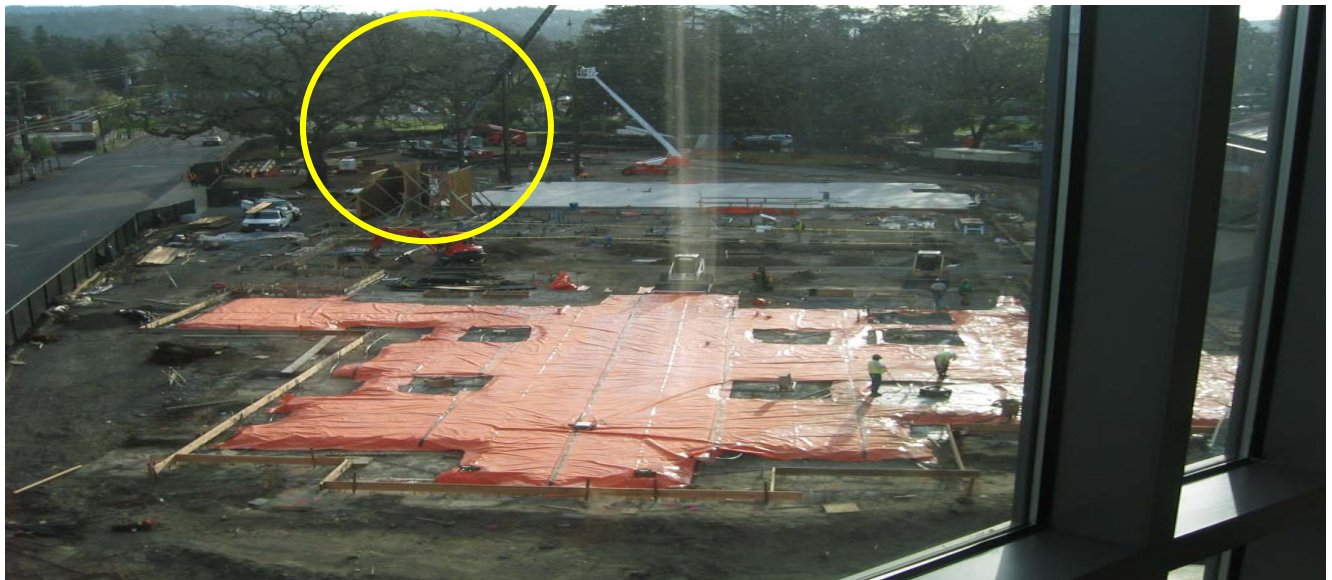
Above: View of the crane at the beginning of the erection process from a neighboring building

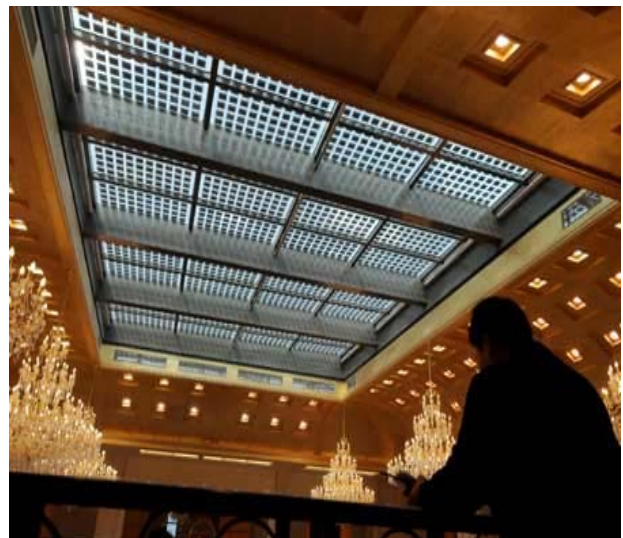
Top Right: An example of how PV panels can be used together with glass to provide shade and gather energy simultaneously
