TECHNICAL ASSIGNMENT THREE

PENN STATE AE SENIOR THESIS

**EPRISCOPAL HIGH SCHOOL
CENTENNIAL GYMNASIUM
ADDITIONS & ALTERATIONS
ALEXANDRIA, VA**

**ERIC FEDDER
CONSTRUCTION MANAGEMENT
DR. CHRIS MAGENT**

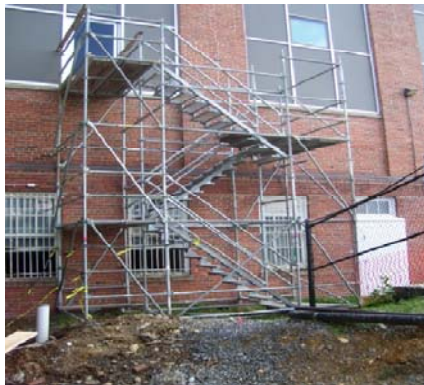
FIGURE 3: Temporary Exterior Stair Tower

The complex phasing of the new construction and renovation work creates several constructability issues for the project. In order to construct the new gymnasium but maintain occupancy in the adjacent existing Centennial Gymnasium, temporary egress facilities had to be erected to maintain a safe environment for the students and faculty at EHS. A temporary exterior/interior stair tower and exit had to be erected to provide a second exit from the gymnasium, shown in Figures 3 and 4. Likewise, an emergency exit was installed in the lower level locker room area due to the elimination of the existing exit into the new gymnasium building pad, shown in Figure 5. It was critical to account for these facilities in the general conditions estimate as well as the overall project schedule to ensure that these activities did not delay the overall project nor prohibit EHS from using the gymnasium. These temporary structures will remain in place until March 2010, when the existing Centennial Gymnasium is turned over to DAVIS for renovation work.

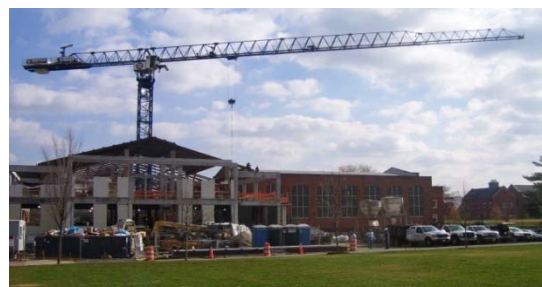
FIGURE 6: Tower Crane for New Centennial

The small building pad also restricted the project team to the use one crane for all lifting activities. Due to the proximity of the adjacent buildings, only one tower crane could be located within the building footprint, as shown in Figure 6, and had to be sized to accommodate all lifts for the construction of the facility. These lifts included concrete, steel trusses (10,200 lbs each), roofing material, masonry material and AHU's (8000 lbs).

each). The concrete subcontractor was responsible for the set-up and dismantling of the crane and the rental during the concrete phase. Once all concrete was completed, DAVIS assumed responsibility of the crane rental and determined what trade was able to use the crane at certain times. Since DAVIS did not have money allocated in the general conditions for crane rental, the project team implemented a rental program that charges each trade by the hour when they have to use the crane.

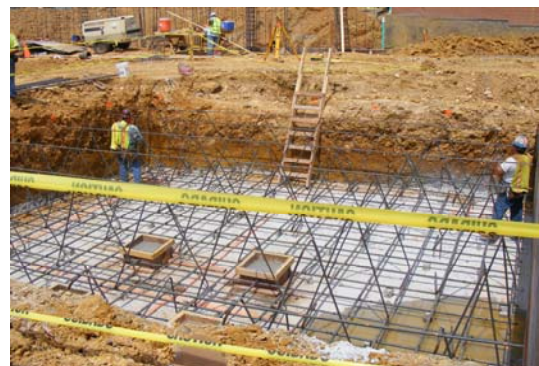
FIGURE 10: Neat Cut Footings

DAVIS and the concrete subcontractor proposed to neat cut all footings, shown in Figure 10, for the pile caps and grade beams to reduce the amount of excess soil that had to be hauled away and to eliminate the use of formwork for the footing concrete. Typically, footings are excavated with two extra feet on each side to allow space for formwork. This value engineering item reduced the amount of labor and duration for this activity by approximately one half and saved the project \$100,000.
