December 1
2009

CARDEROCK SPRINGS ELEMENTARY SCHOOL

JOSEPH HIRSCH
CONSTRUCTION MANAGEMENT
TECHNICAL REPORT 3

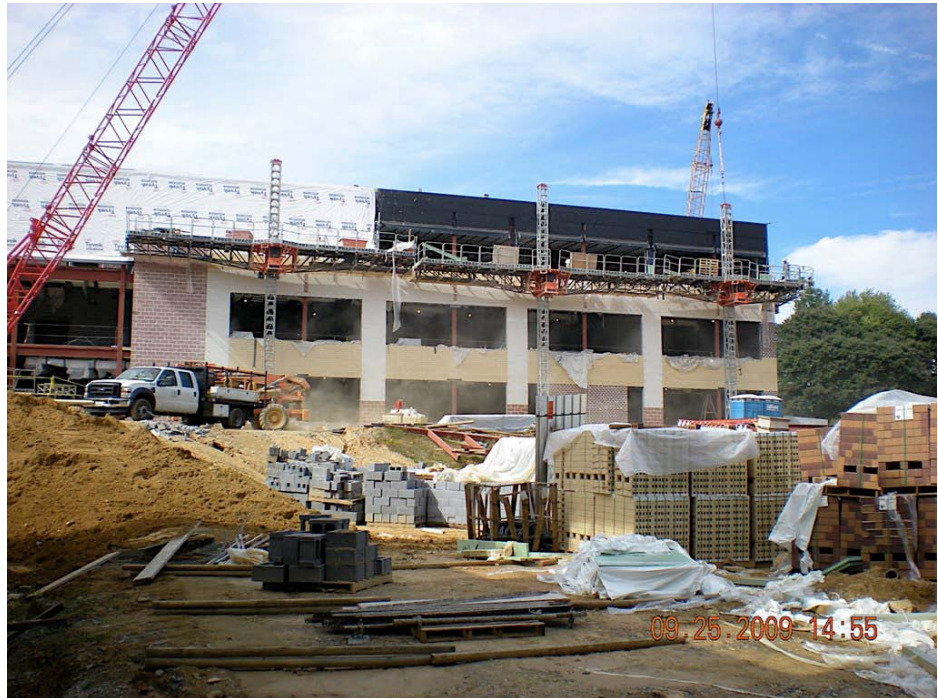
Figure 4 - Masonry Façade

This picture shows the complexity of the façade. Pictured are 3 different brick types. Overall the project has 7 different brick type which introduces the need for an intense quality control program to ensure they are installed in the correct location with correct pattern. Precast would be a solution help to improve overall quality control.

Another issue arose from a complex façade. The façade of this building had many different colors, types of bricks, and patterns to be used in different areas of the building façade. In some areas, the mortar colors and patterns were not the correct type that was designed by the architect. Adding to the problem is the fact that once the mortar has dried, it is a very expensive fix to demolish incorrect work. Usually these situations give way to cheaper fixes which are not equal to the original design intent.

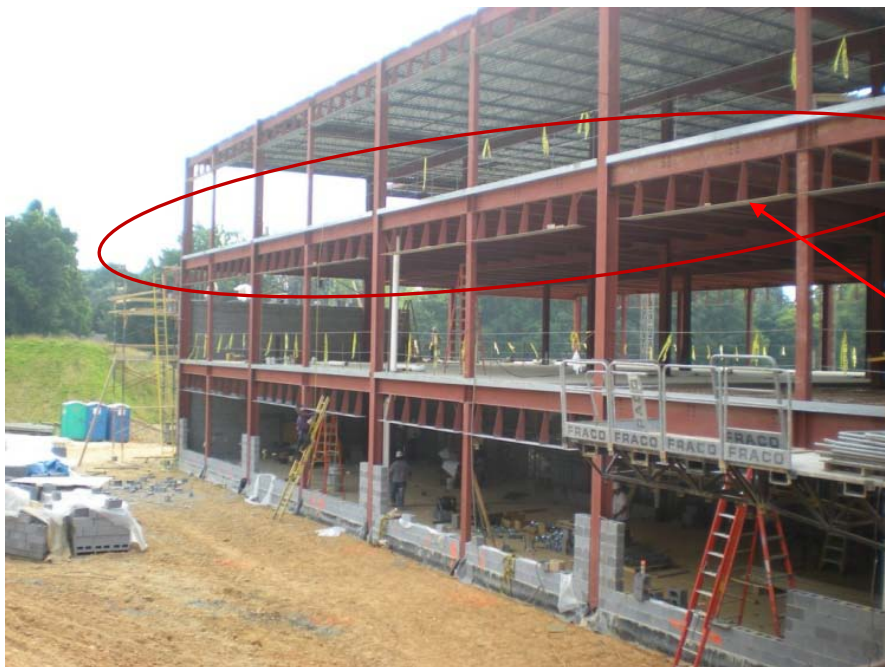
Figure 5 - Hung Plates

Another issue that can be developed is the engineering of different structural systems. One system is the support of masonry above windows through the use of hung plates. These plates were especially vulnerable to damage since they are very small compared to other steel members. A large column easily damages a $\frac{3}{4}$ " thick steel plate. These plates were also

attached to the beams by the steel fabricator prior to delivery making them awkward for storage and transportation.

Hung Plates that created quality and constructability issues

Areas of research to explore will be alternative methods to support masonry above openings. The relation between different topics discussed can also be explored. The impact of changing to precast would have on the structural system as a whole will have to be analyzed in detail. It could also impact the curtainwall system. Connections and building envelope issues would have to be investigated to determine if greater risk to moisture infiltration could negatively affect other proposed ideas. Also there is labor and time associated with flashing, sealing, and caulking of connections when two different systems meet together.
