Loyola Intercollegiate Athletic Complex Baltimore, MD

Technical Assignment # 3

Steven Rogers
Construction Management

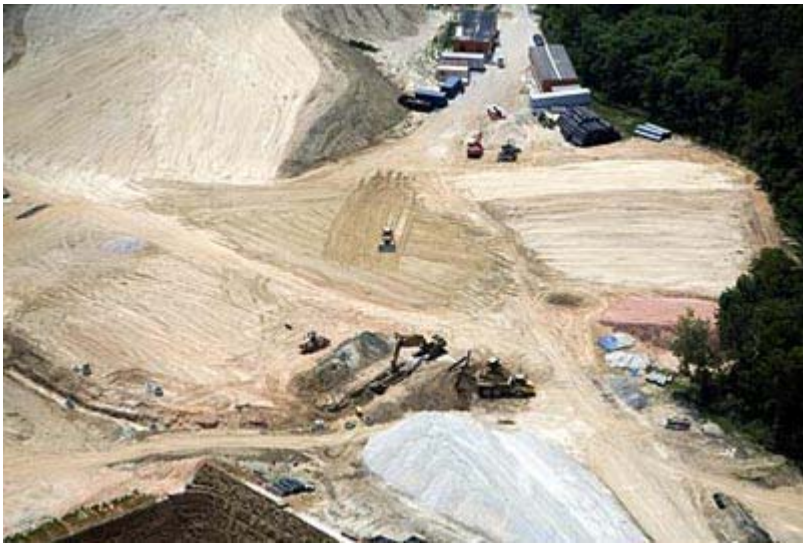
Image 1 Drying the Soil Out

There are several issues with the installation process of the VRSS slopes. One of the main issues was achieving the right soil compaction. VRSS slopes are placed and compacted in 1.5 ft lifts. Lifts consisted of welded wire baskets, primary reinforcement layer, face wrap, vegetation, and reinforced soils, which was composed of soil and a geo membrane. The geo membrane was placed in between each lift. Since there was not enough soil onsite for the mass excavation, the soil had to be brought onto the site from outside sources. Even though the right soil was selected, the compaction levels were not always reached from weather and from damp or wet soil. The soil had to be equal to or more than 93% compacted to pass the compaction test. Also, multiple rows reached the compaction level required, however the wall was pumping too much according to the onsite inspector.

The issue was simple to solve but took a lot of time, manpower, and money. The project staff knew up front of these issues so allotted time in the schedule for these delays. The first step to help remedy the weather was to “close” the soil piles up the night before if there was rain in the forecast. When you close up the soil piles, the dirt crew would simply compact the top layer of soil, which would prevent water from penetrating the soil pile. Next, since the site was so large, was that on nice days the dirt crew would spread out the soil on site to help dry it out so it was suitable to be placed on the wall, refer to the image 1 below. The most challenging issue to accommodate was the pumping within the wall. The solution was to “bridge” the wall

by using two lifts of CR-6, which is the type of rock they used to tie the ends of the walls into the rest of the site. This solution was very expensive but in turn did not cause any delays to the schedule because all the CR-6 was onsite already.

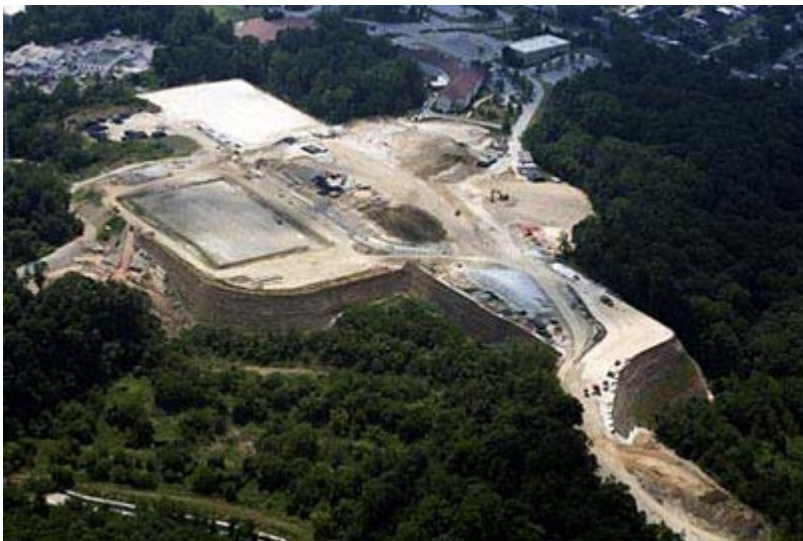
Image 2 Curves on the Walls

A complication came about when the project got to a VRSS slope with curves, refer to image 2 to the left. There was no way to actually keep track of the curves in the slopes. This could cause the slopes to be too far in or too far out. If the VRSS slopes were too far out, they would not be structural sound and could cause the slopes to fail in the future. If

the VRSS slopes were too far in, two things could happen; the playing fields would have to be redesigned to fit in a smaller area or the parking lot would lose valuable parking space.

The project team went through several ideas before deciding on a solution. The drawings included the design equation for the walls. Using this equation, the row the wall crew was on, and the surveys from the surveyor, the data could be put into the excel spreadsheet to let the

project team know how far in or out the wall was off at the specific points. The points were set up by the surveyors. Also, the surveyors sent the AutoCAD files to give the owners a visual of the status of the walls.
