REVISED SENIOR THESIS FINAL PROPOSAL

PENN STATE AE SENIOR THESIS

SUPPORT SERVICES BUILDING

PENN STATE MILTON S. HERSHEY MEDICAL CENTER – HERSHEY PA

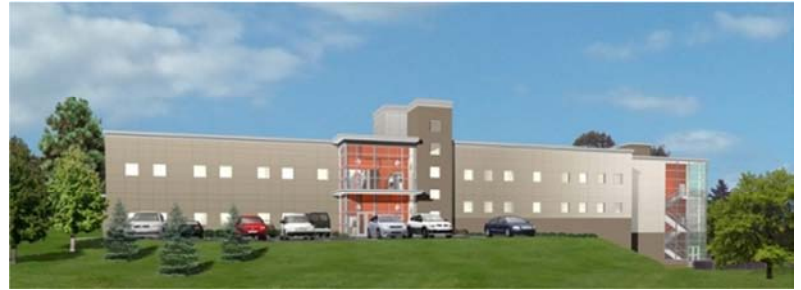
Figure 3: Architectural Rendering of Exterior

curtainwall. Figure 3 shown at right and on the cover page is the architects rendering of what they exterior of the building will look like. Interior finishes include exposed polished concrete and exposed ceilings, as well as conventional ACT ceilings, VCT floor tile, and ceramic tile. Upon completion the project is expected to achieve a LEED Certification rating under the LEED Version 2.2.

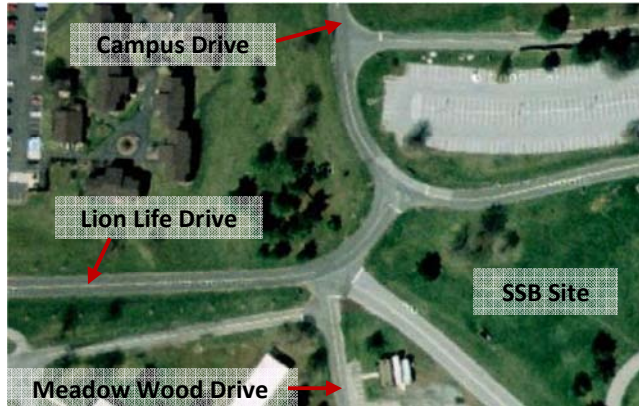
Figure 4: Old Lion Life Drive & Campus Drive Intersection

Another major part of the project is the re-alignment of Lion Life Drive with Campus Drive. Currently vehicles on Lion Life Drive have to wait at a stop sign and let vehicles on Campus Drive pass before turning left onto Campus Drive. With Lion Life Drive being the main access point to the hospital from west, the intersection quickly backs up during shift changes at the medical center. This is also the route in which all the medical supplies are delivered to the hospital. Figures 4 and 5 below show the existing intersection and what the new intersection will look like.
