TECHNICAL ASSIGNMENT ONE

PENN STATE AE SENIOR THESIS

SUPPORT SERVICES BUILDING

PENN STATE MILTON S. HERSHEY MEDICAL CENTER – HERSHEY PA

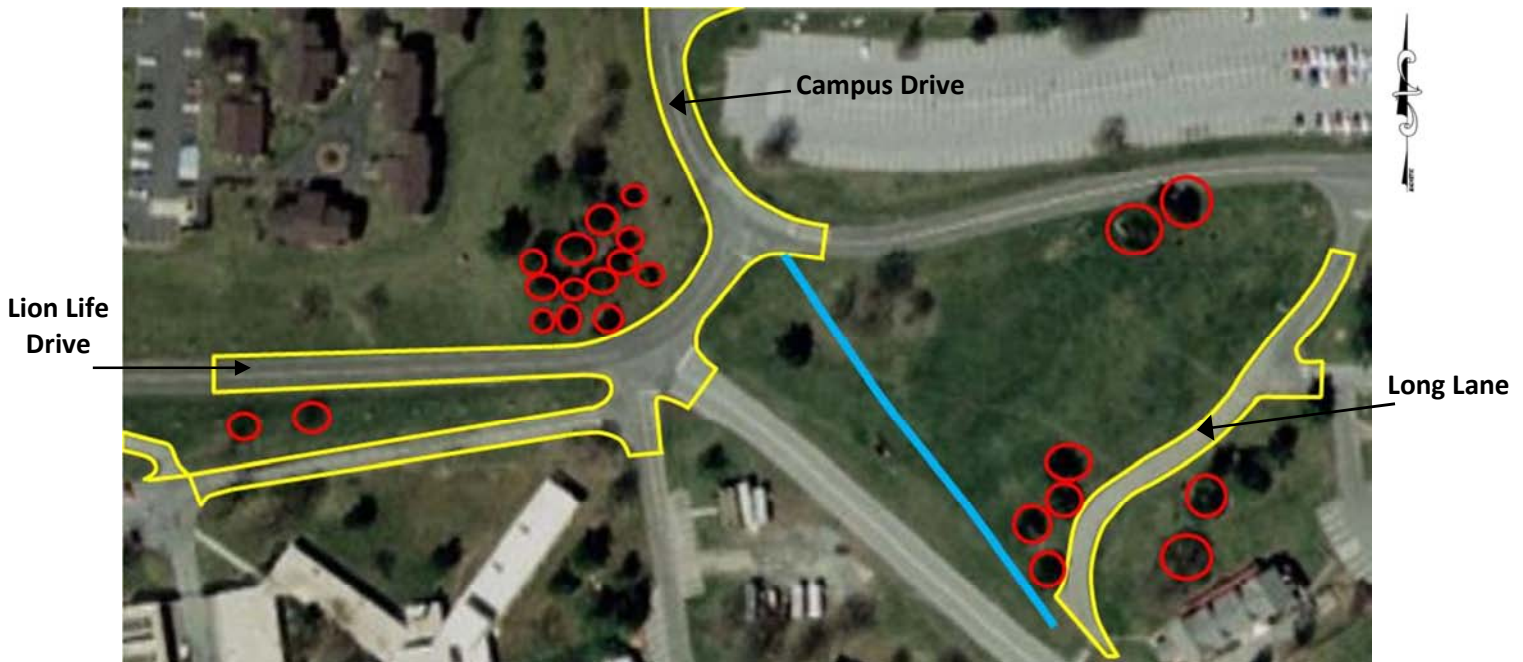
Figure 1: Demolition for Support Services Building

Being that the site that was chosen for the location of the Support Services Building was a barren field minimal demolition was required. However there were approximately 25 evergreen trees, 400LF of an 18" corrugated metal storm drainage pipe, and 45,000SF of asphalt paving that was removed in order to construct the Support Services Building and Campus Drive realignment (See figure 1 below). Of the 45,000SF of asphalt that was removed, approximately 15,000SF came from the removal of a 480LF section of Long Lane (southern part of site) to make room for the building. The remaining 30,000SF of asphalt paving was removed as a part of the realignment of Campus Drive.

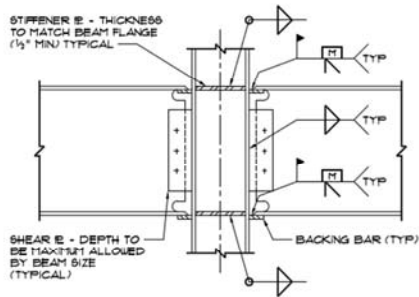
Figure 2: Typical Beam to Column Flange Detail

Acting as the skeletal backbone of the Support Services Building is a rigid steel superstructure. All structural steel on the project is ASTM 992. Typical beam to column moment connections can be seen in figures 2 and 3 below. The lateral loads are transferred through the structure to micropile foundation system where 60 of the 152 piles are battered. Although this system provides the primary resistance to lateral forces, the masonry elevator shafts and stair towers also provide lateral support.

**TYPICAL BEAM TO COLUMN FLANGE
MOMENT CONNECTION DETAIL**
NOT TO SCALE

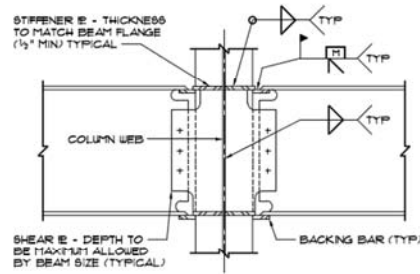
Figure 3: Typical Beam to Column Web Detail

**TYPICAL BEAM TO COLUMN WEB
MOMENT CONNECTION DETAIL**
NOT TO SCALE

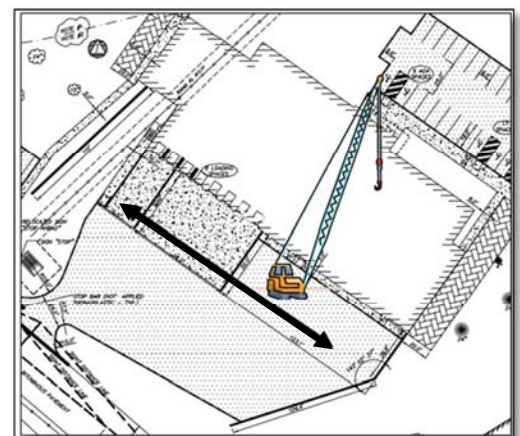
Figure 4: SSB Crane Location

To erect the Support Services Building the construction team will utilize a 100-ton crawler crane. The crane will be able to track back and forth in the parking lot on the north side of the building (See figure 4 at right). The parking lot also provides ample room for deliveries and material lay-down areas.

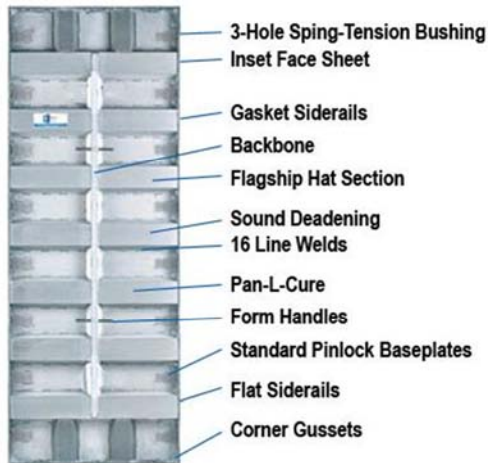
Reinforced cast-in place concrete is utilized for pile caps, foundation walls, slab on grade, elevated slabs, and exterior site retaining walls. All concrete on the project is 4,000 PSI except for the elevated slabs which are 3,500 PSI concrete. All vertical formwork used on the project is Western Forms Flagship Elite series aluminum panels. Typical panel sizes are 2'x2', 2'x4', and 2'x8'. Figure 5 below represents the features of a typical panel. All horizontal formwork is at the discrepancy of the subcontractor. Typically dimensional lumber is utilized however metal is sometimes used (see figure 6 below). The formwork for the elevated slabs is a typical pour stop installed by the steel subcontractor.

Figure 5: Western Forms Flagship Elite Series Aluminum Panel. Image taken from westernforms.com

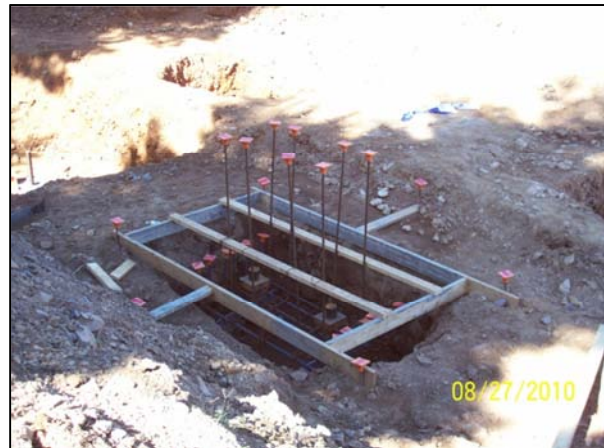
Figure 6: Dimensional Lumber Formwork at Top of Pile Cap

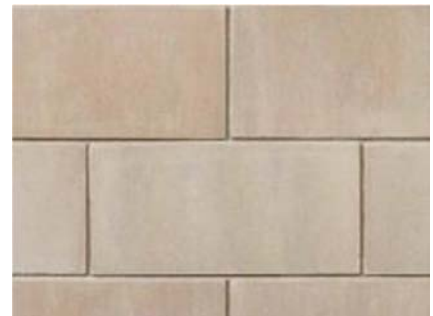
The Support Services Building has a combination of load bearing masonry walls, non-load bearing interior masonry walls, and masonry veneer. The two elevator shafts and three exterior stair towers are constructed of load bearing CMU walls. Two stair towers, stair 1 on the north side and stair 3 on the east side have 12" CMU exterior walls with a 4" Arriscraft Masonry Veneer with a deep sandblasted finish, color Driftwood. The masonry veneer is also carried around the lower portion of the building. The veneer is attached to the building using conventional masonry anchors every 2 courses of CMU. Figure 7 at right shows a finish and color sample of the stone veneer.

Figure 7: 4" Arriscraft Masonry Veneer w/ Deep Sandblasted Finish, Color Driftwood

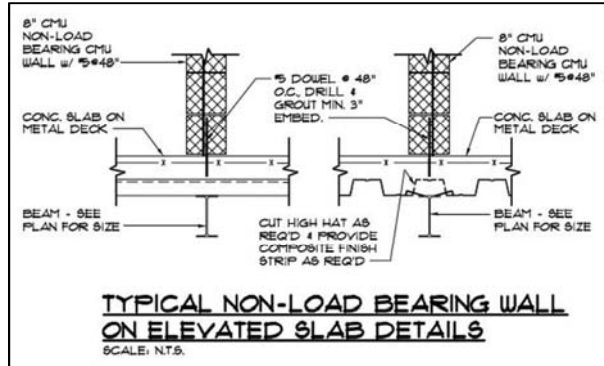
Many of the first level interior walls are non-load bearing 8" CMU walls. This type of wall was chosen for its durability and for its 1-hr fire rating to separate all of the storage areas/shops. Beneath each CMU wall the SOG is haunched to support the weight of the wall. Several of the walls on the second level are also non-loading bearing CMU walls. Located directly underneath the CMU walls on elevated slabs is a steel beam to support the weight of the wall. To keep the wall from moving #5 dowels are drilled and grouted into the slab every 48" (See figure 8 on next page).

Figure 8: Typical Non-Load Bearing CMU Wall on Elevated Slab Detail

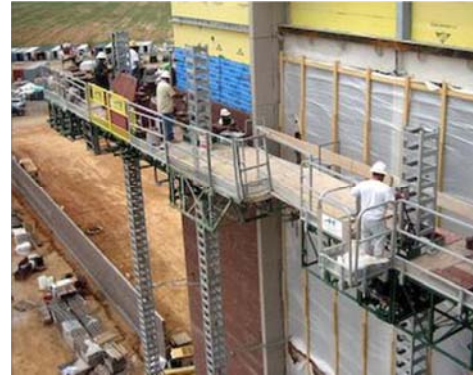
To erect the CMU walls and apply the stone veneer the construction team will utilize both conventional scaffolding and hydro-mobile scaffolding. Interior CMU walls will be constructed off conventional scaffolding stacked as high as needed. The exterior walls and veneer will be constructed off the hydro-mobile scaffolding. Figure 9 on the next page shows a typical hydro-mobile scaffolding system.

Figure 9: Typical Hydro-Mobile Scaffolding. Image taken from hydro-mobile.com

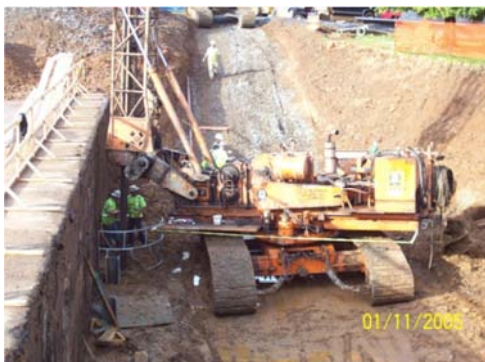
To support the existing tunnel footer, a steel bracket is welded to the steel soldier beam underneath the bottom of the tunnel footer and the entire system is encased in concrete (see figure 11 at right). 3" hardwood lagging is then placed between the steel beams on the excavation side.

Figure 10: Steel Soldier Pile Installation at Existing Tunnel

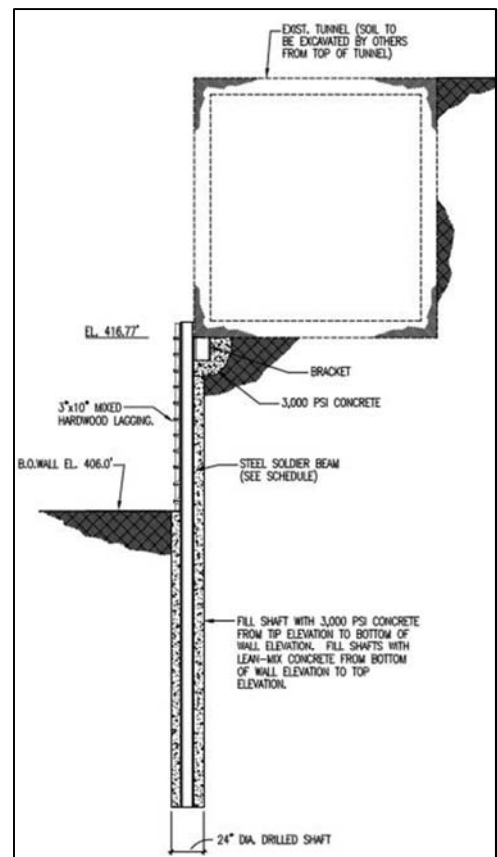
In the southwestern part of the site soldier beams and lagging was also used for support where existing trees prohibited the slope of the excavation to be achieved. Typically these systems will be cut off 3 feet below grade and the remaining portion left in the ground.

Figure 11: Hybrid of Soldier Beam and Underpinning System at Existing Tunnel

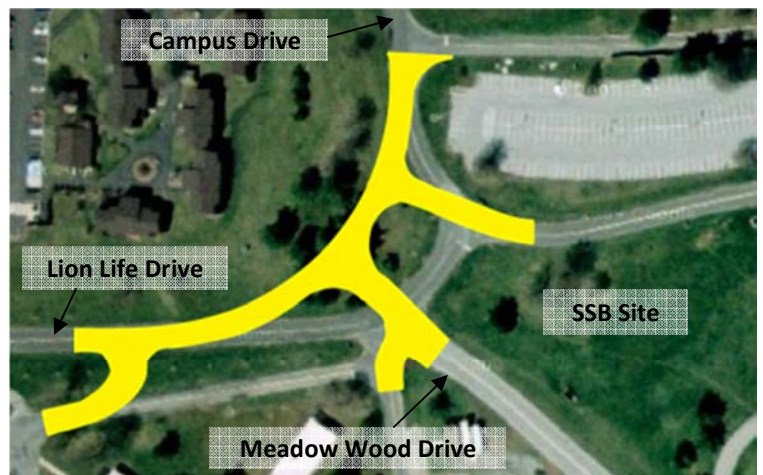
Figure 13: Campus Drive Re-Alignment

Another major part of the project is the re-alignment of Campus Drive. Currently vehicles on Lion Life Drive have to wait at a stop sign and let vehicles on Campus Drive pass before turning left onto Campus Drive. With Lion Life Drive being the main access point to the hospital from west, the intersection quickly backs up during shift changes at the medical center. This is also the route in which all the medical supplies are delivered to the hospital. Figure 12 at right shows what the new intersection will look like. Due to the fact that Lion Life Drive is a major access point to the medical center, Hershey Medical Center has made it a point that at no time can access be restricted from Lion Life Drive therefore detailed planning and construction of temporary roads will be necessary to keep traffic flowing.

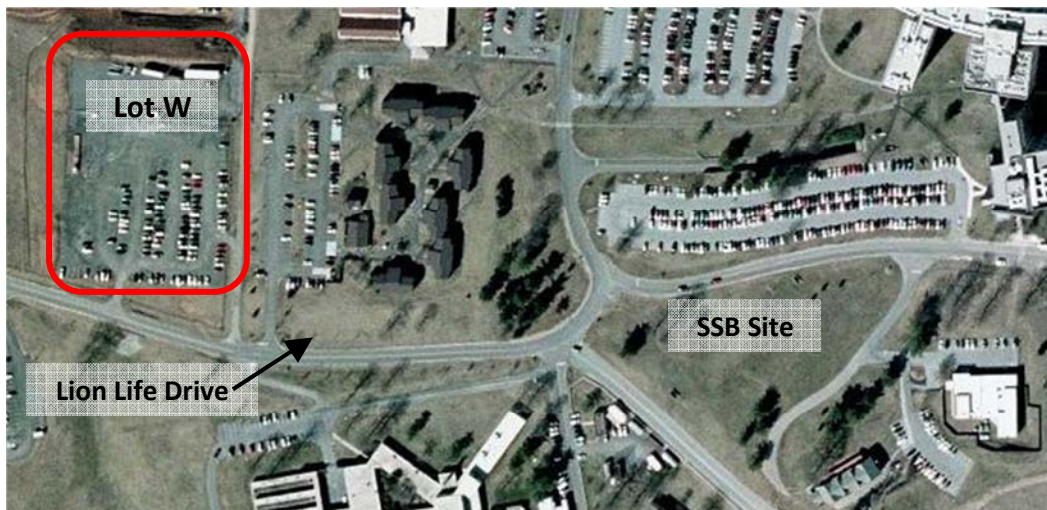
Figure 14: Lot W Contractor Parking & Staging Area. Image taken from Yahoo Maps

Due to the fact that Hershey Medical Centers is a major medical research facility that's serves a major portion of central Pennsylvania and houses the Penn State School of Medicine, parking in the hospitals parking lots is prohibited to contractors. With the triangular shaped site, space is a premium. To alleviate congestion all contractor trailers and parking will be located west of the site in Lot W off Lion Life Drive (See figure 14 below) except for the CM trailer and staff parking. The lot will also be utilized as a construction staging area.

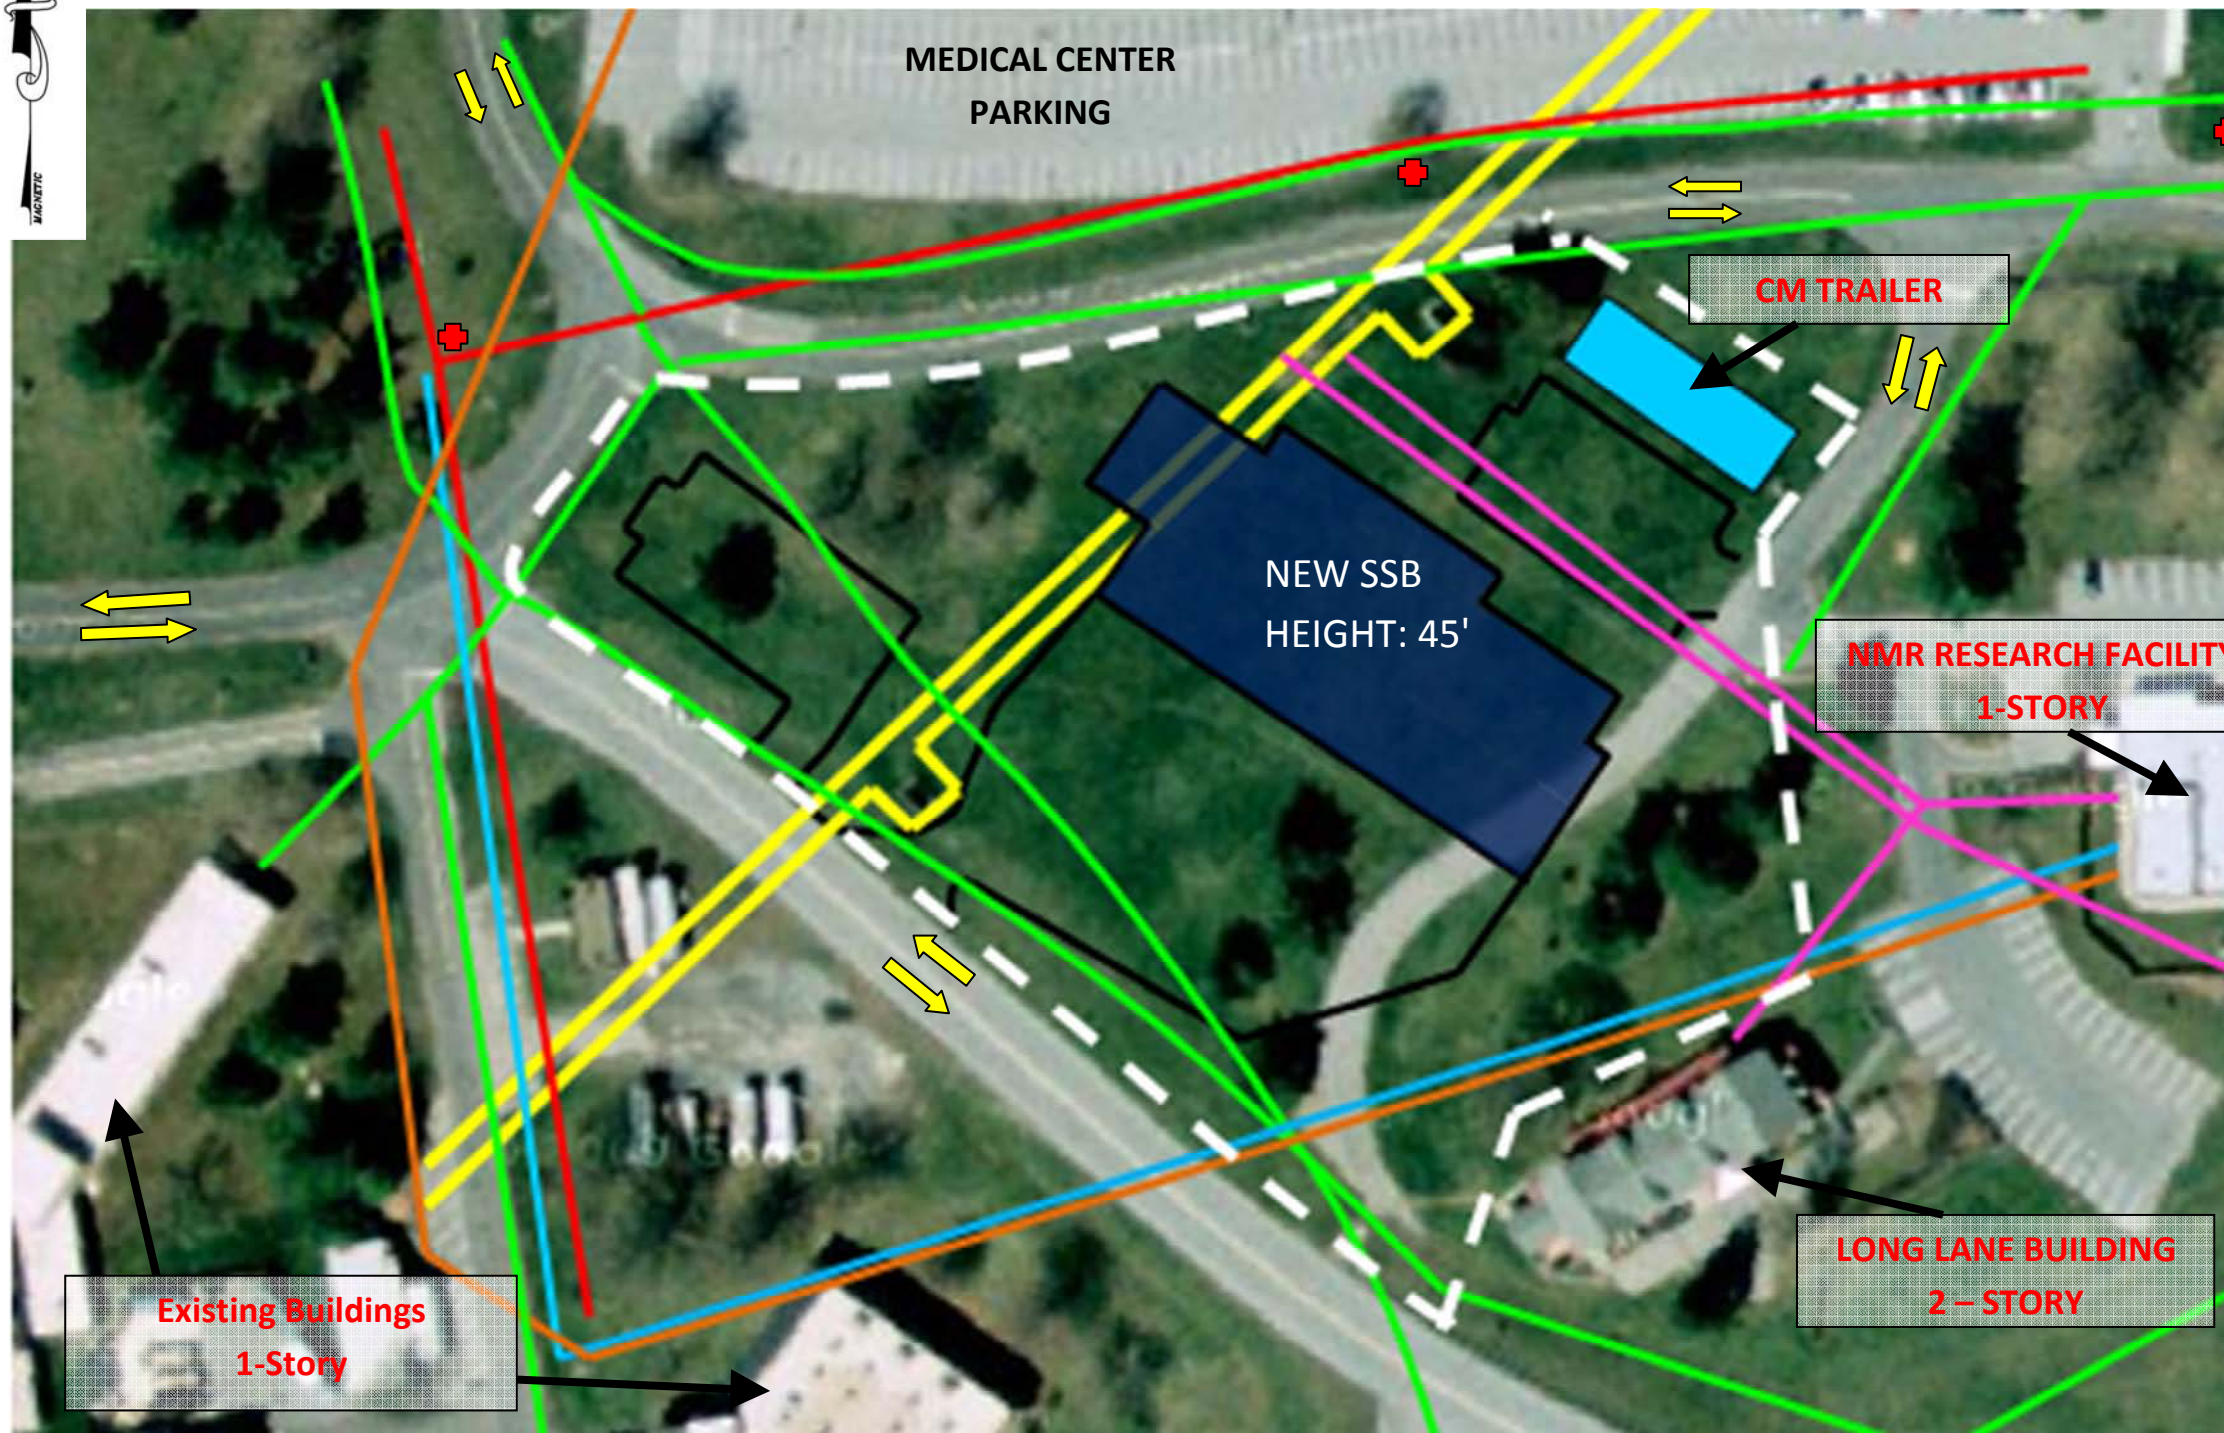
EXISTING CONDITIONS SITE PLAN

The Support Services Building is being built on a triangular shaped site on the southwestern part of the medical center’s campus. It is bordered on three sides by the following roads; Campus Drive, Long Lane, and Lion Life Drive. Also bordering the site is the NMR Research Facility (1-story) to the east and the Long Lane Building (2-story) to the south. Directly underneath the site (8-10 feet below grade) is a utility tunnel which houses the main steam and chilled water lines to the main hospital. The tunnel also serves as an access path for pedestrians and material distribution from the Animal Research Facility (ARF), Boiler Plant, and the existing loading dock/hospital. Construction in and around the tunnel will have to be closely monitored to maintain the integrity of the tunnel and the utilities within it.
