Technical Assignment 3

Kaiser Permanente- Medical Office Building

8008 West Park Drive
McLean, VA 22102

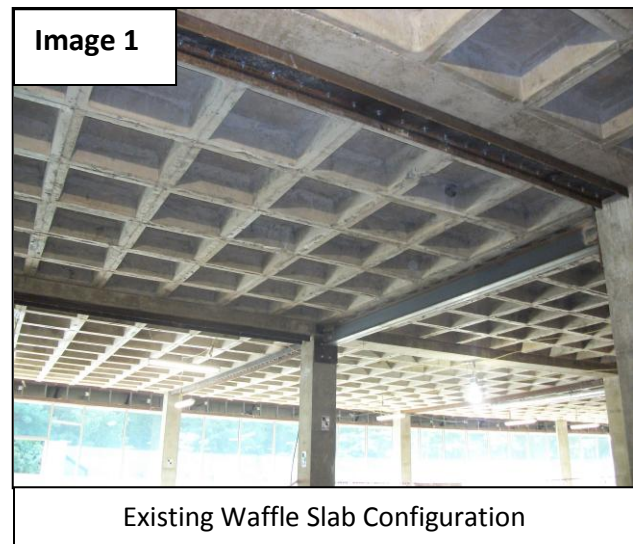
The existing building slab has a waffle configuration as seen in Image 1. This type of slab was difficult to work with throughout the construction process since it is an outdated type of configuration. The challenges associated with this slab were the limited penetration/cutting of structural ribs at waffle units, as recommended by the structural engineer. Since the contract documents were not coordinated between core drill locations (for plumbing and electrical through slab penetrations) and waffle slab rib locations, this presents a coordination issue. In order to mitigate this issue the project team performed an extensive analysis on the slab to configure new drill locations. This analysis started with a laser survey and model of the slab depicting where the drill locations were originally located. Next, recommendations for core drill relocations based on these constraints were made. Lastly, the design team made changes to layout and the partition locations if it was necessary.

The waffle slab of the existing structure presents many issues for this project. As previously described in constructability challenges section, there was a problem with drill locations for MEP connections in the waffle slab. The slab configuration also caused problems with fire rating and insulating the coffers of the waffle slab. The original engineered design was not appropriate and did not pass the QA/QC inspection according to the owner's standards. Therefore, the design was taken back to the engineers for review, redesign and resubmission. Due to more discrepancy with the design and delay in design approval, the final design was received very late. At this point in time, work had already begun for interior build-out. This change in design resulted in reconfiguring phasing of above ceiling rough-in and the inability to hang the track for the framing studs. This in turn created a chain reaction and affected other trades that were to continue or begin work in these areas. This design issue contributed to the 2 month schedule delay of interior build-out, which ultimately affected other activities. As always, time is money, so this delay in schedule affected the subcontractors for having to pay laborers for work days that were spent without work to be done.

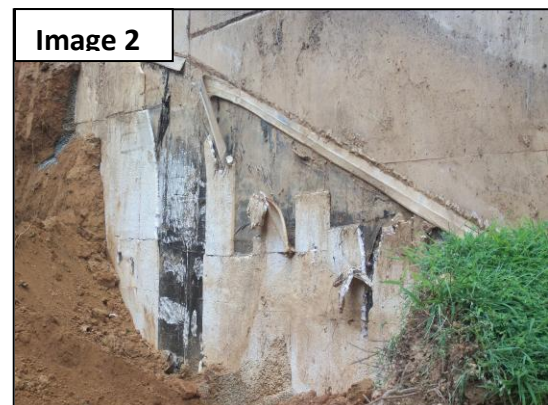
Existing Foundation Waterproofing

The waterproofing issues relating to this project posed many challenges throughout construction, as previously discussed in this report. Unfortunately, the largest issue regarding the foundation wall leaking around the entire perimeter of the building was not accounted for in the initial scope of work. The waterproofing work includes excavation around the perimeter of the building, removing existing waterproofing and replacing it. Due to the extensive amount of work associated with this, it adds a lot of time to the schedule and money to the owner. Also, this work delays a lot of other work around the building because it limits access to the building due to the shoring needed for excavation.

Another major risk to project completion is the upcoming perimeter waterproofing work that will take place, which impacts the entire building foundation. It includes excavating around the entire perimeter of the building to a depth of up to 40 feet in some locations. This excavation also requires the need for engineered shoring systems to be designed and installed. The issues related to this activity are access for construction crews and owner vendors around the building perimeter. This waterproofing activity also affects the original scope construction components that cannot be completed because of the activities constraints. These original scope components include hardscaping / landscaping around the building perimeter, completion of metal canopies at the building entrance, and completion of paving at entrance and loading dock areas. Due to the timeframe of cost approval, this work is expected to start in January 2012, and will continue through project substantial completion and through building activation period (March 16 through August 2012). Since the work will start during the winter months, this adds another level of challenge, since application of the waterproofing product requires maintaining a certain temperature. This alone could generate more potential delays, and also creates the need of tenting and providing temporary heat at the ditch (or moat). The challenge will be to make sure the work is complete prior to the opening date of the facility, which is in August 2012.

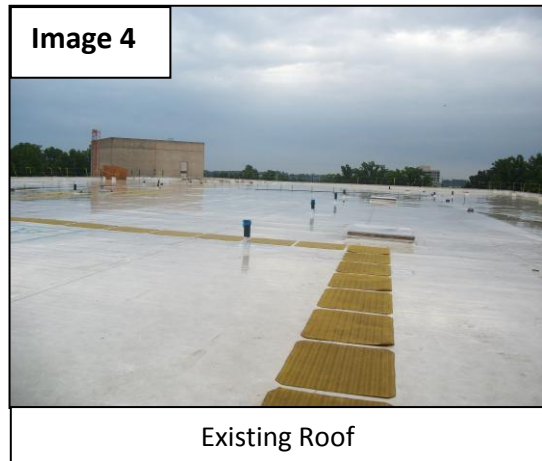
Along with the LED energy savings, the building can also increase its sustainable features by adding a green roof. Since the roof of the existing building needs to be replaced due to water infiltration, this could be an opportunity for Kaiser to earn more LEED points. It can be seen in Image 4 below that the area of the roof is fairly open and will not house mechanical equipment due to the construction of the mechanical tower. With these factors considered, it leaves open space to utilize a green roof. The different types of green roofs could be researched and compared to see which would apply best for a medical facility. Also, the cost could be

compared to the cost of the original roof replacement and see how this could potentially benefit the owner. In order to consider this option, a thorough structural analysis would need to be developed in order to ensure the building can support the load of a green roof. Maintenance costs would also need to be factored into this option since a green roof would require more upkeep than a traditional roof.
