TECHNICAL ASSIGNMENT THREE

VIDA FITNESS CENTER, WASHINGTON D.C.

Clara K Watson

Construction Option

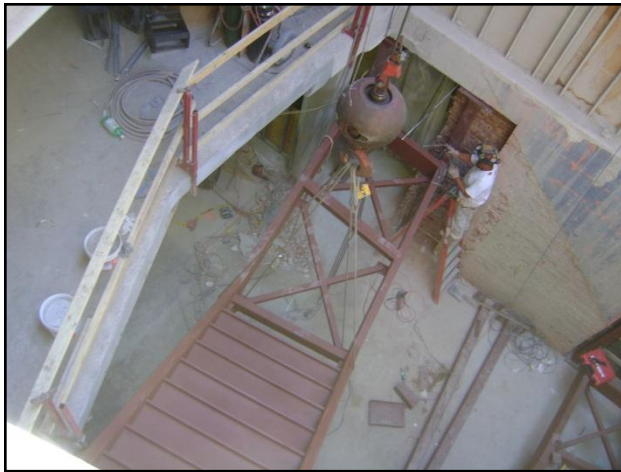
Due to early delays in the slab-cutting, the project team met with the steel fabricator and the Owner to discuss ways of shortening the monumental stairwell schedule. One of the solutions reached was to leave the opening in the roof slab uncovered to prevent tedious time spent on removing, placing, or securing a cover. Because this part of the project took place during May and June, there was little

Figure 1: Stair Section Suspended by Crane through Slab Cut; Picture Taken by Clara Watson

weather to worry about. The Owner also agreed to this because all of the exposed floors had been gutted, and only the concrete structure was left unprotected.

The second idea for increasing the speed of the project was to prefabricate the stairwell in sections to save time and allow for ease of construction. The number of prefabricated sections varied according to floor, due to the unique nature of the stairwell and the fact that it disconnected at every level. There were up to four sections on each floor, which were each lowered through the hole in the roof slab, suspended, and tack-welded into place (shown in Figure 5). This process began on the first floor and moved upwards through the building. Prefabricating the sections allowed for quicker installation and erection of the stairwell on each floor level.

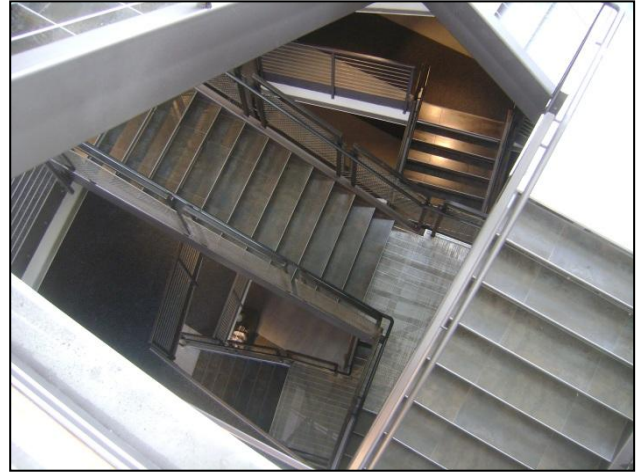
The project management team also met with the Owner to decrease the delay in the stairwell's schedule and to discuss the finishes applied to the stairwell. Originally, all finishes were designed to differ per floor, but due to long lead times and a tight schedule, the Owner agreed to allow the treads of each stair to be finished with tile and the railings to be finished with a silver paint. A view showing all floors of the completed stairwell can be seen in Figure 6.

Figure 2: Monumental Stairwell; Photo Taken by Clara Watson

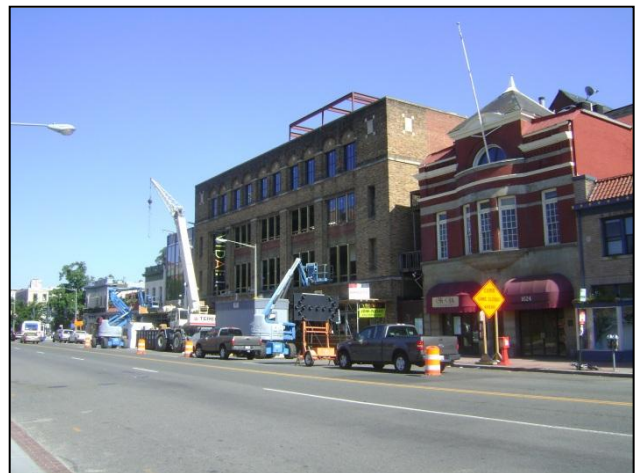
A public space permit was acquired for the front of this project because of the small Owner's trailer and dumpster that were kept in the front of the building for part of the construction process. Only six parking meters existed in front of the building, and during construction hours of 7AM-7PM, Forrester Construction had permits for this parking lane and the first lane of traffic in front of the site. These spots were reserved for deliveries, lifts, cranes, and Superintendent, Project Manager, and Assistant Project Manager parking. This congested parking and delivery area can be

Figure 3: Congested Site Parking; Picture Taken by Clara Watson

seen in Figure 7. All other construction workers were required to find parking either on neighboring streets or in the parking garage up the street.

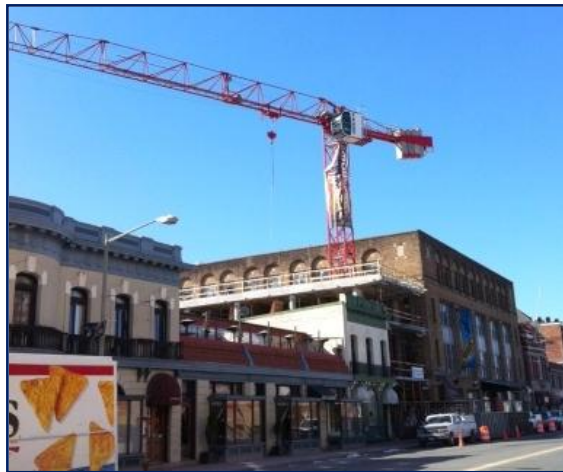
Figure 5: Tower Crane Located in Center of New Addition, Picture Courtesy of Luis Ortiz

Another innovation to combat the challenges associated with a zero lot line was to locate the tower crane used in the beginning of the project directly in the new addition's construction area. The addition was constructed around the tower crane, which allowed the crane to remain on-site overnight, rather than parking another type of crane in the front of the building between the hours of 7AM-7PM. The tower crane and its location within the new addition are shown in Figure 9.

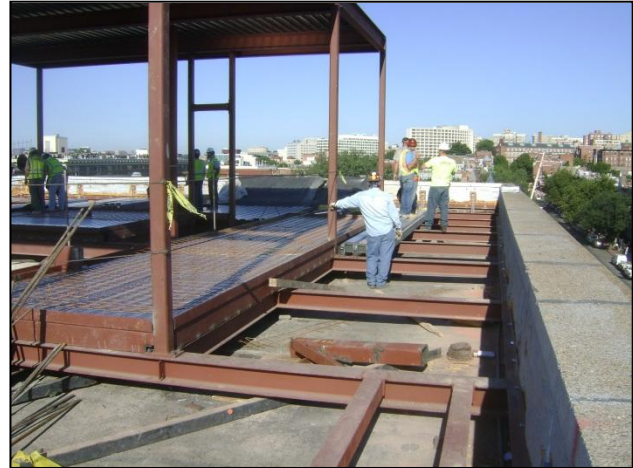
It is difficult on any project to ensure water-tightness, but was especially challenging on this project due to the unique nature of the existing building's roof. A swimming pool, accessed through the fifth floor penthouse, was installed on this main roof. This level also contains a bar, fire pits, and cabanas for guests. To ensure the addition of the pool did not infringe too heavily on the floor-to-floor height below it, a new roof was constructed approximately three feet above the existing roof (shown in Figure 10). This increased the ceiling height on the fourth floor below it enough to place the building's main mechanical room in the area under the pool.

Figure 6: New Roof Constructed Over Existing Roof, Picture Taken by Clara Watson

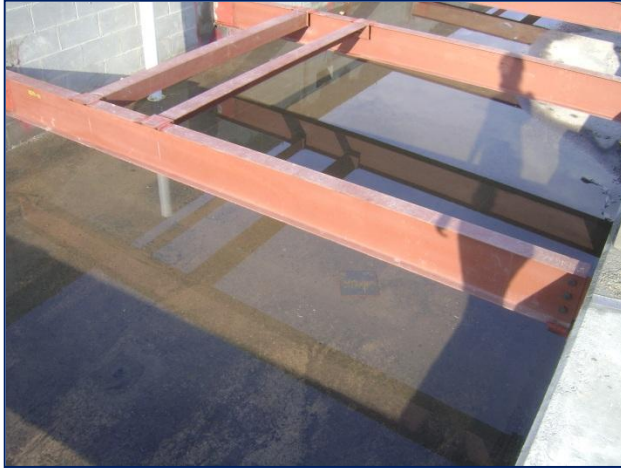
Figure 8: Pooled Water on Existing Roof; Picture Taken by Clara Watson

opening in the roof slab was protected by the penthouse, at this stage of the project the windows had not been installed and water leaked through their openings despite measures taken to temporarily seal them from the elements. Water also pooled on the original existing roof before construction on the new roof had been completed (shown in Figure 12). The existing roof was not level or water-tight and allowed for a great deal of water to enter the building in various locations, a fact that was of great concern due to ongoing finish installation inside of the building.

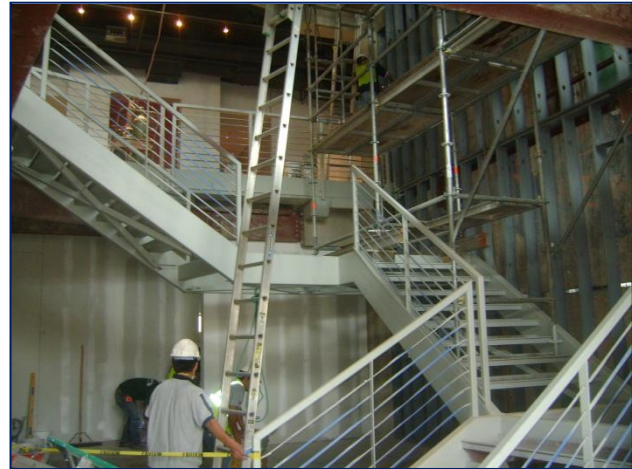
The signature wall behind the monumental staircase stretches five floors from the first floor to the roof penthouse and is lit from the sides to showcase the staircase. This signature wall was originally designed to be finished with custom wood Interlam Panels but the finish was changed through the value engineering process to a ceramic tile with a unique wave texture. Not only did this decrease the material cost, but the lead and installation times were both shortened, allowing the scaffolding to be removed almost a month before originally scheduled (shown in Figure 15). This change saved the Owner approximately \$188,560 in both material and installation costs but still provided an attractive finished product.

Figure 11: Scaffolding and Signature Wall Installation; Picture Taken by Clara Watson

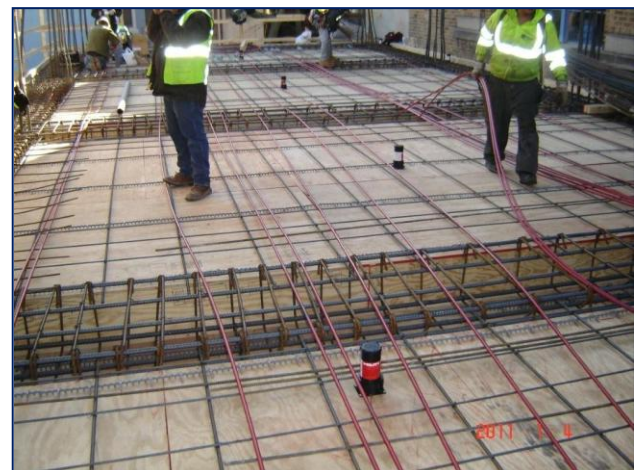
Figure 12: Post-Tensioning Installation on the New Addition; Picture Courtesy of Luis Ortiz

tensioned structure, both would have increased the elevated slab thickness due to the integration of rebar for structural support. These thickened slabs would then be unable to line up directly with the floor slabs of the existing building, resulting in a step where the two slabs met. Deciding this would be too much of an eyesore, the Owner opted to keep the originally designed post-tensioned system that would allow for thinner floor slabs that directly lined up with the existing building. Installation of this system is shown in Figure 16.
