Technical Report 3

The Center for Sustainable Landscapes for The Phipps Conservatory and Botanical Gardens – Pittsburgh, PA

Penn State AE Senior Thesis

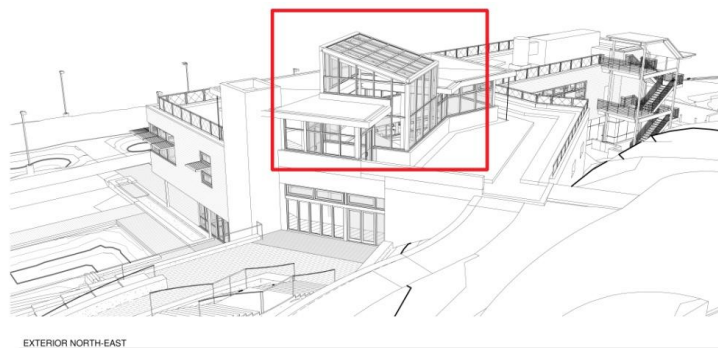
Figure 6 - View of exterior from northeast site. Lantern outlined in red.

The one key area that value engineering was implemented on this project was to increase the constructability of the passively designed atrium space. On the west perimeter of the atrium space is a large concrete encased spandrel beam designed to support a portion of the roof structure in addition to increasing the space’s thermal mass. Located 28’ off of the slab on grade, the construction of this spandrel beam would have increased the atrium’s construction duration, and a required a large amount of temporary shoring to support the elevated formwork. As a more affordable alternative, the spandrel beam was redesigned to be a bulk head with a limestone plaster coat. Additional changes to the atrium space during construction included the removal of thermo radiant ceiling tiles, and the removal of an operable thermal blanket that covered the lantern portion of the atrium space (space located at the top of the atrium, highlighted in Figure 6). Both features where designed to reduce the heat loss from the space during the winter months but were not implemented due to the added cost (cost data not available).
