TEAM NEXUS

Structural Systems

Team Registration Number: 02-2013

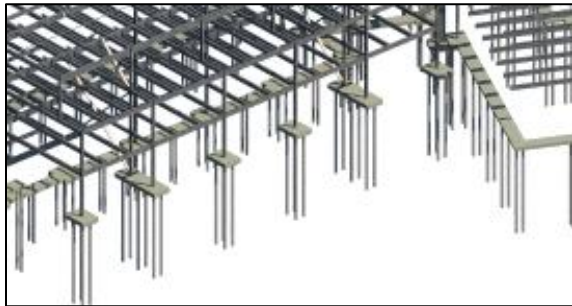
Figure 4: Driven Pile Foundation System

As a result, driven piles and pile caps seem to be the best option for the building due the unknown costs stemming from the uncertainty of the subsurface soil conditions. Although the installation of the piles can be an expensive process, the structural team believed that they could limit the number of required piles to a minimum by making changes to the structural bay sizes in the building. Also, the team investigated the piles recommended by the geotechnical report and determined that for many of the isolated columns in the building, only two piles will be needed as opposed to the recommendation for three piles in the report.

As mentioned previously, the soil conditions on the site are not favorable. The geotechnical report provided for the site suggested three different systems for the foundation: compaction grouting, site excavation and replacement, and driven piles. After evaluation of the three options and conversations with the construction team, it was determined that the best solution would be driven piles and pile caps. Using the 10" diameter steel piles suggested, the structural team determined that for many of the isolated columns, two piles will be sufficient instead of the three recommended by the report. In order to assure adequate lateral support of the foundation system, the ICF walls transfer forces directly to the rigid floor diaphragms at the floor levels and at the slab on grade where applicable.

The poor soil conditions were the driving force in choosing the foundation system. As previously mentioned, the geotechnical report suggests three options: compaction grouting, excavation and compaction, and driven piles with pile caps. The option to excavate and compact was discussed with the construction team early during the design process. It quickly became clear that this option would be very expensive and time-consuming. Although it would likely give the structural team the opportunity to use a simple shallow foundation system, it was determined to be a poor choice because of cost concerns. The second option, compaction grouting, was also looked at carefully. A major concern with using compaction grouting was the

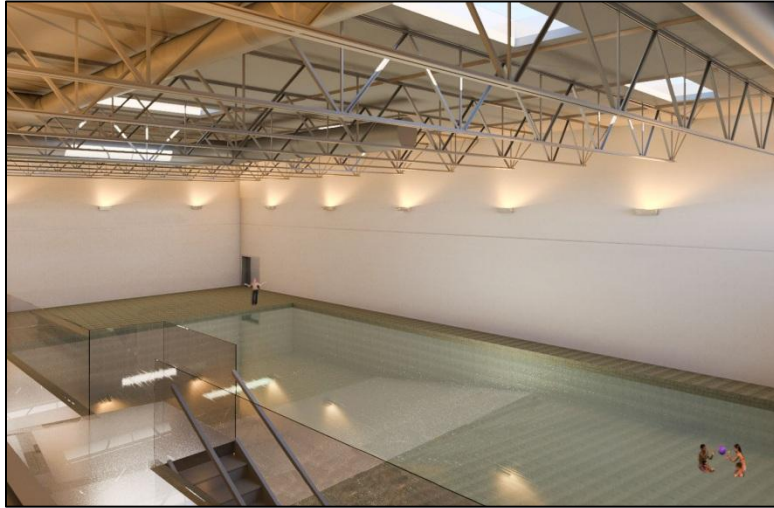
Figure 6: Pool Roof System

The roof system over the pool consists of long-span steel joists with non-composite metal roof deck. The roof system over the gymnasium also uses long-span steel joists, but with a 3" non-composite deck and 3" concrete slab over the gym to help satisfy FEMA shelter requirements, which is explained in the following section. The roof system over the classrooms consists of non-composite beams with non-composite metal roof deck. The biggest concerns for the roof were snow drift loads, which were calculated to be a maximum of 49 psf for a school in Reading.

Long span steel joists were chosen to be used in the pool and gym areas not only because of the long spans, but also since the exterior concrete bearing walls are available to support the roof system. Since there is no need for interior columns in these spaces, the depth of the joists was controlled by optimizing the joist spacing in both rooms.
