Kaiser Permanente Largo Medical Office Building – Largo, MD

Christopher Pozza - CM

Technical Assignment 1

September 21, 2012

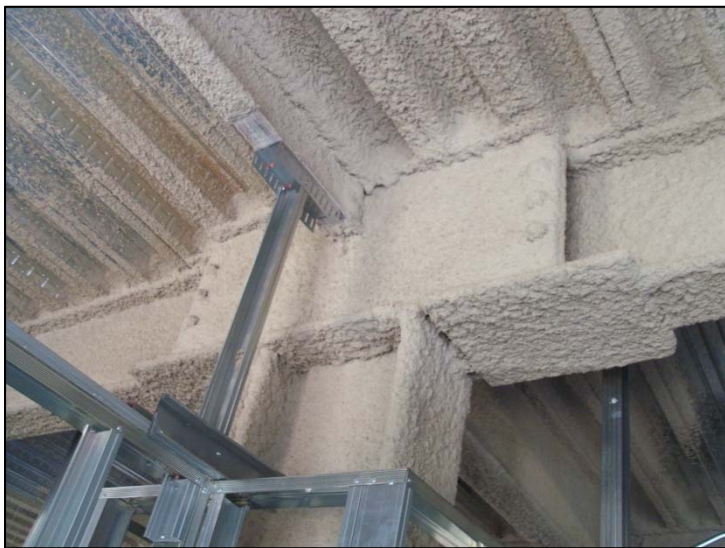
Figure 2 – Photograph of a Sideplate system (a moment frame that connects columns to beams and girders and can be single or double sided). Spray-on fireproofing has already been applied to the structural steel at this point of construction. Personal photograph taken by Chris Pozza.

A unique aspect of this project is the structural steel connections. A Sideplate Frame System, seen in Figure 2, has been selected. This is much more popular on the west coast, not traditionally being

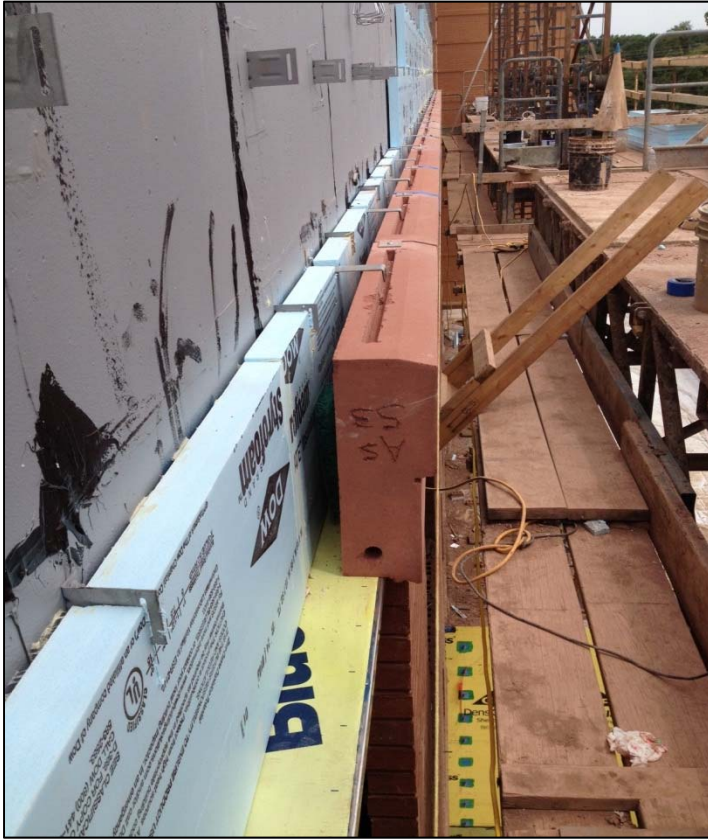
Figure 6 - Precast concrete can be seen above which make up the accent band along with east elevation. Personal photograph taken by Chris Pozza.

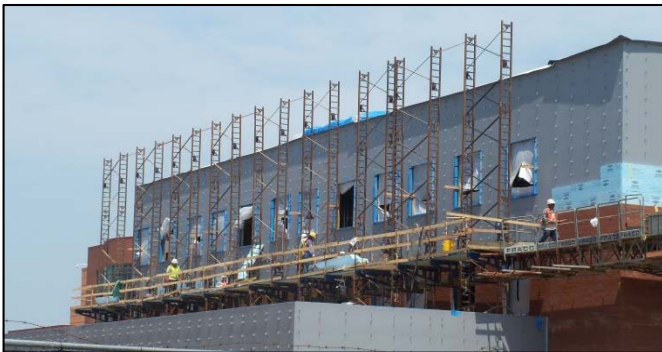
Figure 10 - View looking at southwest elevation. A MasonKing lift is required in areas where work is done above rooftops. These lifts have to be simultaneously cranked by hand to be lowered or raised. Personal photograph taken by Chris Pozza.

Fraco Lifts were set up around the perimeter of areas placing brick. MasonKing lifts were required in areas where veneer work was done above rooftops, which are shown and described below in Figures 10 and 11.

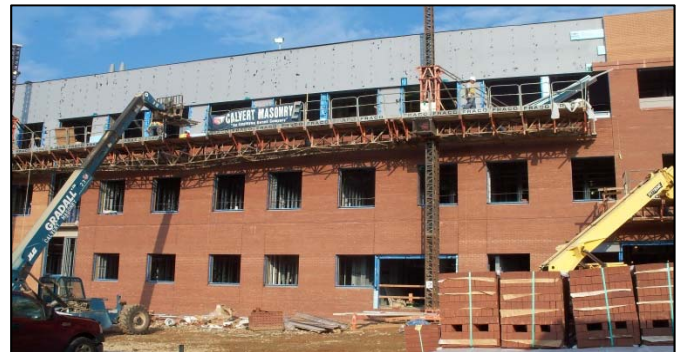
Figure 11 - View looking at east elevation. Fraco Lifts are used around exterior to provide efficient flow of construction along a large percentage of elevation at a time. Materials are lifted into place with a boom lift. Personal photograph taken by Chris Pozza.

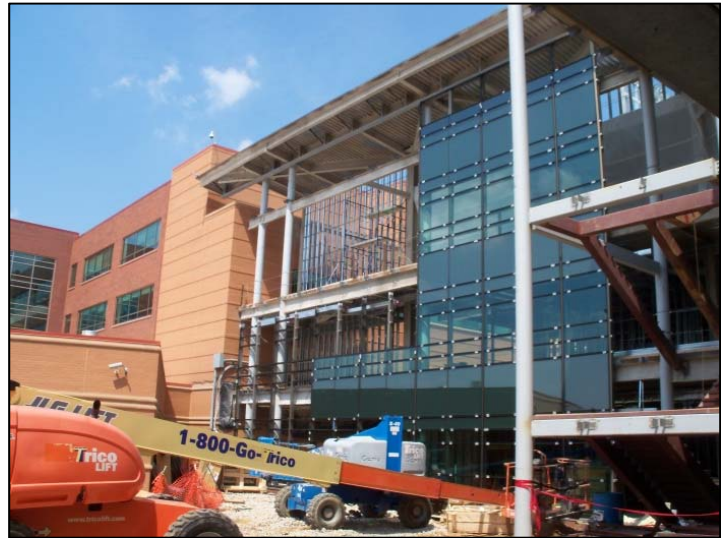
Figure 12 - View of west elevation curtain wall system under construction. The boom lift used during construction of the façade system can be seen at the bottom of the photo. Personal photograph taken by Chris Pozza.

Prefabricated aluminum curtain wall systems are used mostly on the west and south elevations. This wall system consists of 2.5" wide by 8" deep exposed mullions and caps at multistory locations. At low rise locations, 2.5" wide by 6" deep exposed mullions and caps are used. There are horizontal and vertical expressed caps along with the two main types of glass; 1" clear low E coated insulated glass and 1" spandrel glass. The system is thermally broken and designed to accommodate horizontal and vertical movement. Glass is lifted into place and sealed by two workers using a using JLG lift.

An exterior view of glass curtain wall going in place is shown above in Figure 12. To the left is Figure 13, an interior view looking at the same area on the second floor is seen. Eventually, this area will be a corridor into the existing building (straight ahead) with waiting areas to the right, getting plenty of natural daylight.

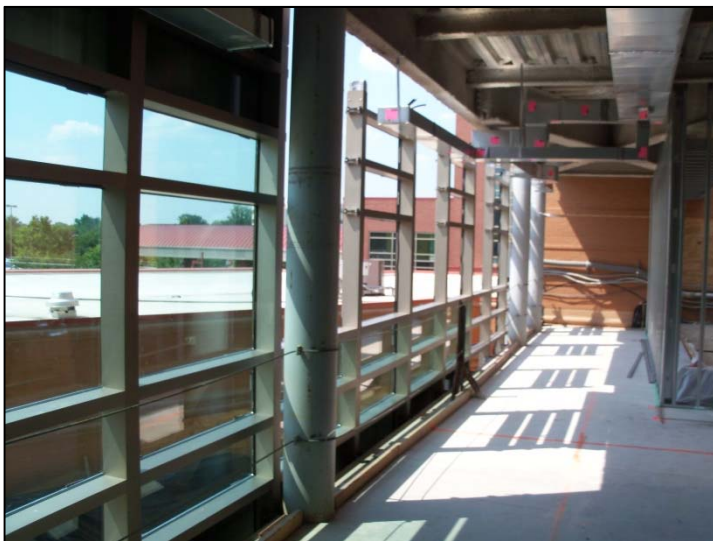
Figure 13, *left* – Interior view of west elevation curtain wall system under construction. Personal photograph taken by Chris Pozza.

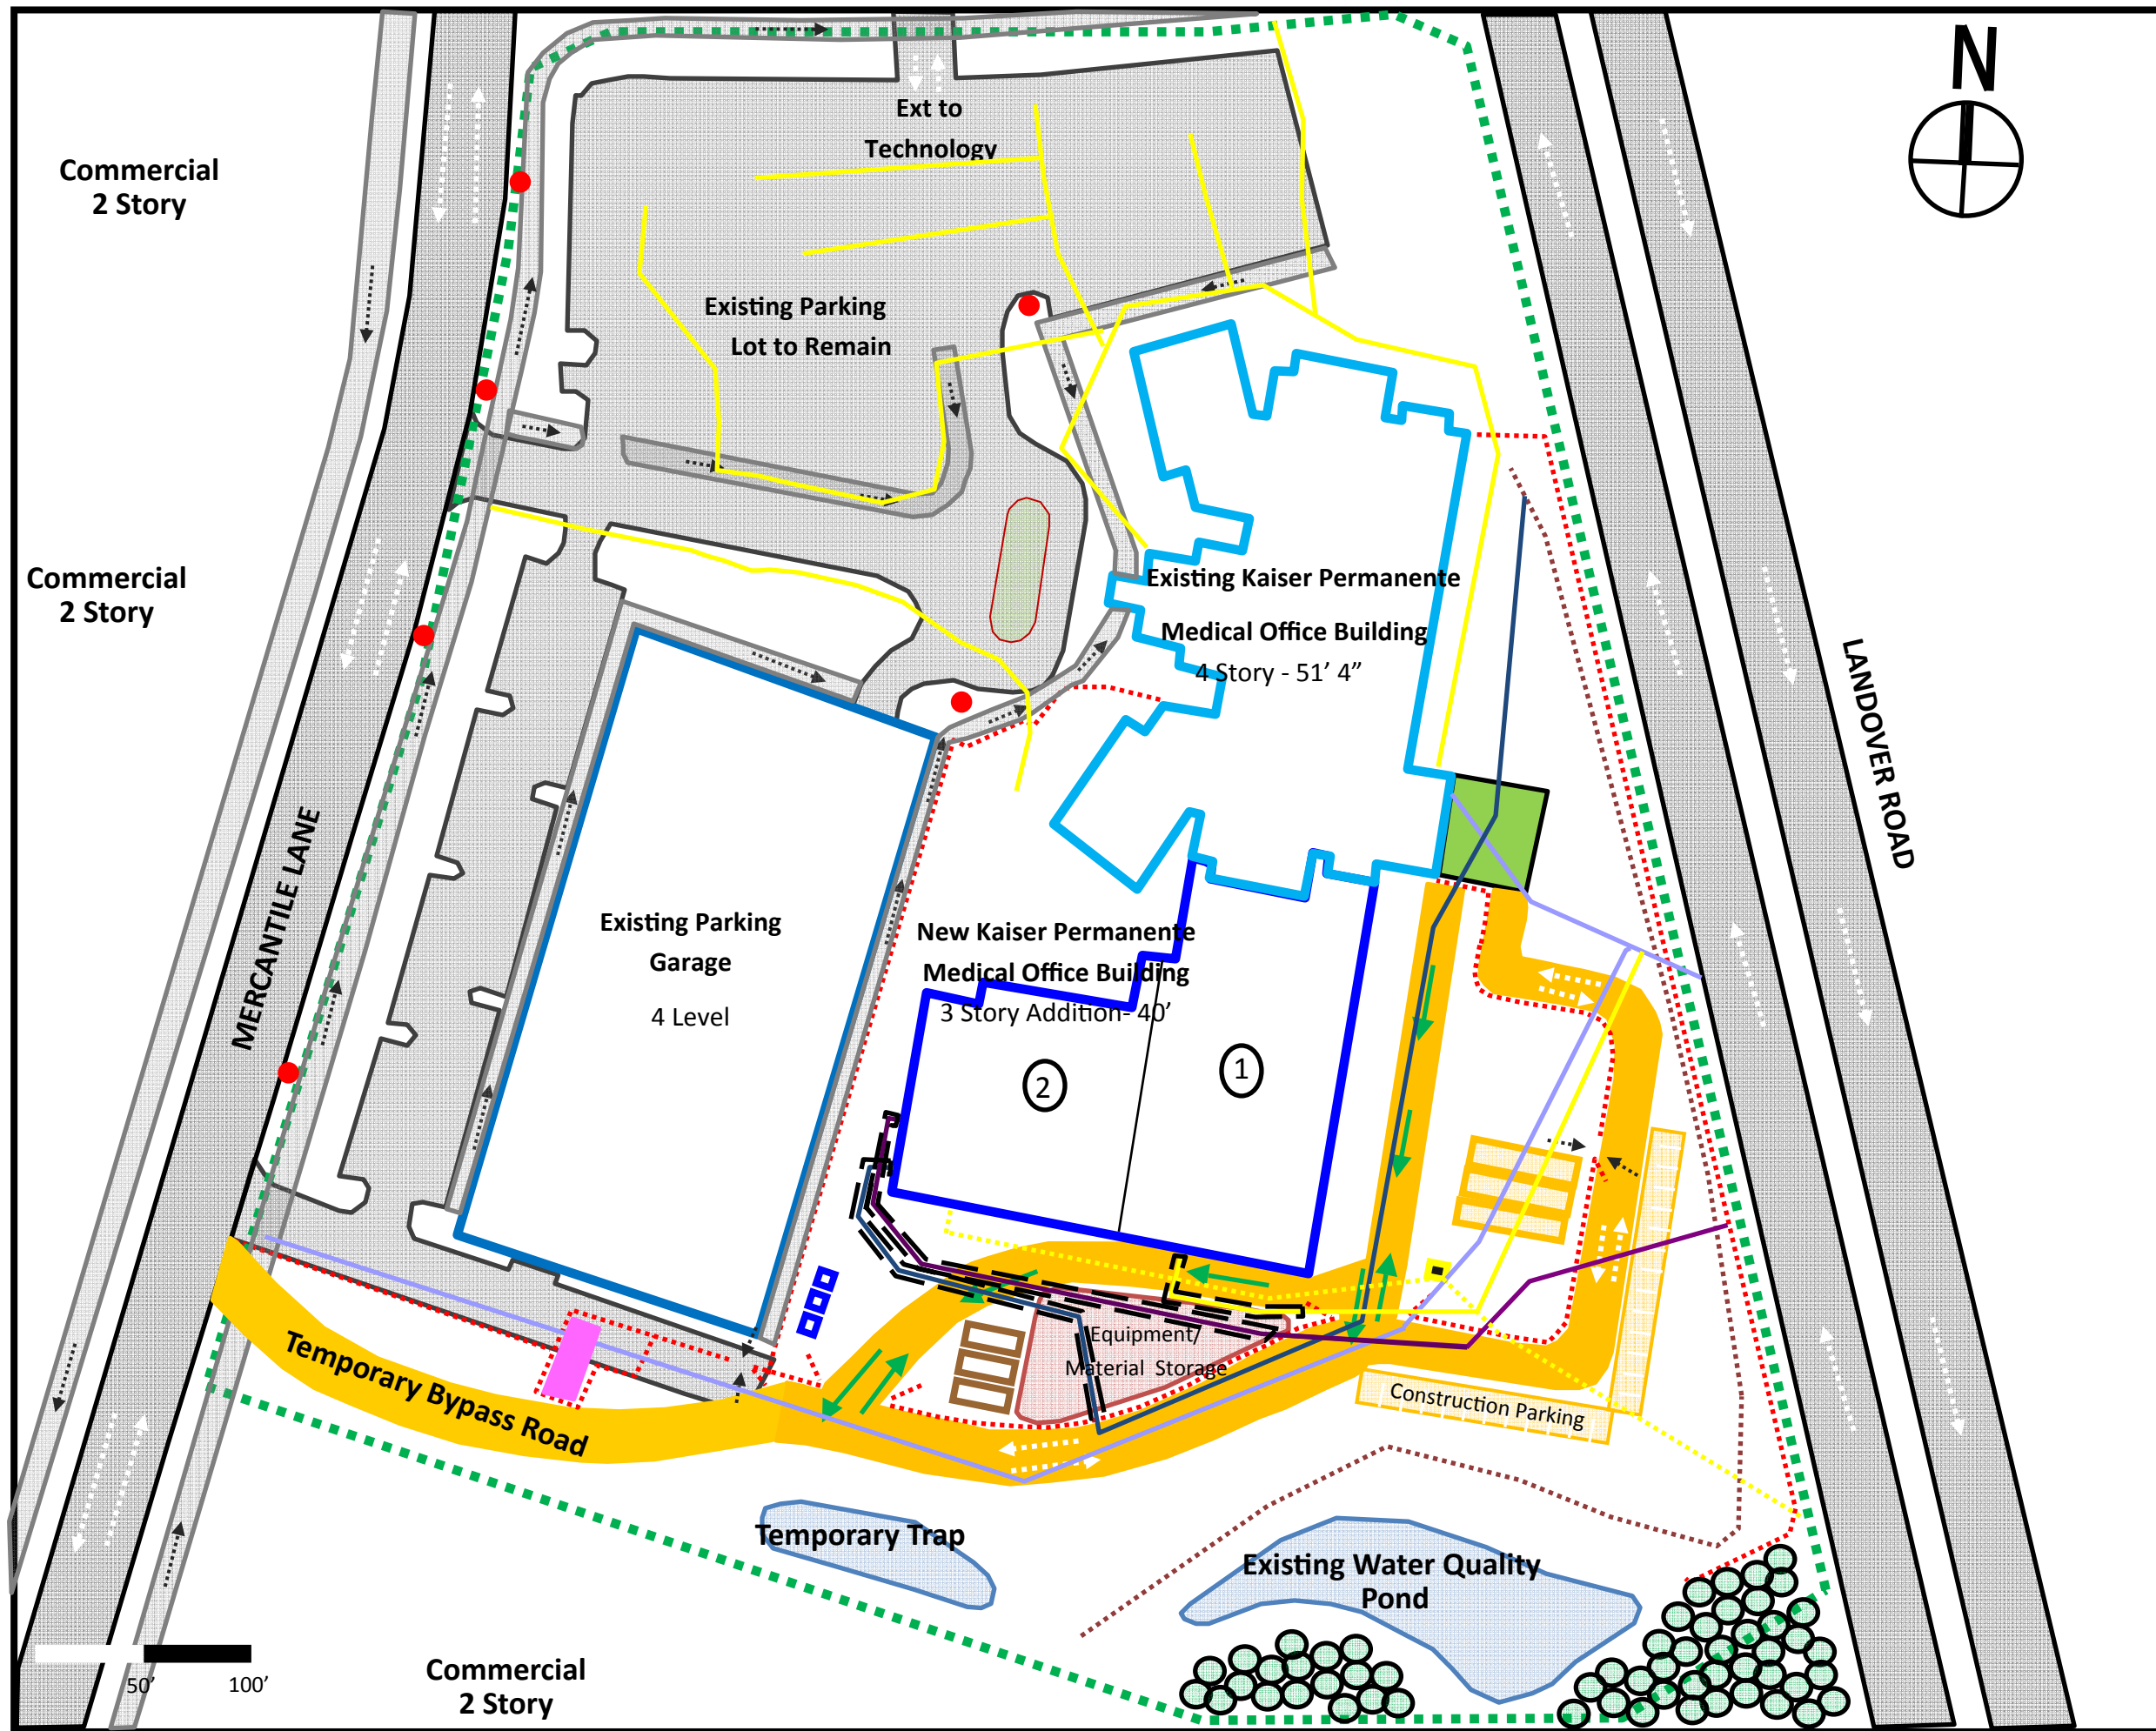
Largo, Maryland
Chris Pozza
Excavation & Mobilization
September 21, 2012
Tech Assignment 1

A temporary bypass road has been placed adjacent to the south entrance of the existing parking garage. The majority of the existing parking lot has been demolished for the new building footprint. This, with a legend and detailed plan can be seen on the Excavation & Site Mobilization plan found in **Appendix E**.
