TECHNICAL ASSIGNMENT 1

GHAITH YACOUB, CM

THE URBN CENTER & URBN CENTER ANNEX

PHILADELPHIA, PA

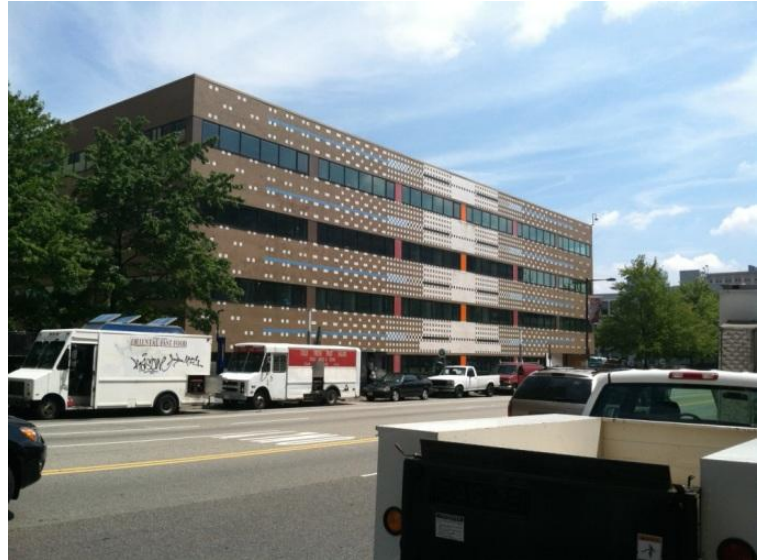
Figure 3: South Facade Of the URBN Center

Due to the historical significance of Venturi's original design, there is some preservation of certain aspects of the design that were untouched during the renovation. For example, there was full preservation of the façade along the south side of the building which features a classic mosaic design by Robert Venturi. Also, there are various art designs on several walls of the original design that were preserved due to their historical importance.

Due to historical significant of Venturi's design, the façade on the south side of the building was completely preserved and remained untouched during construction. New masonry units were placed on the other three sides of the building. The existing masonry façade is a brick façade and there were no changes to the existing bricks on the exterior of the building. The only removal of the façade was in the location of the new curtain walls. All other existing masonry bricks remained in place.
