Student Life Building

Technical Report 2

Northampton Community College
Tannersville, Pa

Kendall Slivka
Construction Management
Faculty Advisor; Dr Robert Leicht

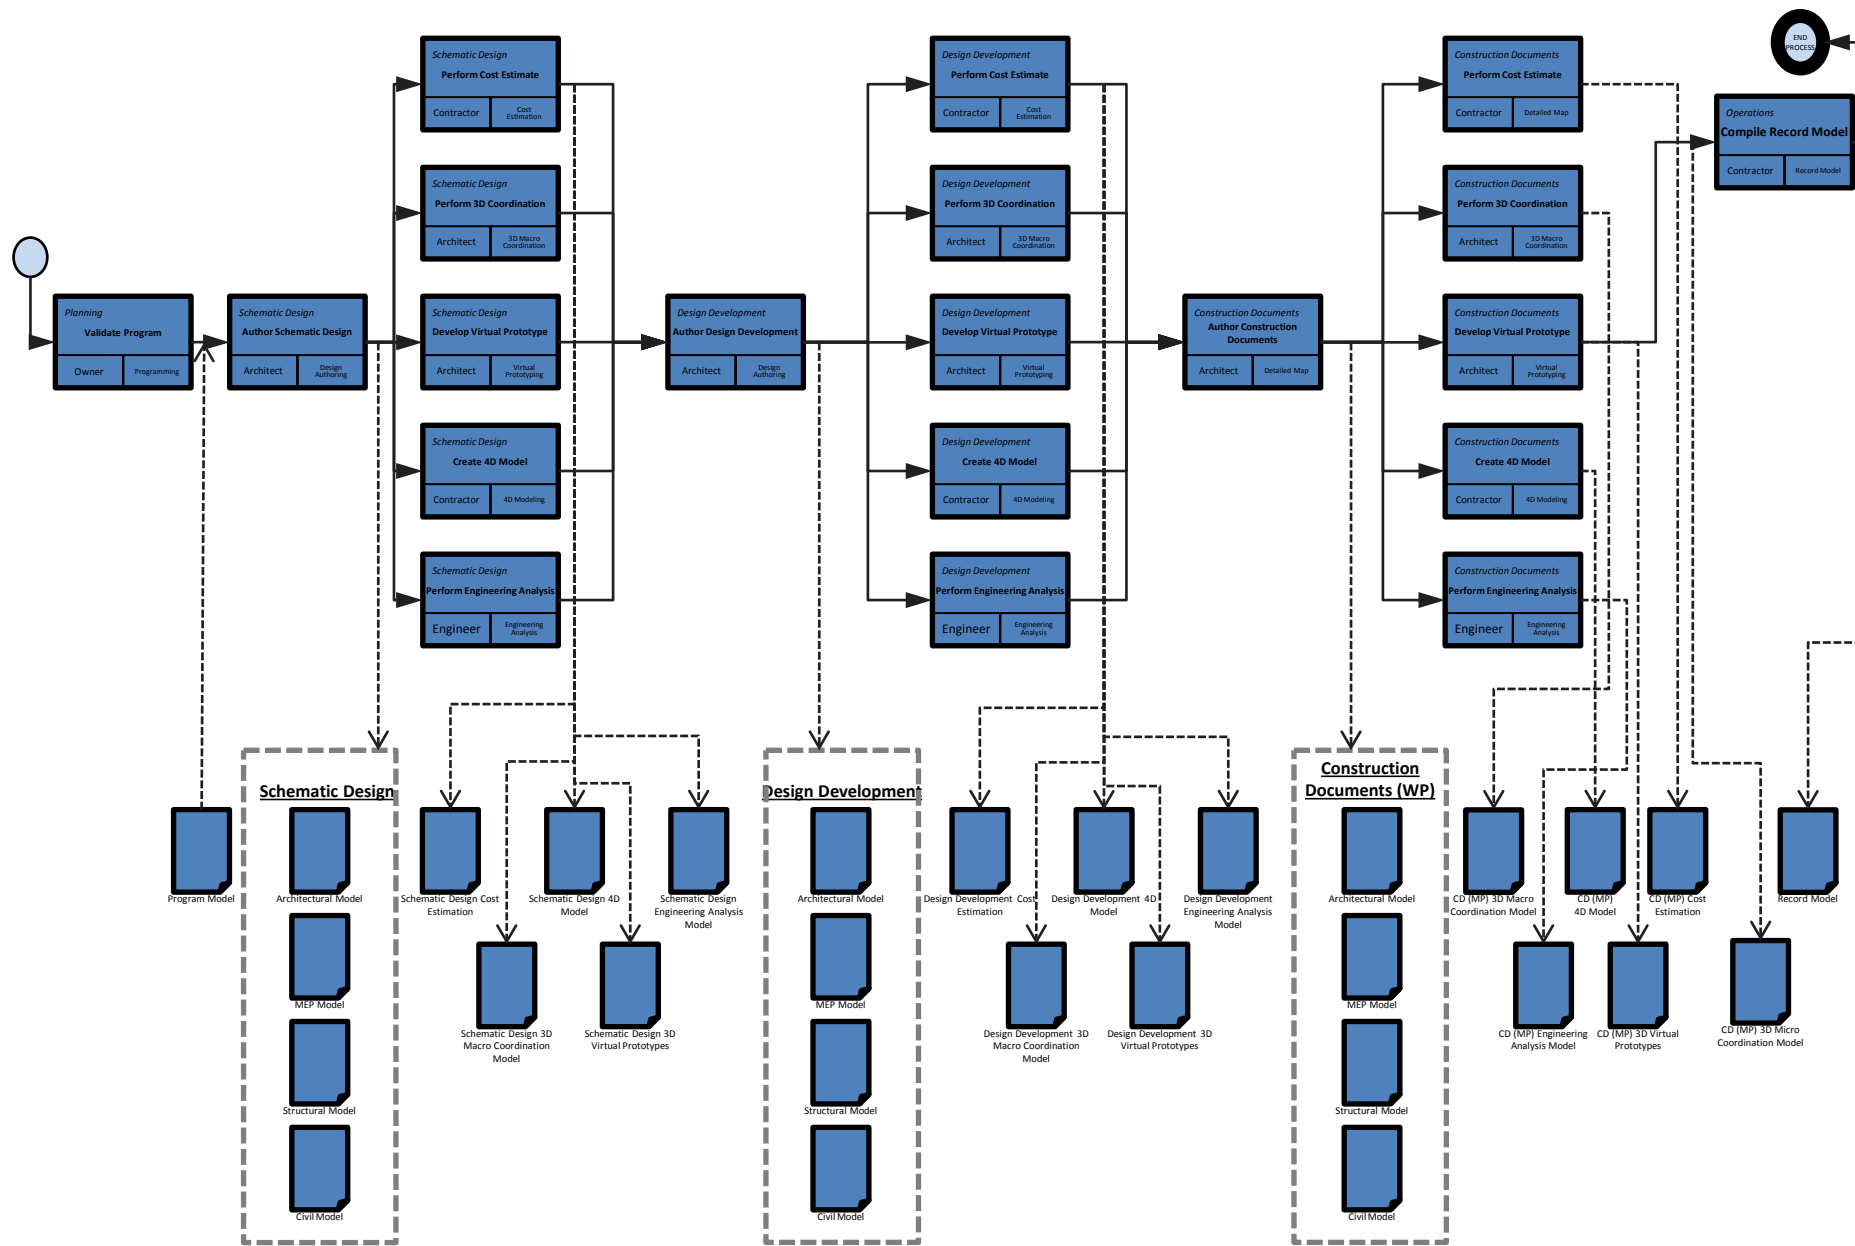
Level 1: BIM Execution Planning Process

Project Title: Student Life Building, Northampton Community College

***Level 1 Process Map attached in Appendix C**
