# U.S. GENERAL SERVICES ADMINISTRATION HEADQUARTERS MODERNIZATION – PHASE 1

1800 F ST. NW, WASHINGTON, D.C.

THE PENNSYLVANIA STATE UNIVERSITY ARCHITECTURAL  
ENGINEERING CAPSTONE PROJECT

RAMUEL HOLGADO | CONSTRUCTION MANAGEMENT OPTION | ADVISOR: DR. CHIMAY ANUMBA

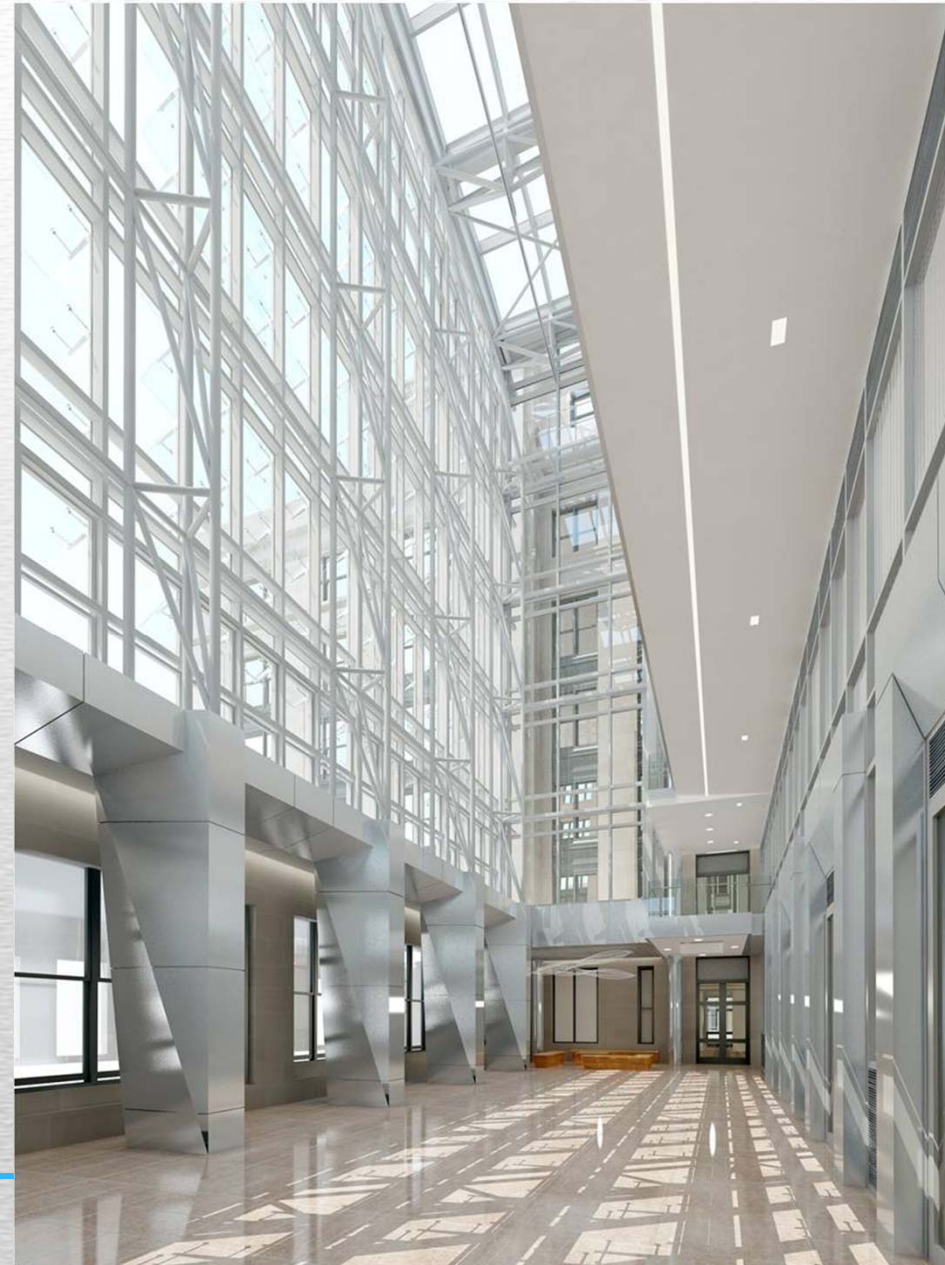
## Problem Identification

- Delivery of trusses
- Site congestion
- Cost of smart glass
- Contrasts with neoclassical style

## Proposed Solution

- Downsize the atrium
- Use shorter built-up truss columns

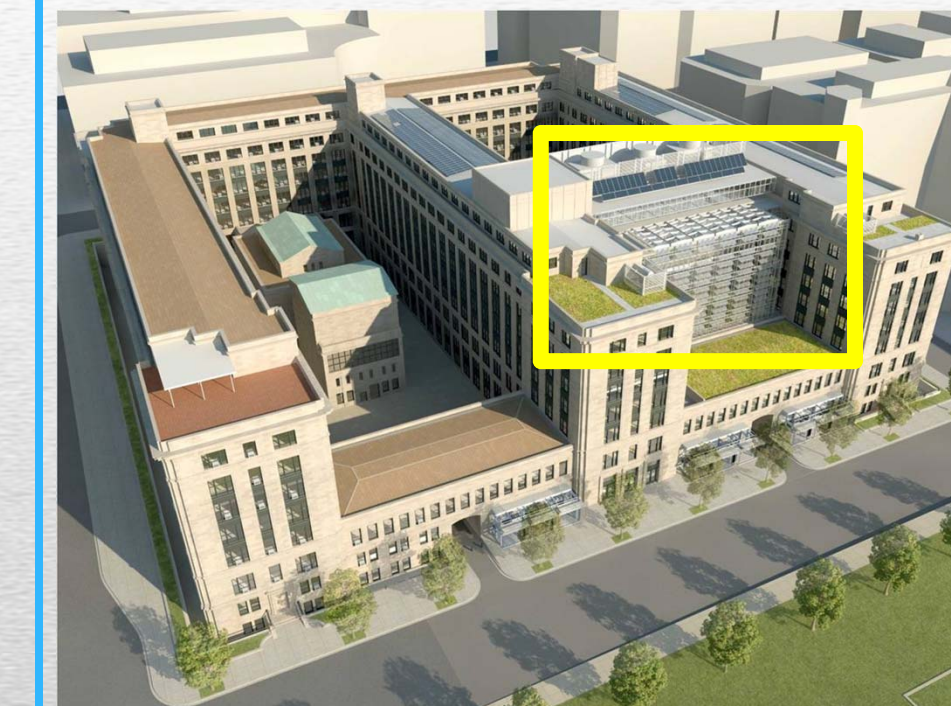
Original Design

- 78-foot built-up truss columns
- Surface area of glazing: 13,175 SF

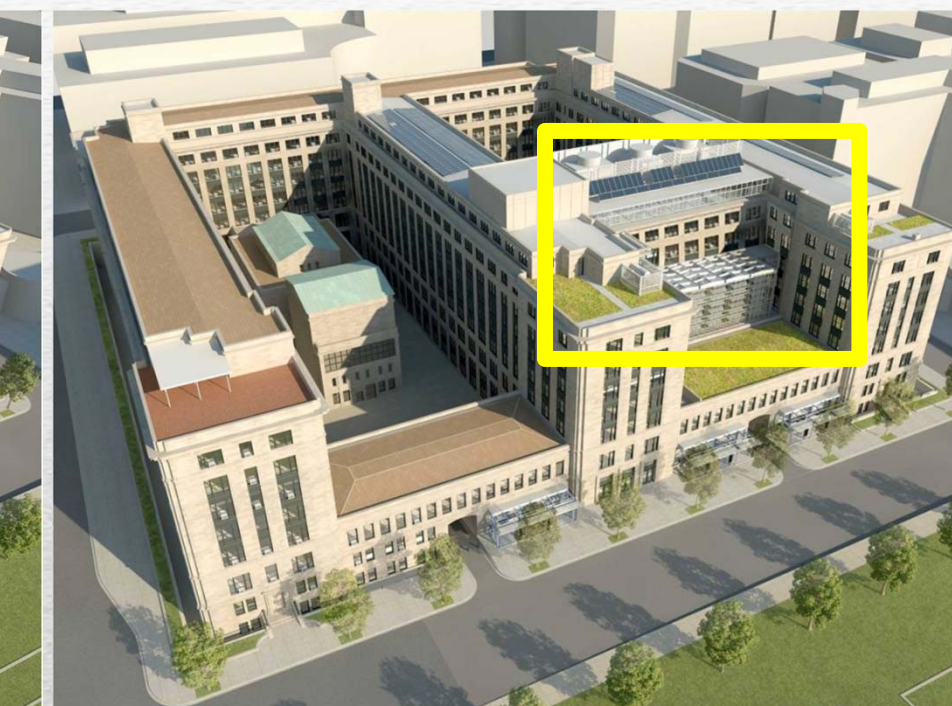
Alternate Design

- 51-foot built-up truss columns
- Surface area of glazing: 9,000 SF
- Walls of 5<sup>th</sup> and 6<sup>th</sup> floor constructed similar to existing building façade

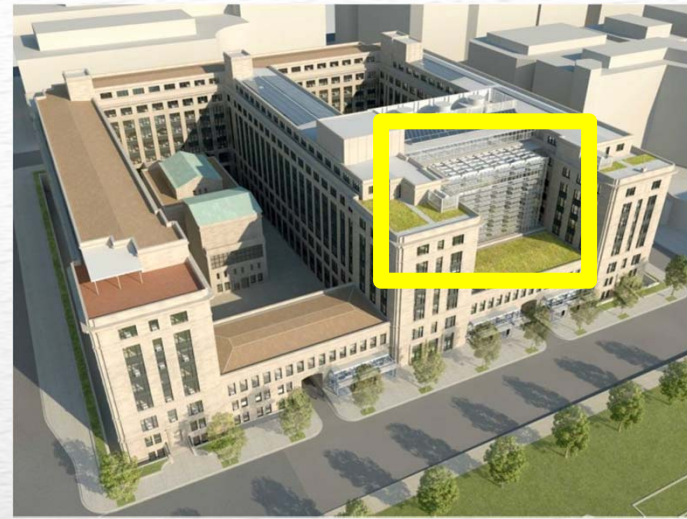
Original Design

- Original Atrium Design (Public Circulation)
  - NC Rating: 46
  - RC Rating: 48
- Alternate Atrium Design (Public Circulation)
  - NC Rating: 46
  - RC Rating: 47
- Alternate 5<sup>th</sup> and 6<sup>th</sup> Floor Design (Open Plan Areas)
  - NC Rating: 40
  - RC Rating: 40

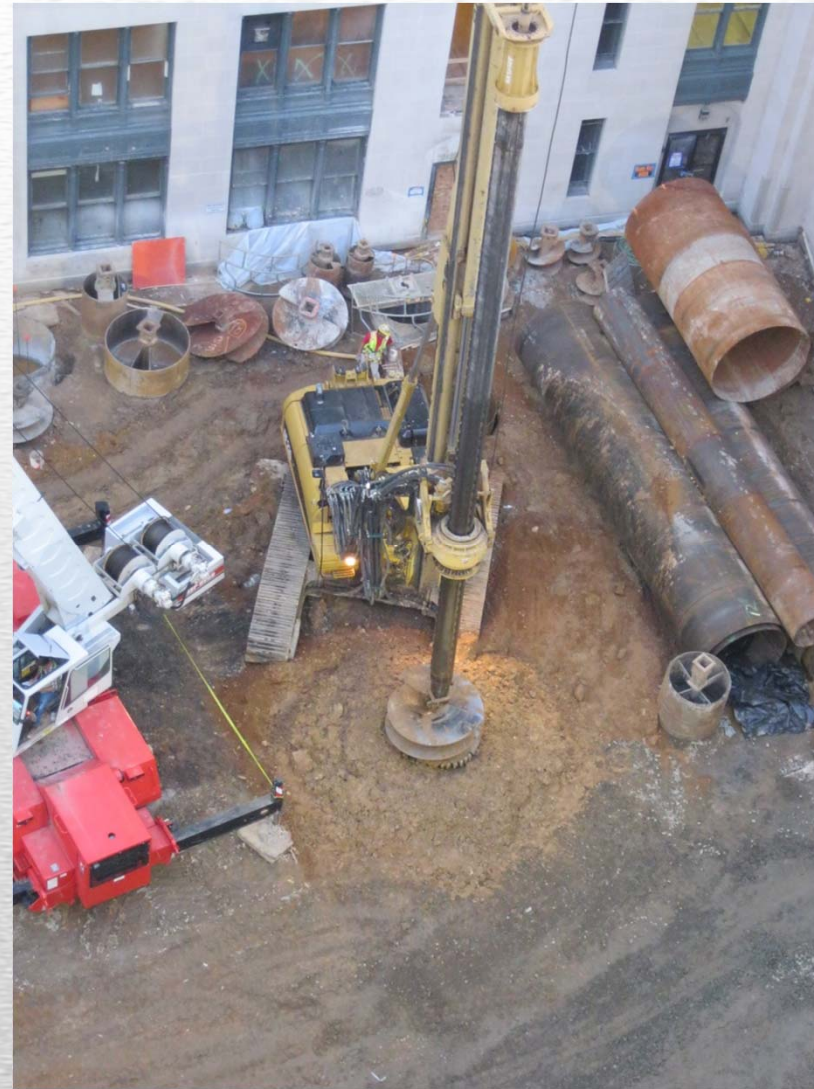
### Problem Identification

- New Addition original foundation system: caissons and grade beams
  - Cost 30% structural system
  - Long duration

### Proposed Solution

- Existing building foundation system: spread footings
- New Addition alternate foundation system: spread footings

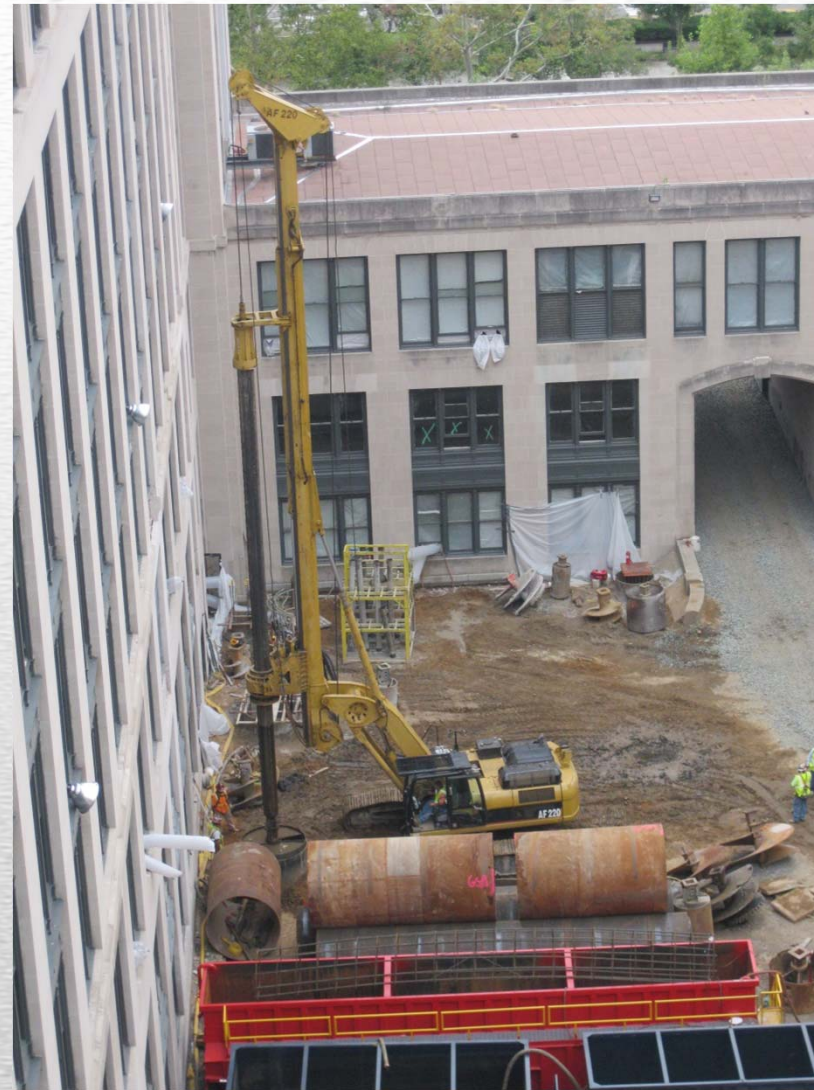
### Geotechnical Report

- Natural soils are relatively consistent with the regional geology and include:
  - Clay
  - Silty clay
  - Clayey-sand
  - Poorly-graded sand
  - Poorly-graded sand and gravel
  - Clayey sand and gravel

### Building Loads and Material Properties

- Column loads = 285k and 225k
- Allowable Soil Bearing Pressure = 5000 psf

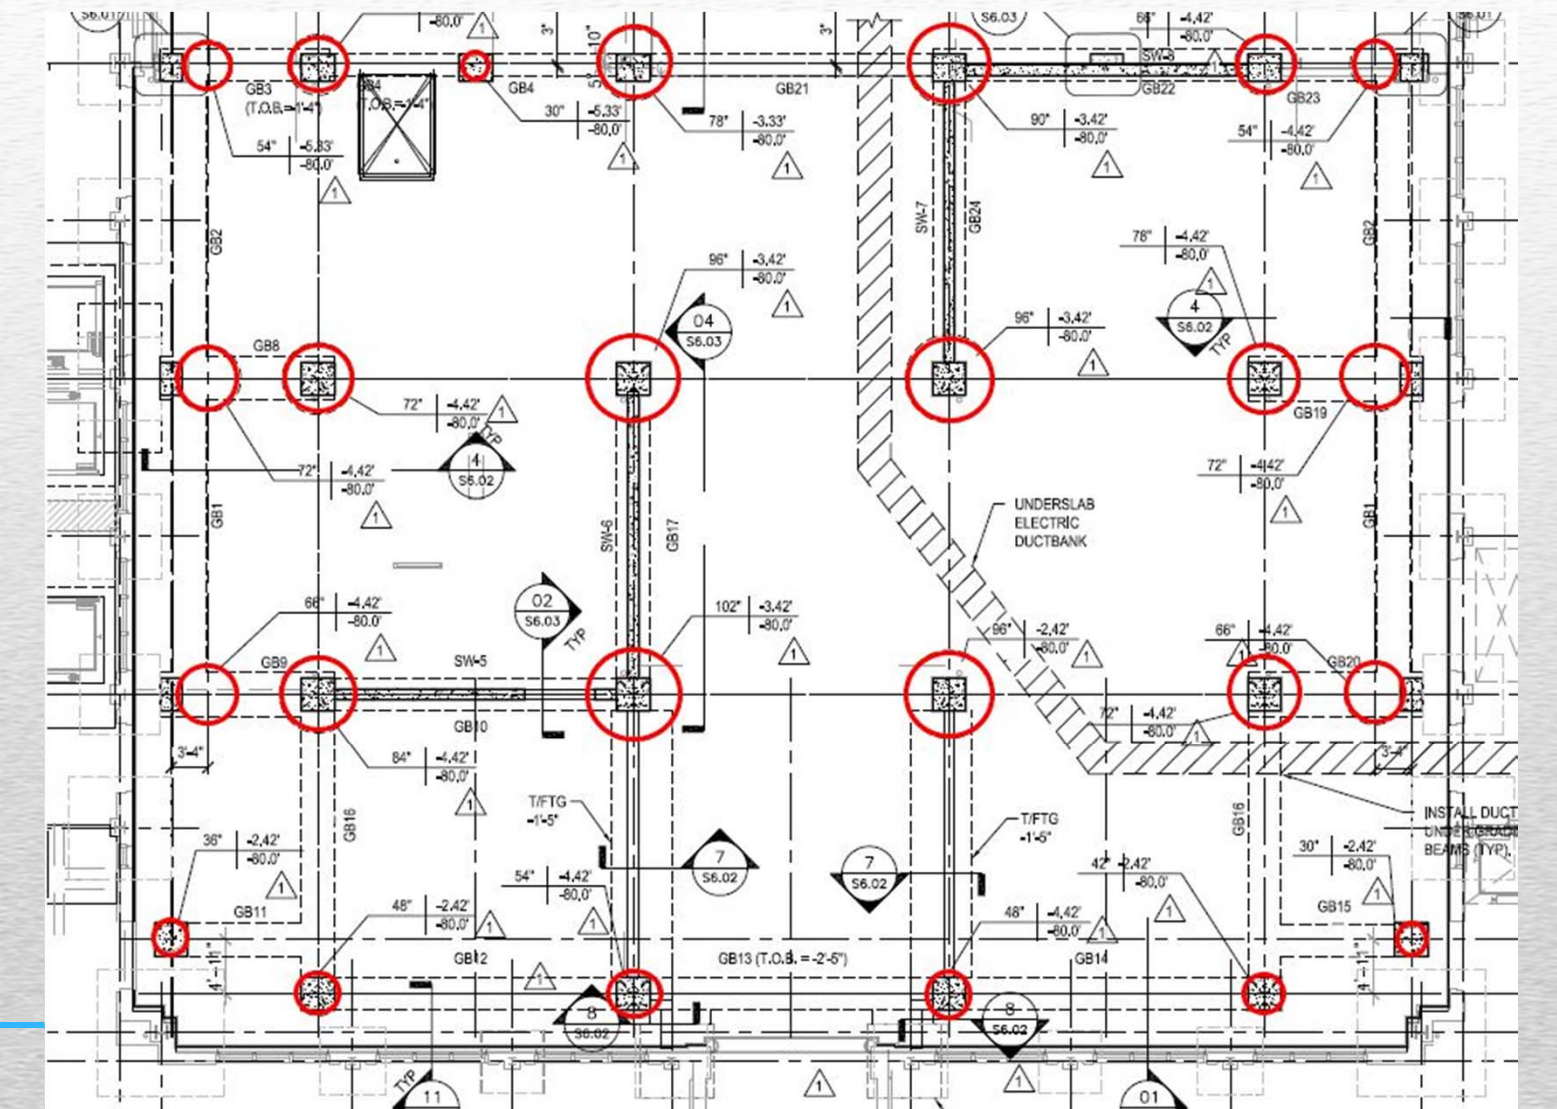
- Typical spread footing:
  - Size: 7'-4" x 7'-4" x 2'-6"

- 25 caissons
  - Shaft diameters: 30 inches to 102 inches
  - Drilled 75 feet to 80 feet deep
- 24 grade beams

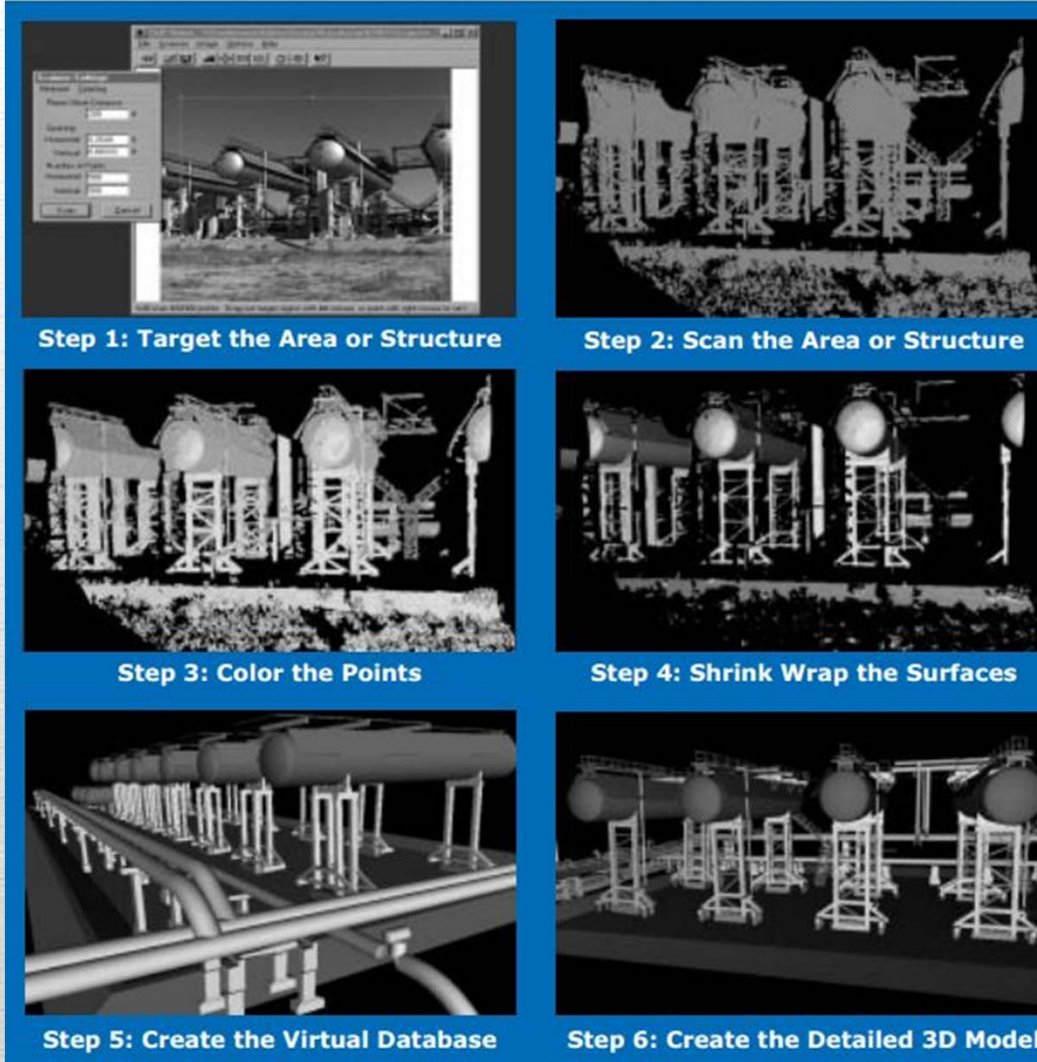
### Proposed Solution

- Leica ScanStation C10
- Leica Cyclone

### ScanStation C10

- 3D laser scanner
- Full-dome interior scans in minutes

### Cyclone

- 3D point cloud processing software
- Web-based sharing and viewing

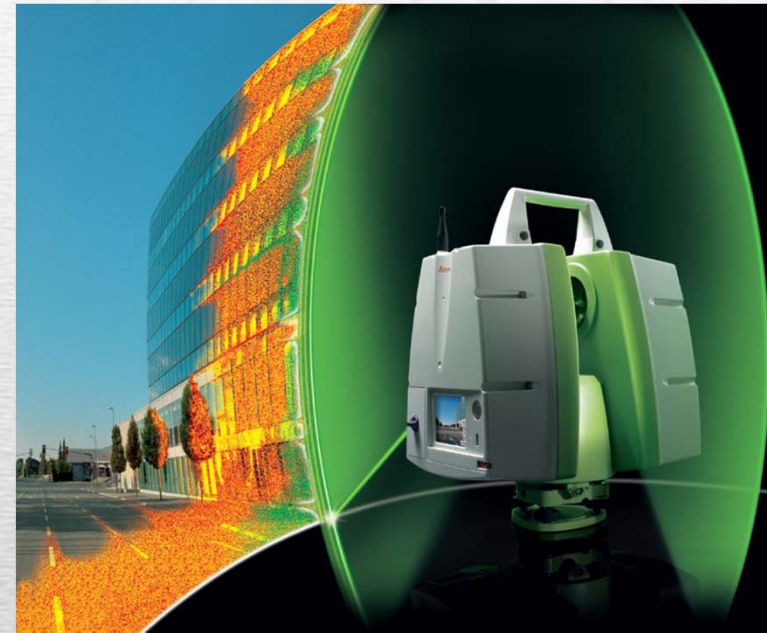
### Creation of As-Built Drawings

- 2D as-built drawings
  - Plans, elevations, sections, and details
- 3D models of existing conditions

### Improved Coordination and Design

- Simultaneous access of 3D point cloud data sets and models from anywhere
- Clash detection

### Quality Control Verification On Site

- Slab levelness, truss column plumbness, installation locations, etc.
- Quality control will be maintained throughout the project
