SOLAIRE WHEATON

Technical Report 2

Construction Management

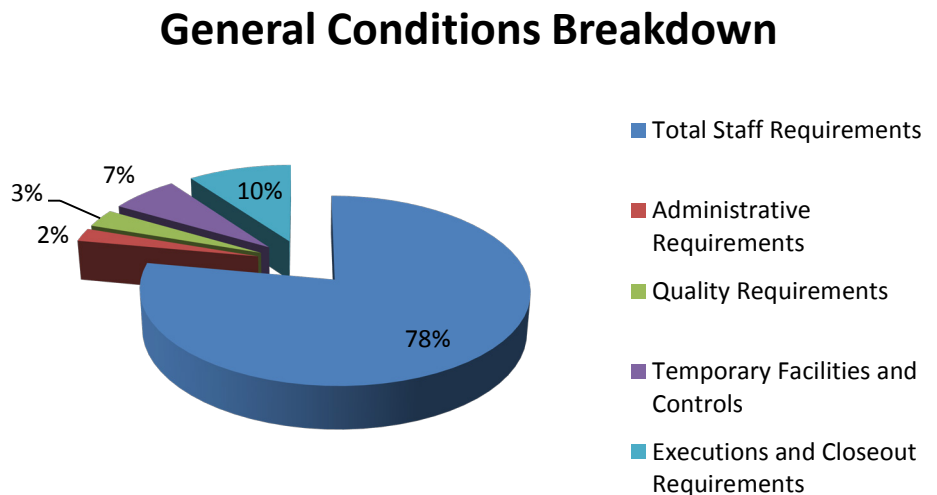
Figure 9. General Conditions Cost Breakdown

The chart shown in Figure 9 shows the breakdown of the general conditions costs. As you can see the staff of the project team accounts for 78% of the general conditions. This type of breakdown can be typical of the CM @ Risk delivery method. Unlike a project with a general contractor, the CM does not carry much of the cost and liability for tools and equipment. As mentioned, many of the temporary facility costs such as the tower crane were placed under the guaranteed maximum price or picked up by specialty contractor scopes. For example, temporary fencing was bought by the balcony railing contractor. In comparison with the actual general conditions cost, the estimate was about \$200,000 high. This is because the original GC estimate excluded an assistant superintendent who was added to the project team. Had this member of the team been present at the beginning of the project, the GC estimates would have been similar. The \$1.8 million estimate is 6% of the overall GMP which can be expected.

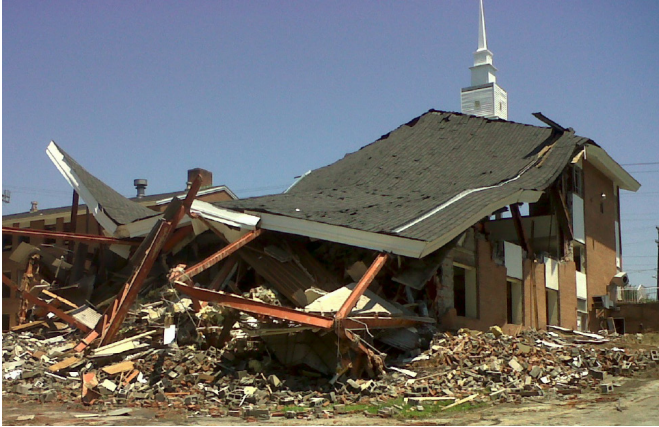
Figure 10. Image Courtesy of Clark Builders Group

Prior to the start of excavation and construction, the existing structure, seen in Figure 10, needed to be abated of hazardous material and demolished. The recycling of the existing structure greatly contributed to attaining the LEED MR2 credits for greater than 75% waste diversion. As seen in the demolition layout plan in appendix C, the parking lot west of the existing structure was used for the trailers, and abatement/recycling dumpsters. Once the demolition phase was completed, the excavation and foundations phase began.

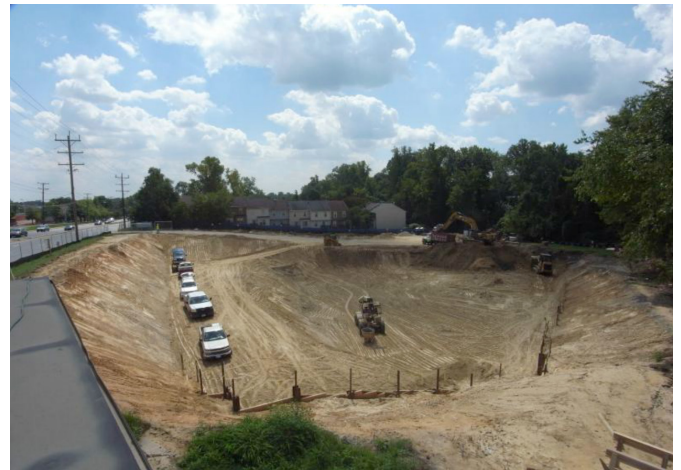
Figure 11. Image Courtesy of Clark Builders Group

To accommodate for the two stories of semi-below grade garage, the site required a fair amount of excavation. As noted in the geotechnical report, the soils were classified as clayey sand with varying amounts of gravel, silt, asphalt, and organics. These were favorable conditions with ground water table below the depth of excavation. The geotechnical report suggested an earth retention system in the Northeast corner of the site. As seen in Figure 11, the excavation was trenched back towards Georgia Avenue eliminating the need for the an extensive earth retention system. Entrance to the site is available by means of the southern gate with the soil stockpile in the Southwest corner of the site.

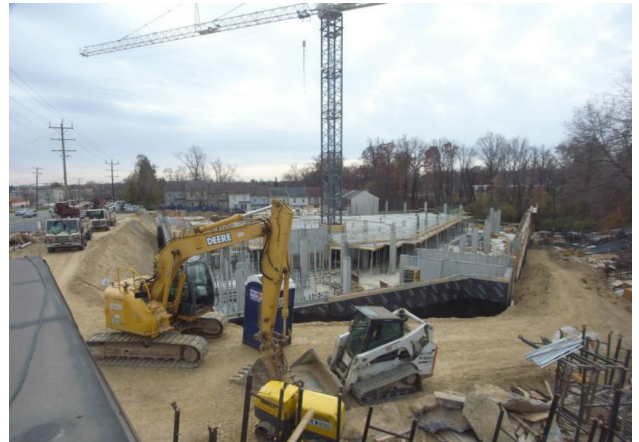
Figure 12. Image Courtesy of Clark Builders Group

As the excavation wrapped up, the tower crane pad can be placed and crane erected. In order to erect the crane, a designated area of the mall parking lot will be used, as seen in the layout plan in Appendix C. This requires great coordination with the mall security and parking authorities to limit disruption of the flow of mall traffic. The concrete phase will begin to utilize both entrances along Georgia Avenue. Site access is restricted by the steep grade change from east to west and the single adjacent road. In addition to laydown areas along Georgia Avenue, there is also space on the north of the site in the mall parking lot. As shown in Figure 12, the sequence of work flows outward from the tower crane in a counterclockwise manner from the southeast corner.

This allows the east foundation walls to be placed early, waterproofed and backfilled.

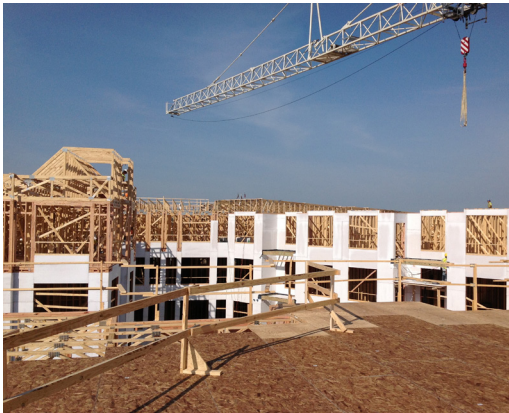
Figure 13. Image Courtesy of CBG

Figure 13 faces the west, again showing the flow of work out of the southwest corner. During the structural wood framing phase of the project, the east side of the building started to get more congested as there was constant material deliveries and dumpster pulls. Workers began to establish the east elevation building entrance as the construction entrance. This is where the porta-johns were located, and all foot traffic went through the busiest area of the site. Some consideration could have been made for placement of the porta johns and construction entrance on the north side eliminating the safety risk with constant equipment movement and material deliveries on the east side.

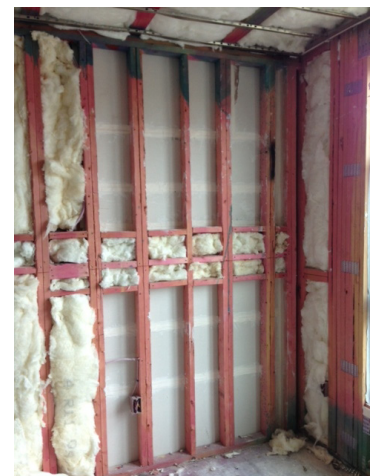
Figure 16. Image by KAM

The photograph at the right, Figure 16, shows the solution to the constructability issue. The drywall contractor was required to install small pieces of drywall in the stud cavity and tape the joints. This only solved the accessibility issue. To meet the wall assembly requirements, a fire engineer was required to analyze and sign off on the assembly. This issue created significant labor time and consultant fees to resolve. This was an issue that easily could have been solved in a coordination meeting with the designer and CM, had they existed. Although the contract language rids the architect of construction means and methods liability, they could have (along with their third party inspector) suggested a solution for this apparent issue. The framing contractor could have left out a few studs in order to slip the drywall through. These types of issues require creative solutions from collaborative teams.

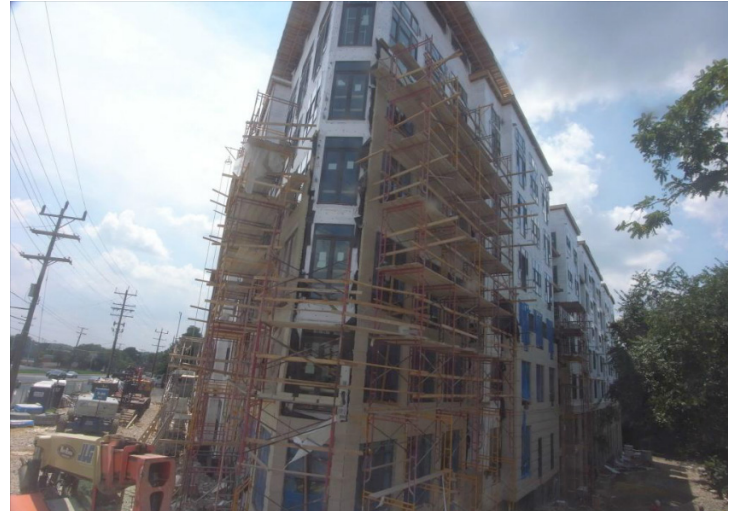
Figure 17. Image Courtesy of CBG

One of the reoccurring constructability issues on the Solaire Wheaton project was the extremely tight jobsite with limited access. As noted in the site layout plans, the site can only be accessed by Georgia Avenue, which runs along the east side of the building. This can be seen at the left side of Figure 17. This is the location for material laydown, jobsite toilets, material deliveries, building entrances, and current facade work. This poses a significant safety risk, especially with the ongoing stone and brick work on the scaffolding. The site drops off significantly from east to west with narrow access around the entire building. The other elevations are only accessible by track equipment and basket lifts, which are still subject to getting stuck in the mud. This was a major issue during construction in terms of movement of material to the work stations, and equipment access. For this reason the team needed to install a temporary road, which was not included in the general conditions for the project.

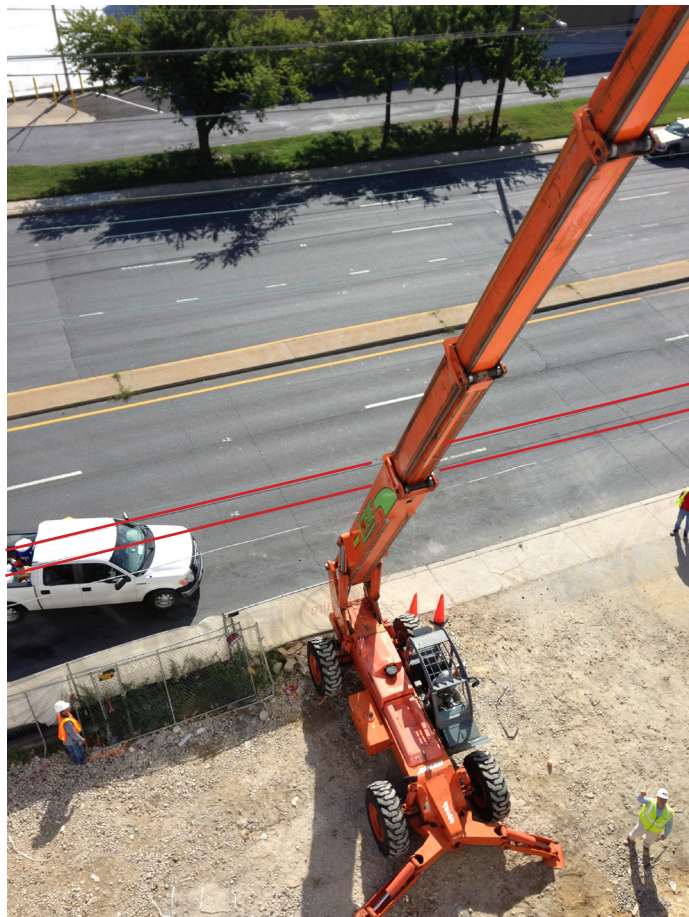
Figure 18. Image Courtesy of KAM

These types of constructability concerns pose great safety risks. For example, in Figure 18 the forklift is in the process of lifting material to the 6th floor. At this point the elevators were not in service yet and the 6th floor needed to be loaded to keep the interior finishes on schedule while not affecting the critical path. The forklift happens to be only a few feet away from the overhead electrical lines, which are highlighted in red in Figure 18. The boom of the forklift is approximately 3 feet away from the lines. These types of safety issues are items that need to be discussed prior to construction. There should be contingency plans formed to deal with situations like this. One solution to deal with the site constraints could have been to use a material hoist. The project team could have also put the elevator installation on the critical path to be sure it was in service for material deliveries.

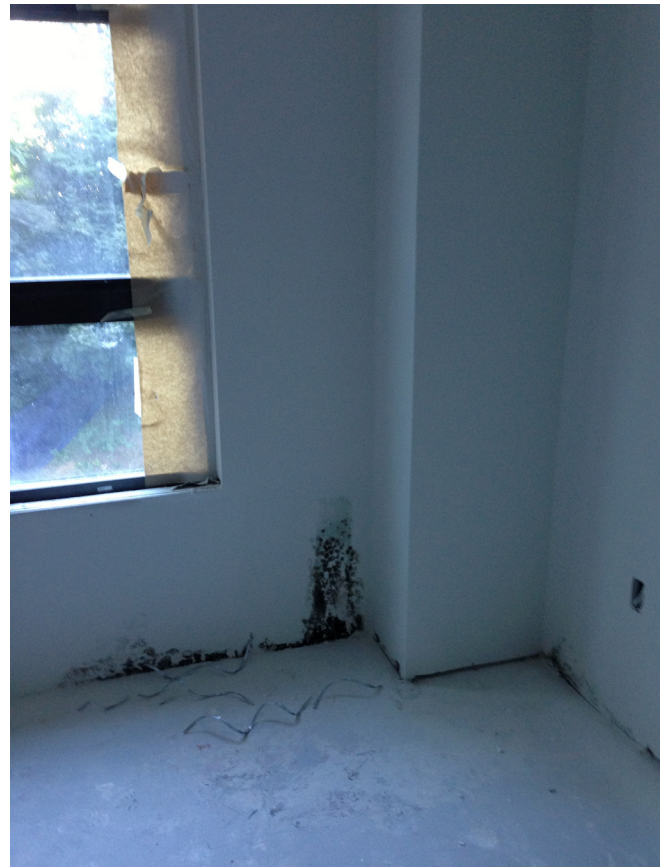
Figure 19. Image Courtesy of KAM

On the Solaire Wheaton project, the gypcrete was scheduled to be poured after drywall, so the second bottom plate was not included and therefore not installed. Gypcrete started on the 6th floor after the drywall had been installed, and resulted in issues with mold growth as seen in figure 19. As this problem arose, the team decided to go ahead and gypcrete the remaining floors prior to drywall installation due to delays with the drywall contractor. This eliminated the mold issue, however, it added significant material and labor cost of adding bottom plate nailers between the studs.
