Prince  
Frederick  
Hall

Tech Two

Construction, Sowers, 16 Oct 2013, PSU AE, University Park, Maryland

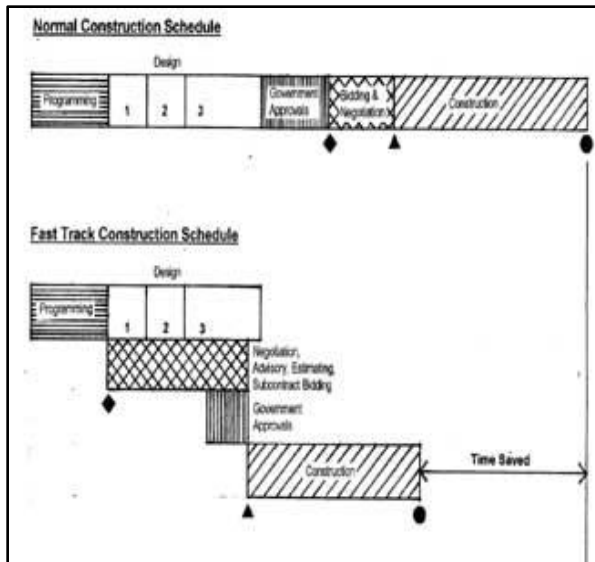
Figure 2: Linear vs. Fast Track Scheduling

Extensive site work and excavation begin during mobilization and continue through to the completion of phase one. These activities include demolition and excavation, demanding a linear schedule due to the site-wide nature of these tasks. Once Phase two begins this linear approach changes to a much faster staggered method, neatly fast tracking the project. Instead of having a task impact the whole site, tasks are broken up floor by floor. On site this sort of schedule demands heightened focus and attention from management to ensure each task is completed in a timely manner. This schedule, though difficult to manage, does greatly increase productivity day to day and can cut months or more off a project. This faster pace ensures Prince Frederick Hall is completed in time for occupation.

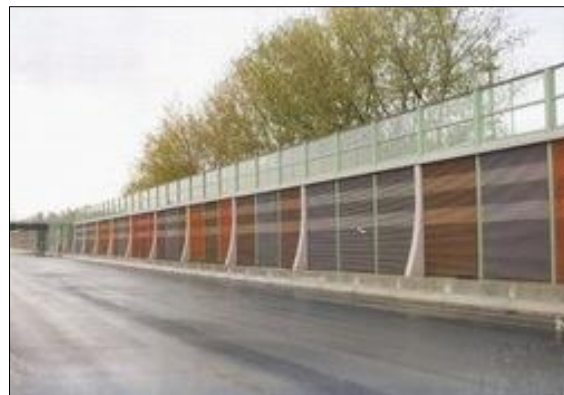
Figure 3: Construction Noise in Decibels and Acoustic Fencing

Due to the location of the site, construction noise and vibration will impact a large number of students in the surrounding dormitory buildings. Because of this the University requested that construction not occur during finals weeks and on commencement days. However, since students would hopefully desire to be studious all the time, additional measures can be taken to minimize noise disruption. Scheduling noisier site activities for later in the day is a simple means to ensure the student population stays content and happy. Additionally, use of absorptive materials along the site fencing or around a particularly noisy activity such as pile driving could significantly decrease the noise present on the site. Unfortunately absorptive fencing would add a great deal of cost and should be used as a last resort.

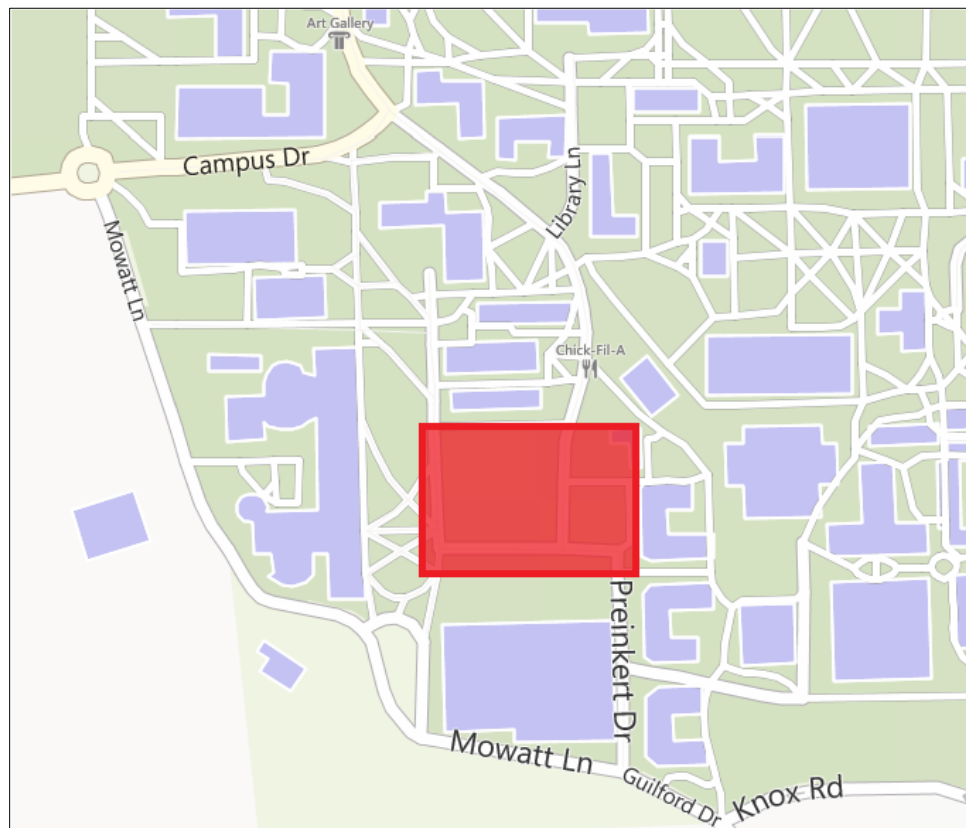
The final construction concern for this report is the fact that the site has only one entrance for materials. This resulting in needing to ensure that nothing blocks the access route to the site due to lack of proper back up. As you can see on the map below, where the site is highlighted in red, there are only two roads to bring materials in through. However, Preinkert Drive is being used to provide parking for the students and thus not for material uses unless there is an emergency. To ensure the access road stays open staff should familiarize themselves with the campus that they will be driving through. Weekly updates on heavy traffic days should aid drivers in moving quickly and efficiently to and from the site.
