TECH 2

Ramy Labna – CM Option
10/16/2013
Advisor: Prof. Sowers

*Cost & Schedule
Analysis*

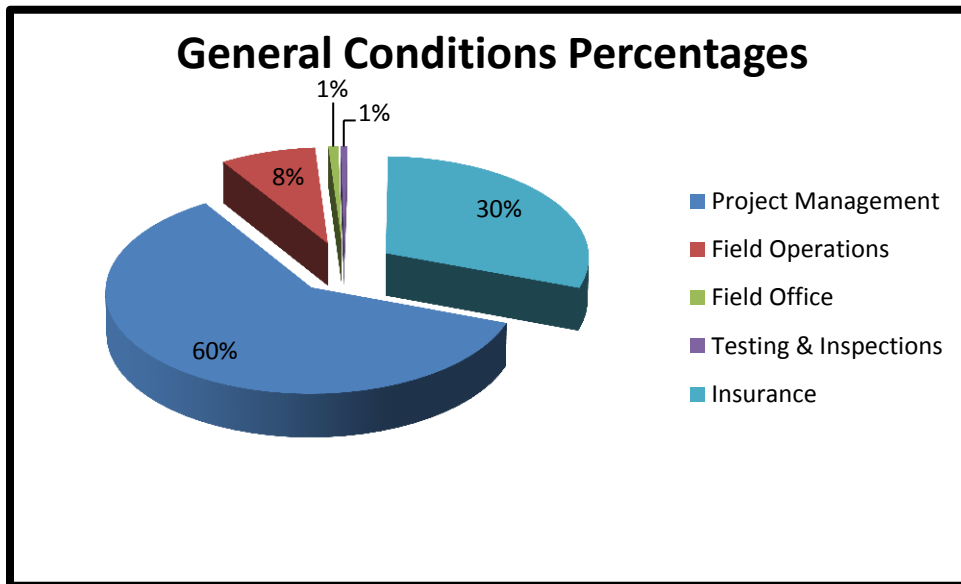
Figure 2 – General Conditions Estimate Graph

Table 3 and Figure 2 on the next page provide a summary of the General Conditions Estimate as a percentage of the entire estimate.

Category	Project Cost	% of GC
Project Management	\$ 662,100.00	60%
Field Operations	\$ 86,443.95	8%
Field Office	\$ 9,070.00	1%
Testing & Inspections	\$ 6,125.60	1%
Insurance	\$ 331,372.26	30%
Total	\$ 1,095,111.81	100%

The general conditions estimate was done with the assistance of RS Means Cost Works database (Web source) and Commitment Construction Percentages for Insurance work. The total estimated cost for General Conditions is \$1,095,111.08, which can be seen in detail in Appendix D. This cost was grouped into 5 sub categories, which included, Project Management, Field Operations, Field Office, Testing & Inspections and Insurance. There will be a difference in values when comparing the estimate to the actual, as both are based on pricing and evaluation of different countries. The summary of the schedule breakdown can be seen on Table 3 and Figure 2 below.

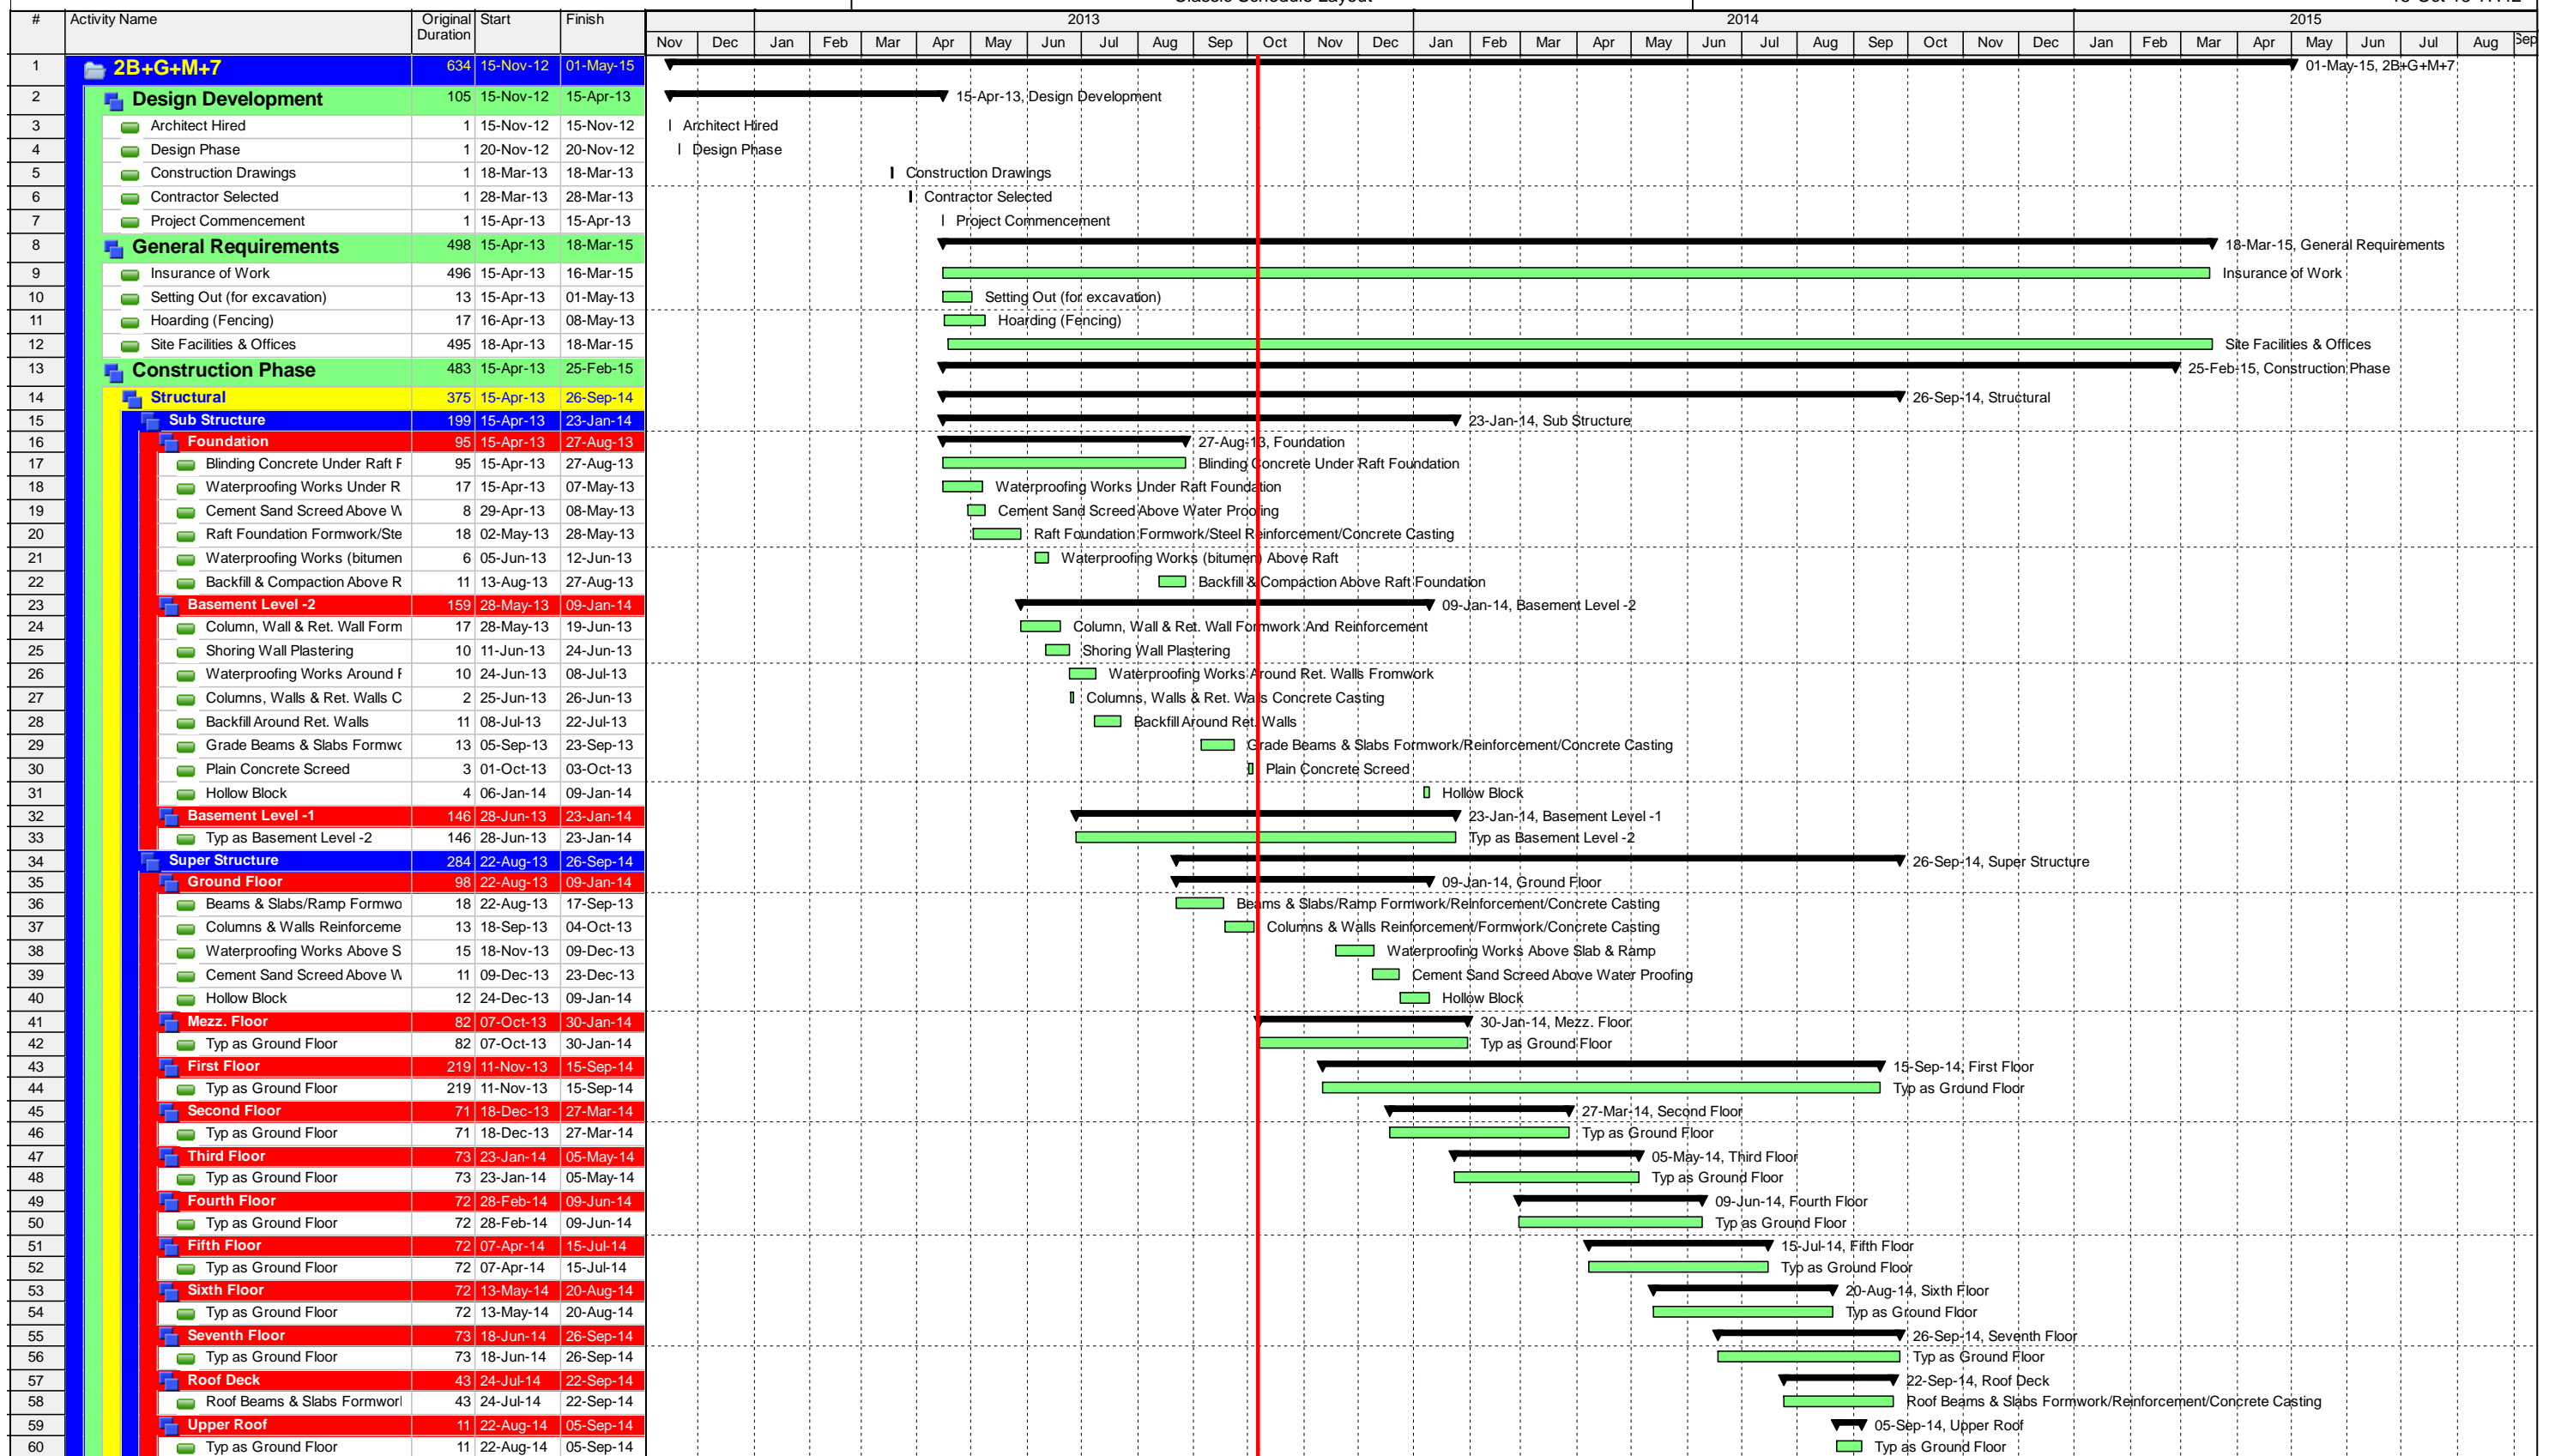
Appendix A – Detailed Project Schedule

The Mansoura Development detailed project schedule begins on November 15, 2012, when Petra Design Architecture Firm was hired to take on the project. The Contractor was selected after construction drawings were produced, on March 28, 2013. The construction schedule lasts 24 months. The schedule is broken down into a floor to floor sequence rather than by trades. The following table gives a summary of the major design and construction phases:

Detailed Schedule Summary			
Phase Description	Start Date	End Date	Dur. (Days)
Design & Pre-Construction	11/15/2012	5/8/2013	128
Sub Structure Structural	4/15/2013	1/23/2014	199
Super Structure Structural	8/22/2013	9/26/2014	284
Plumbing Installation	8/19/2013	1/27/2015	374
Arch Rough-ins	9/23/2013	2/19/2015	359
Electrical Installation	12/30/2013	2/25/2015	303
Fire Safety	1/2/2014	1/30/2015	282
Ventilation & AC	1/8/2014	1/28/2015	276
External Façade Finishes	9/22/2014	2/19/2015	109
Elevator Installation	10/9/2014	1/23/2015	77
External Site Work (Landscape)	10/29/2014	12/29/2014	44
Testing & Closeout	1/14/2015	5/1/2015	81

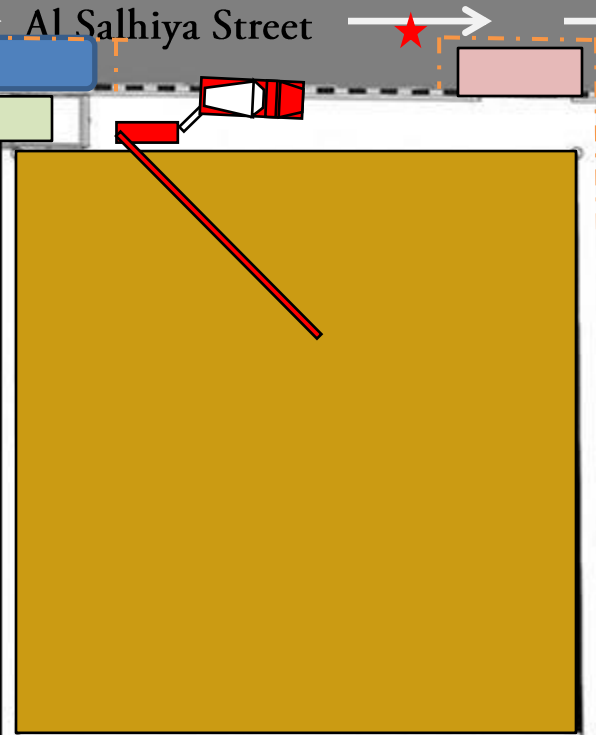
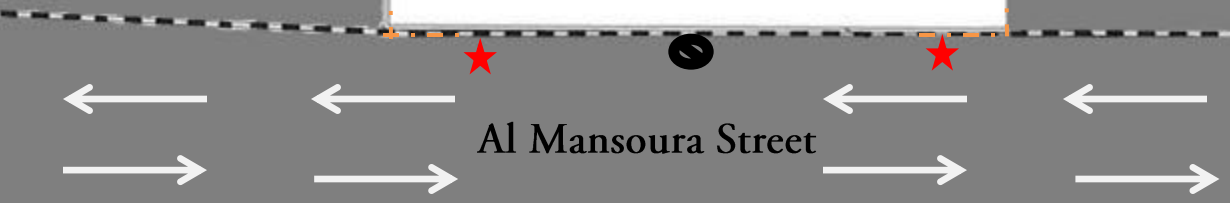
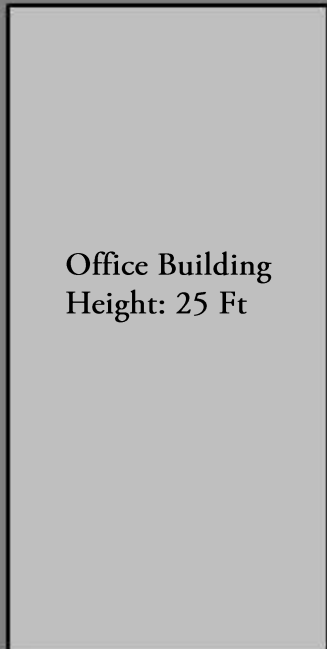
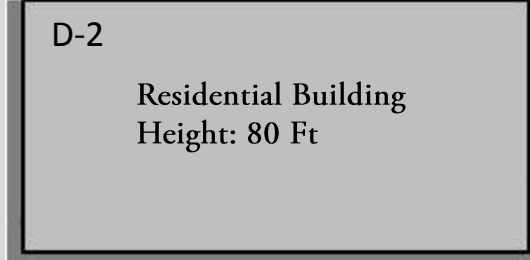
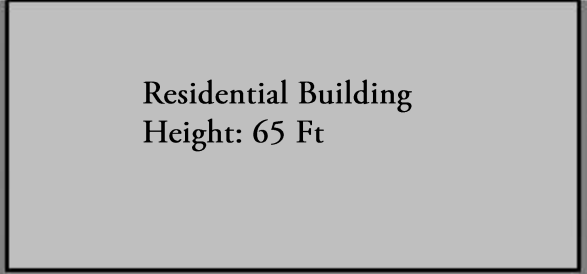
This is one of the last phases of the project. Having a crane in the elevator shaft prevents the need to move the crane, as it can build and reach the entire perimeter of the building from the same point. The crane will then be dismantled once the elevator is ready to be installed, as mentioned before in the Detailed Project Schedule. The use of scaffolding and hoist helps to haul up material and laborers to their respected floors. As in the previous plan, both gates will be utilized, in order for material delivery trucks to transport the materials to their respected storage areas.

***See Appendix D-3 for further detail of the Exterior/Interior Finishes plan.**
