# **NATIONAL MUSEUM OF** **THE MARINE CORPS**

**MICHAEL R. LOCKWOOD**  
**CONSTRUCTION MANAGEMENT**

## **TECHNICAL ASSIGNMENT I – EXISTING CONSTRUCTION CONDITIONS**

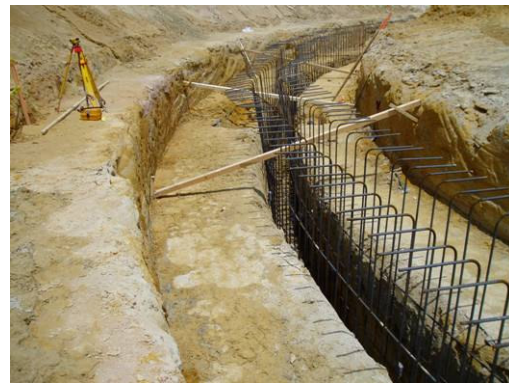
**Figure 1 – Shear Key Footing System**

The inner ring consists of a deep shear key footing topped with a 15' wide x 60" deep ring footing to support the load of the cast-in-place concrete wall and the earth backfill against the wall. Both components of the inner ring footing system are poured against the earth. The adjacent figure 1 represents an excavated portion of the shear key footing system during construction.

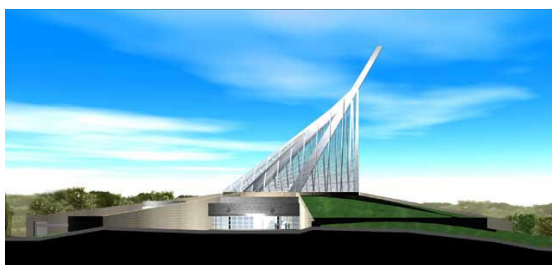
**Figure 3 – Skylight System Elevation 1**

A unique element of the museum project is the large skylight system. The design of the skylight system reflects the flag raising at Iwo Jima. A 210-ft. mast extends from the main skylight system. The skylight soars 160’ above ground consisting of structural steel framing members and high-energy efficient glazing. The skylight system is one of many sustainable design features of the building. The following graphics depict the skylight system

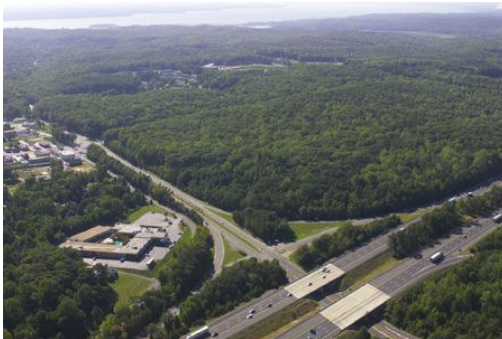
**Figure 5 - Existing Site Conditions**

The site of the National Museum of the Marine Corps is located adjacent to the main entrance to the Quantico Marine Corps Base in Quantico, VA. The site was originally a wooded area with approximately a 50' varying elevation changes. The location of the building on the site will result in cuts up to 45' deep. Figure 5 below show the existing site conditions and figure 6 shows the construction site conditions.
