## **Executive Summary**

This assignment goes into depth into the existing lighting conditions of the Rio Hondo Library and Learning Resource Center. The lobby, Reference Stacks and Microfilm Area, the Stack Area on the second floor, and the main entrance of the building will all be evaluated for redesign. The existing lighting layout, luminaries, lamps, and light loss factors are included. Daylight needs to be addressed in all interior spaces to assure that the space is neither over lit nor is power wasted.

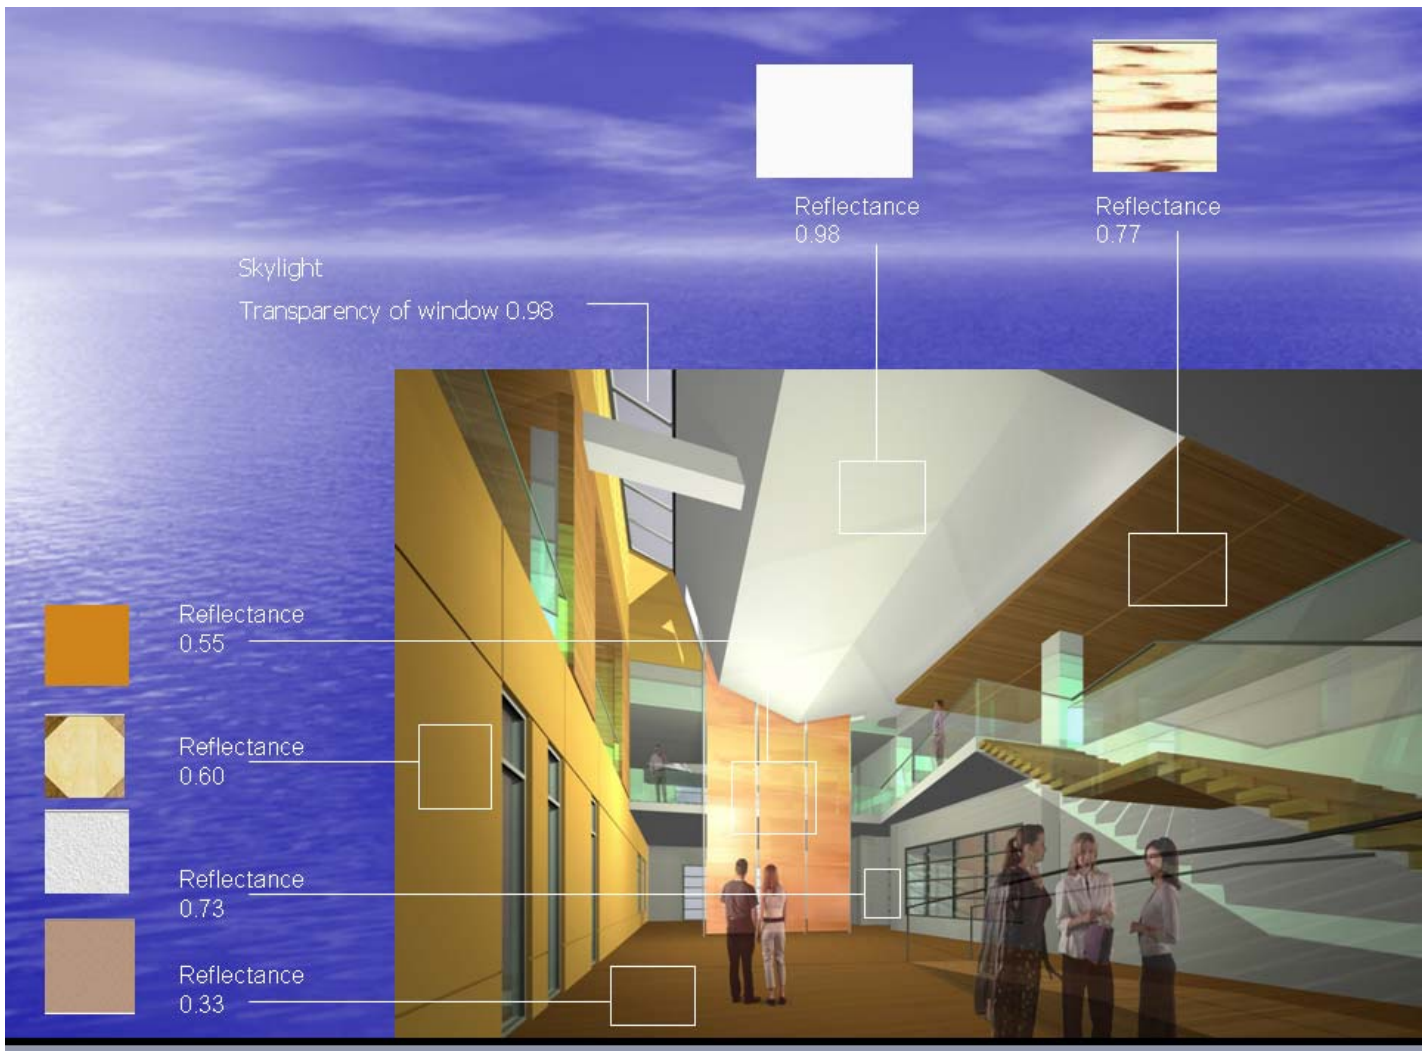
**Figure 5. Materials and Reflectance**

Location	Ceiling	Floating Ceiling	East Wall	Entry wall	All other walls	Floor
Materials	Painted Gypsum Board	Wood	Wood Veneer Paneling	Painted Concrete	Painted Gypsum Board	Carpet
Reflectance	0.98	0.77	wood 0.6	0.73	0.73	0.33

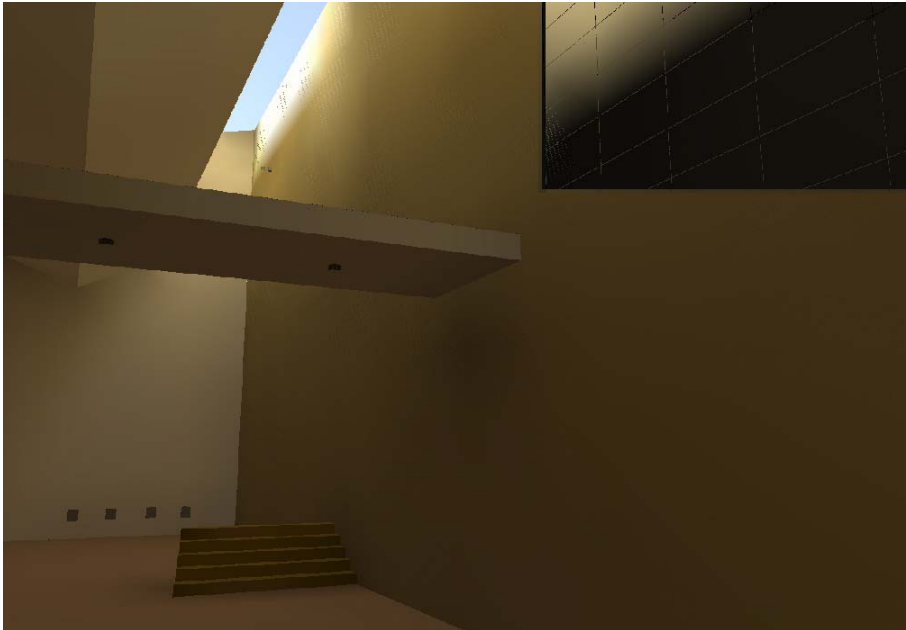
**Figure 8 Daylight only 5:54 pm, clear sky conditions**

5:54 PM	
<b>Illuminance Values (fc)</b>	<b>Ground floor</b>
Average	42.03
Maximum	92.4
Minimum	0
Avg/Min	0
Avg/Max	0
<b>Illuminance Values (fc)</b>	<b>Bridge</b>
Average	93.31
Maximum	185
Minimum	17.8
Avg/Min	5.24
Avg/Max	10.43
<b>Illuminance Values (fc)</b>	<b>East Wall</b>
Average	499.33
Maximum	776
Minimum	270
Avg/Min	1.85
Avg/Max	2.88

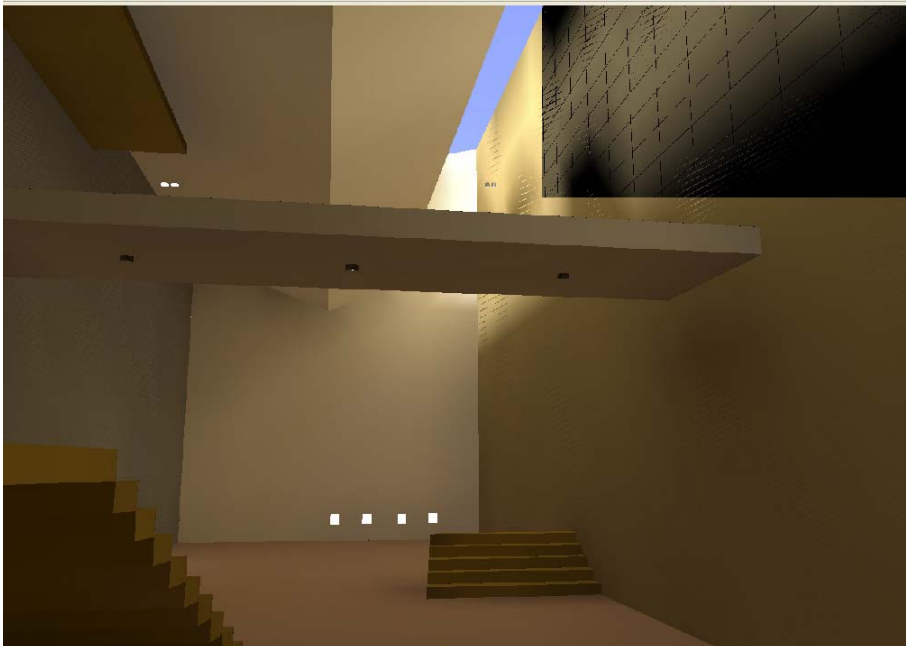
**Figure 9 Daylight and Electric Lights, 7:54 am, clear sky conditions**

7:54 AM	
<b>Illuminance Values (fc)</b>	<b>Ground floor</b>
Average	117.96
Maximum	437
Minimum	3.8
Avg/Min	31.04
Avg/Max	115.03
<b>Illuminance Values (fc)</b>	<b>Bridge</b>
Average	266.32
Maximum	567
Minimum	62.2
Avg/Min	4.28
Avg/Max	9.13
<b>Illuminance Values (fc)</b>	<b>East Wall</b>
Average	5992
Maximum	7021
Minimum	5406
Avg/Min	1.11
Avg/Max	1.3

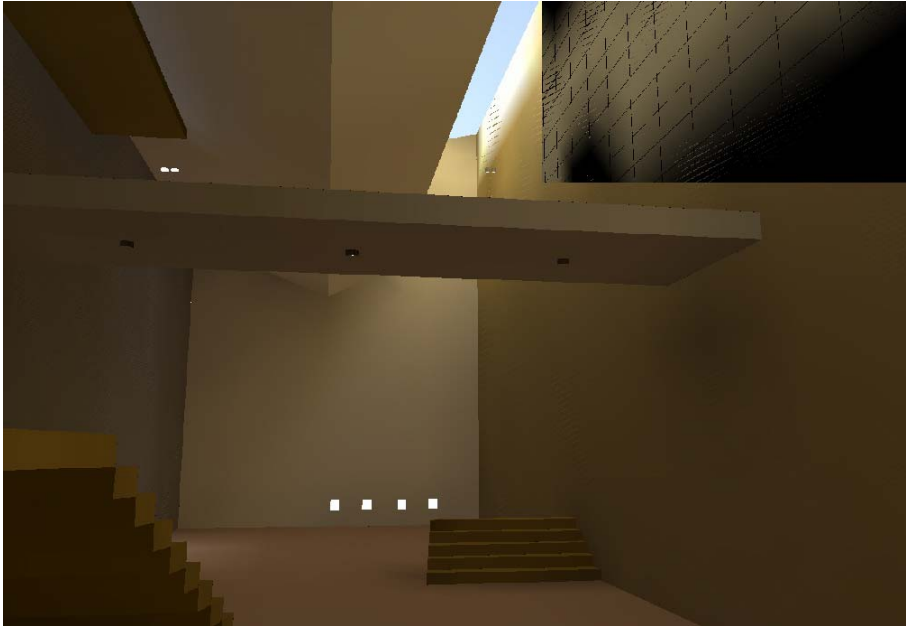
Figure 10 Daylight and Electric Lights, 12:54 pm, clear sky conditions

12:54pm	
<b>Illuminance Values (fc)</b>	<b>Ground floor</b>
Average	178.29
Maximum	538
Minimum	3.6
Avg/Min	49.53
Avg/Max	0.33
<b>Illuminance Values (fc)</b>	<b>Bridge</b>
Average	464.3
Maximum	842
Minimum	131
Avg/Min	3.54
Avg/Max	0.55
<b>Illuminance Values (fc)</b>	<b>East Wall</b>
Average	5179
Maximum	9778
Minimum	632
Avg/Min	8.19
Avg/Max	15.46

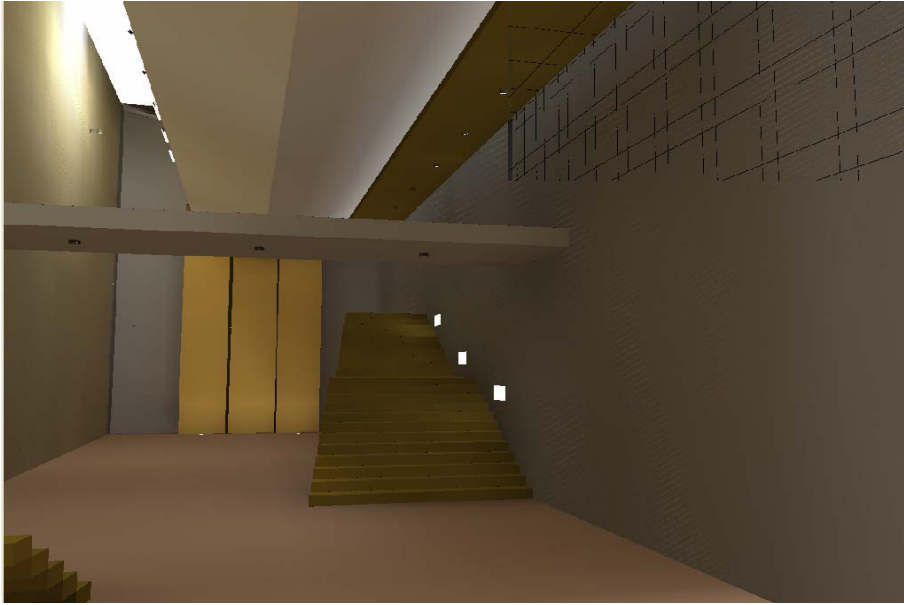
Figure 12 Daylight and Electric Lights, 7:54am, clear sky conditions Dec 7

7:54 AM	
Illuminance Values (fc)	Ground floor
Average	28.12
Maximum	340
Minimum	0.5
Avg/Min	56.24
Avg/Max	681.4
7:54 AM	
Illuminance Values (fc)	Bridge
Average	46.31
Maximum	97.7
Minimum	15.5
Avg/Min	2.99
Avg/Max	6.3
7:54 AM	
Illuminance Values (fc)	East Wall
Average	36.49
Maximum	335
Minimum	6.4
Avg/Min	5.7
Avg/Max	52.48

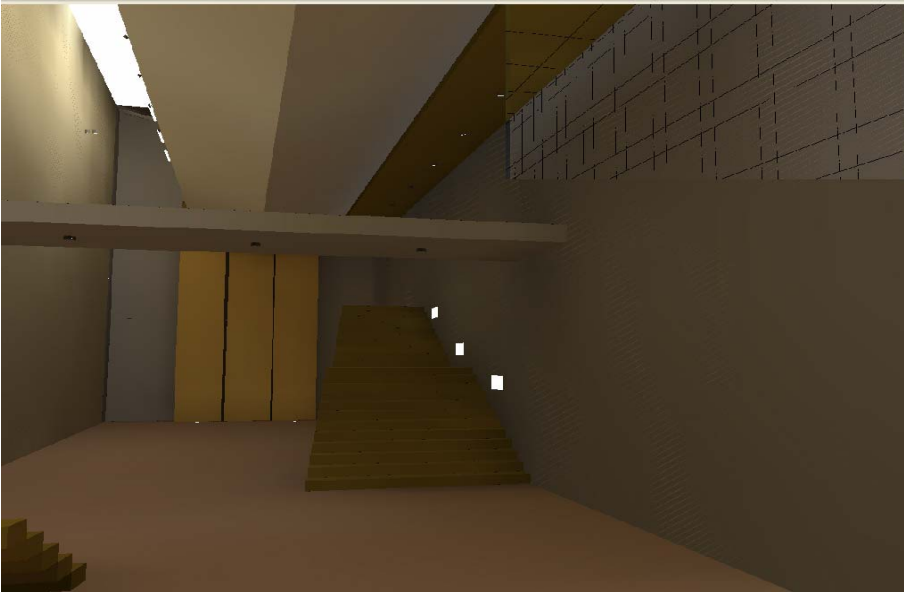
Figure 13 Daylight and Electric Lights, 12:54pm, clear sky conditions Dec 7

12:54 PM	
Illuminance Values (fc)	Ground floor
Average	83.68
Maximum	408
Minimum	2
Avg/Min	41.84
Avg/Max	204.4
12:54 PM	
Illuminance Values (fc)	Bridge
Average	190.96
Maximum	414
Minimum	46.6
Avg/Min	4.1
Avg/Max	8.9
12:54 PM	
Illuminance Values (fc)	East Wall
Average	222.93
Maximum	822
Minimum	22.1
Avg/Min	10.09
Avg/Max	37.23

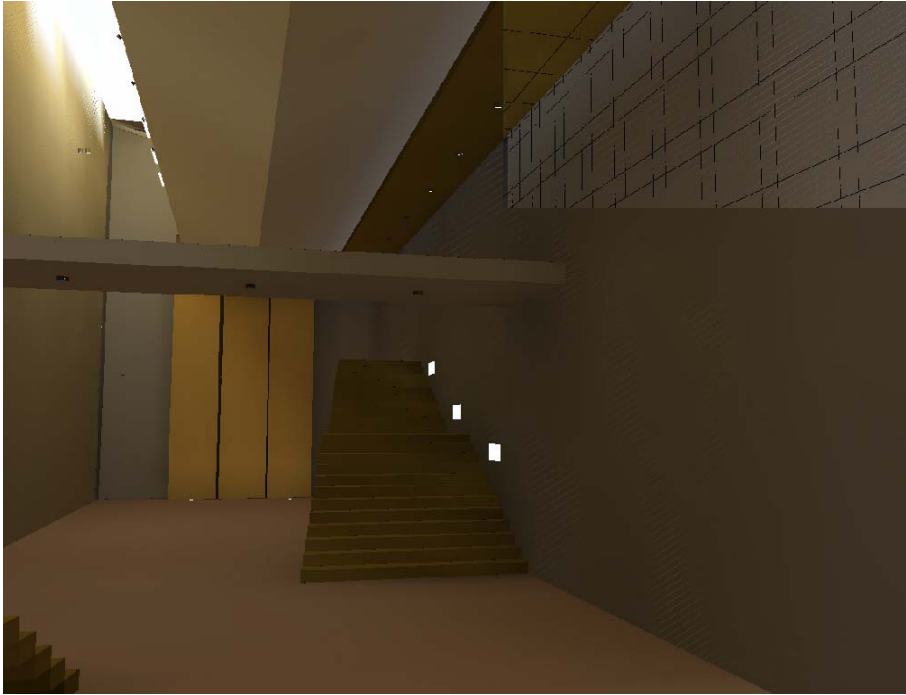
Figure 14 Daylight and Electric Lights, 5:54pm, clear sky conditions Dec 7

5:54 PM	
Illuminance Values (fc)	Ground floor
Average	49.17
Maximum	359
Minimum	1.2
Avg/Min	40.98
Avg/Max	299.42
5:54 PM	
Illuminance Values (fc)	Bridge
Average	95.11
Maximum	190
Minimum	25.5
Avg/Min	3.73
Avg/Max	7.49
5:54 PM	
Illuminance Values (fc)	East Wall
Average	204.94
Maximum	2960
Minimum	16.6
Avg/Min	12.35
Avg/Max	178.32

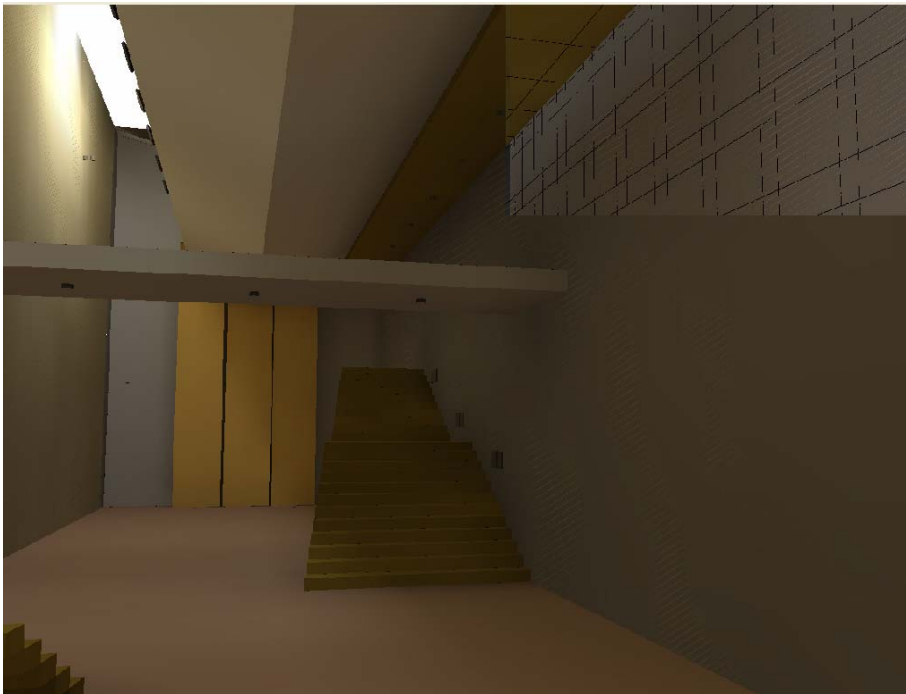
Figure 15 Daylight only, 7:54am, clear sky conditions Dec 7

7:54 AM	
Illuminance Values (fc)	Ground floor
Average	11.99
Maximum	29.3
Minimum	0
Avg/Min	0
Avg/Max	0
Illuminance Values (fc)	Bridge
Average	23.07
Maximum	45.9
Minimum	4.1
Avg/Min	5.63
Avg/Max	11.2
Illuminance Values (fc)	East Wall
Average	32.9
Maximum	316
Minimum	4
Avg/Min	8.23
Avg/Max	79

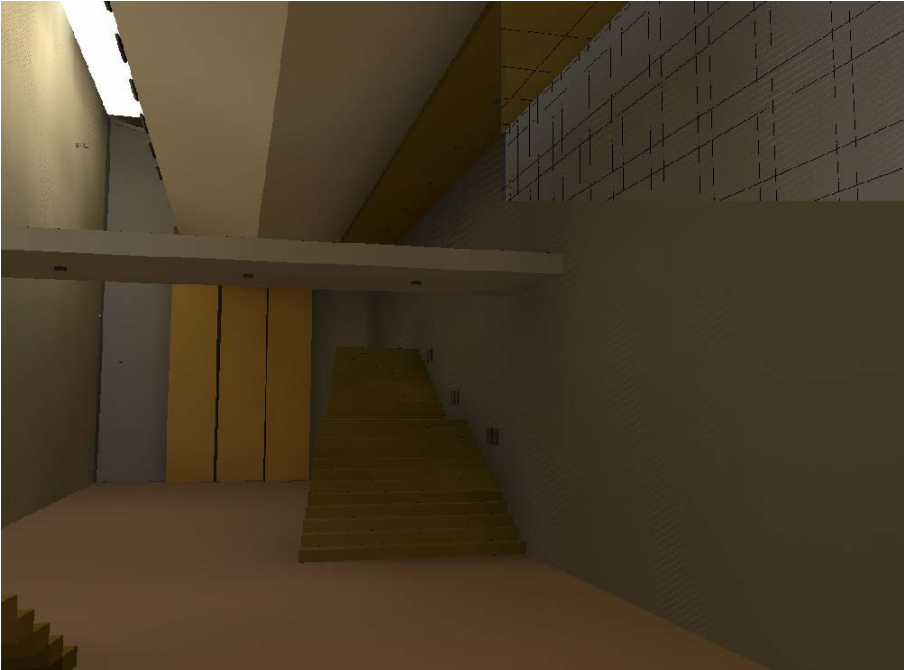
Figure 16 Daylight only, 12:54am, clear sky conditions Dec 7

12:54pm	
<b>Illuminance Values (fc)</b>	<b>Ground floor</b>
Average	67.68
Maximum	203
Minimum	0
Avg/Min	0.00
Avg//Max	0.00
<b>Illuminance Values (fc)</b>	<b>Bridge</b>
Average	167.67
Maximum	362
Minimum	34.2
Avg/Min	4.90
Avg//Max	10.61
<b>Illuminance Values (fc)</b>	<b>East Wall</b>
Average	218.68
Maximum	922
Minimum	22.1
Avg/Min	9.9
Avg//Max	41.74

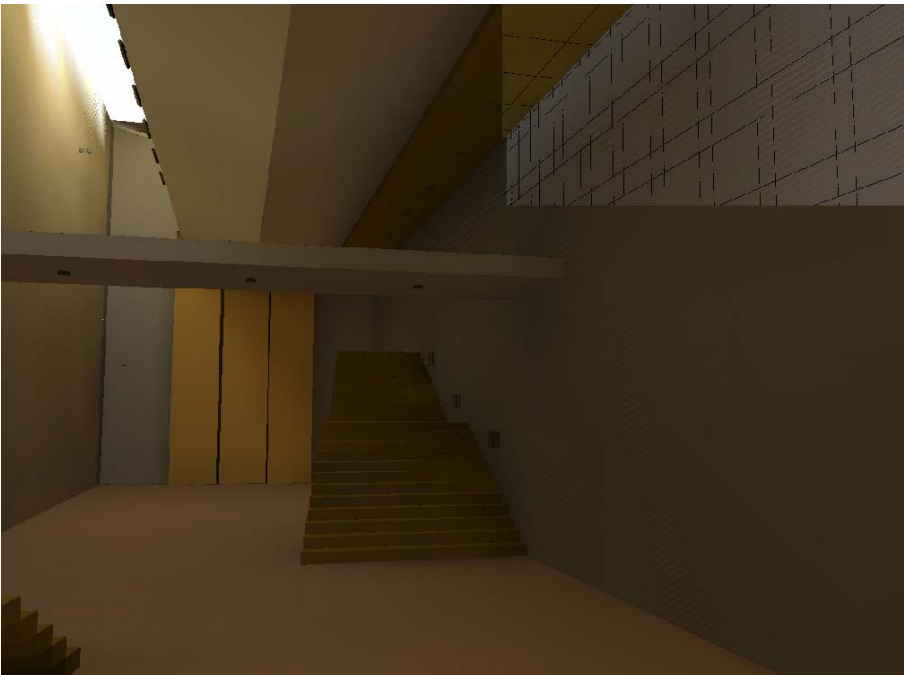
Figure 17 Daylight only, 5:54pm, clear sky conditions Dec 7

5:54 PM	
<b>Illuminance Values (fc)</b>	<b>Ground floor</b>
Average	32.95
Maximum	72.3
Minimum	0
Avg/Min	0.00
Avg//Max	0.00
<b>Illuminance Values (fc)</b>	<b>Bridge</b>
Average	71.6
Maximum	143
Minimum	13.6
Avg/Min	5.26
Avg//Max	10.54
<b>Illuminance Values (fc)</b>	<b>East Wall</b>
Average	197.71
Maximum	2939
Minimum	13.3
Avg/Min	14.87
Avg//Max	221.02

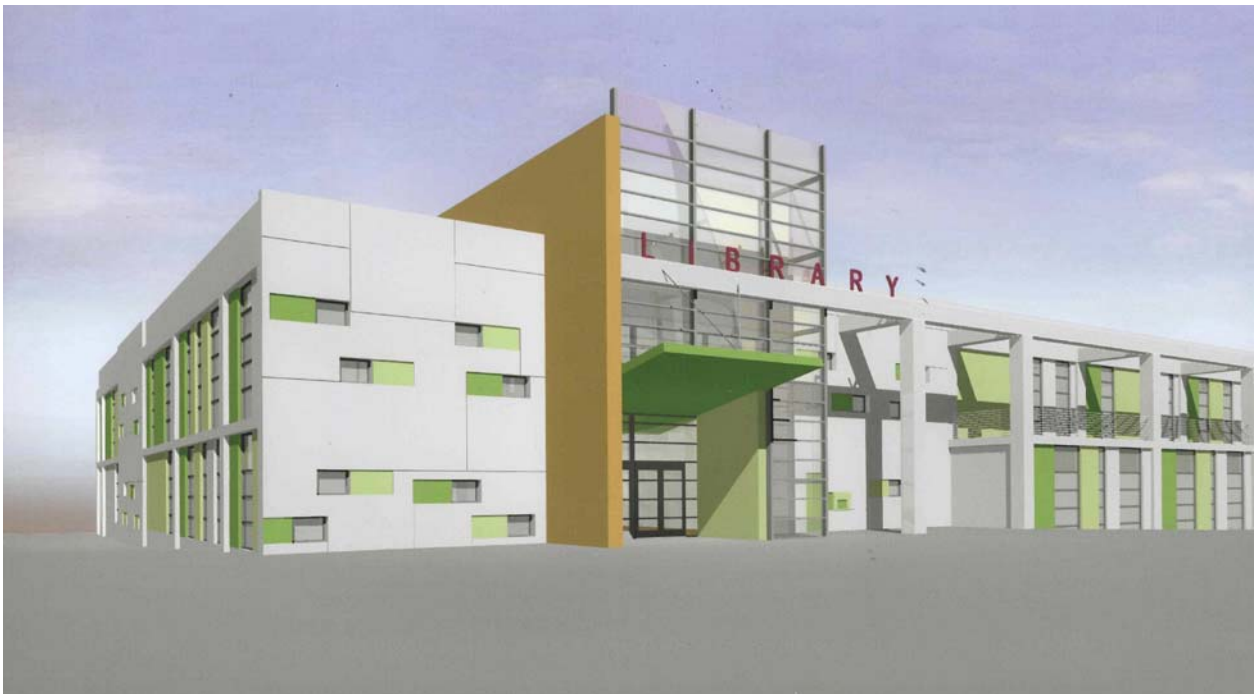
**Figure 43 Exterior view of entrance**

Currently exterior lighting consists of spotlights mounted high integrated with the framework of the glass curtain wall. These spotlights light the wall behind the curtain wall achieving the “lantern” effect. The canopy contains surface mounted downlights. With the slant of the canopy a direct line of sight into the lamp could be uncomfortable for entering visitors.
