**Pentagon – Wedge 3  
Julie Rankin  
Construction Management**

**Technical Assignment 1**

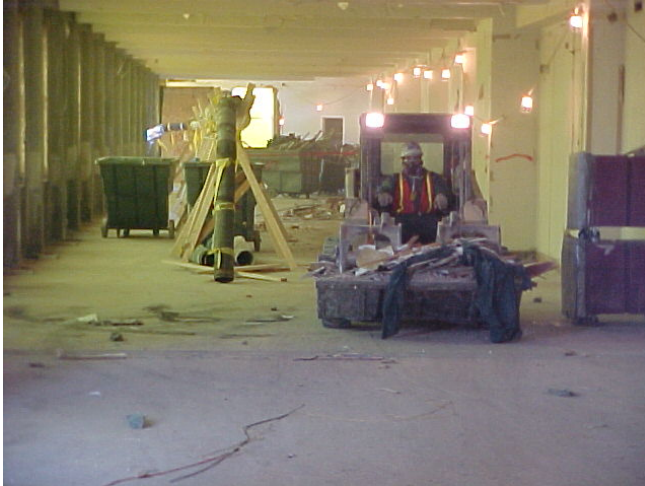
Figure 1 - A bobcat removes trash in Wedge 3 demolition area.

Wedge 3 of the Pentagon Renovation project has an atypical scope of work. The demolition process includes the removal of all utilities; mechanical, plumbing, electrical, data, fire fighting. The scope also includes all interior walls being removed, floors stripped to the existing concrete slabs, and all windows taken out. There are several dangerous materials found in Wedge 3 that require proper removal techniques. There are millions of pounds of asbestos containing materials, lead paints, and PCB's in several older ballasts.

The abatement process is much more involved than normal waste removal. These zones are contained with plastic, and workers wear protective clothing and breathing apparatuses to prevent inhalation of hazardous materials. Leads and PCB's are contained in large steel barrels and sealed.

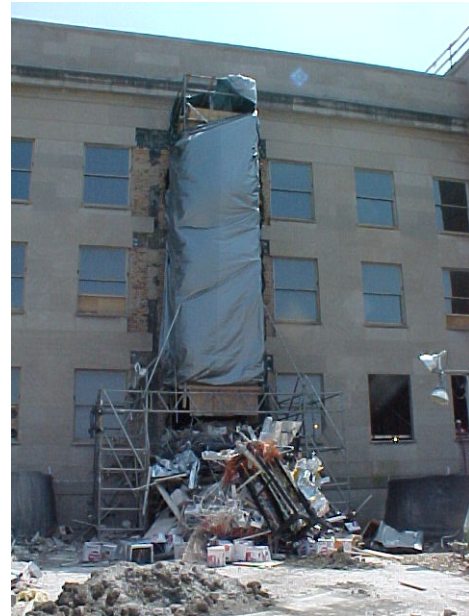
Fig. 2 - Trash chute in demolition area.

During the peak of demolition, there may be up to three hundred employees working. Most utilities are torn down with this man power, and bobcats handle tearing down of many of the walls and larger objects. Non hazardous materials are either carted by hand, or pushed by the bobcats, and taken to a large trash chute found near the high side of corridor seven, just at Wedge 3. The trash then falls to a dumpster below and is shipped off sight. Much of the recyclable material is separated beforehand and carted to their respective dumpsters for proper collection.

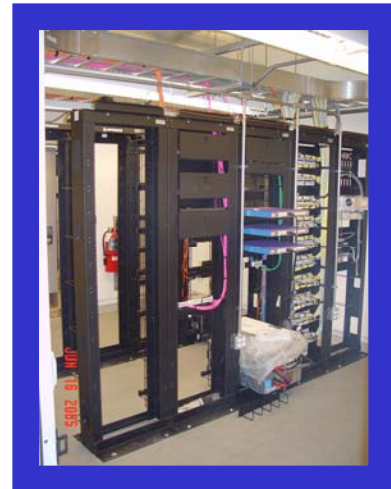
Figure 3 – A telecommunication closet from Wedge 2, which looks similar to the design for Wedge 3.

The main electrical supply for Wedge 3 is not located there, and information regarding its location and capacity may not be discussed at this time. However, the design depicts several electrical closets located on each floor along the some of the five rings. Power comes from the main power supply into these closets at 480 volts, and is distributed from there. Four inch conduit runs overhead with these wires. Telecommunications closets are located on each floor, and deliver communication and send data throughout Wedge 3. Security systems run from this as well. Low voltage power lines run overhead in cable tray with some of these wires.

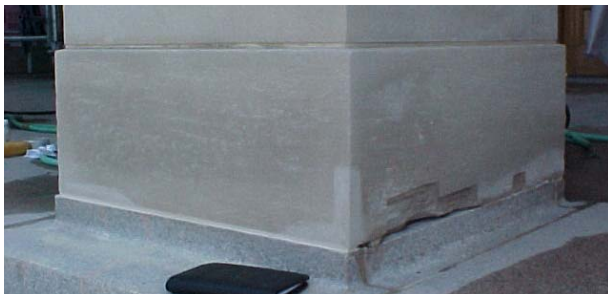
Figure 4 - An example of poorly matched limestone patching on an historic mall entrance column.

The existing exterior walls of the outer E-ring and the inner A-ring, visible from the outside of the Pentagon and from the center courtyard, respectively, are limestone masonry with matching mortar. Some stones will be repaired, and others replaced. An issue from Wedge 2 that will carry over to Wedge 3 is the delicate process of matching the color of the mortar perfectly to the existing. A large area where the limestone has been removed is at the location of the trash chute, and several onsite color matching tests will be performed by Masonry Arts until the PenRen quality inspectors approve a match.

In addition to the masonry walls, there will also be repairs done on the existing limestone columns of the mall terrace entrance. Once again, the mixing must be done carefully, with a balance of sands, cement mix and water.

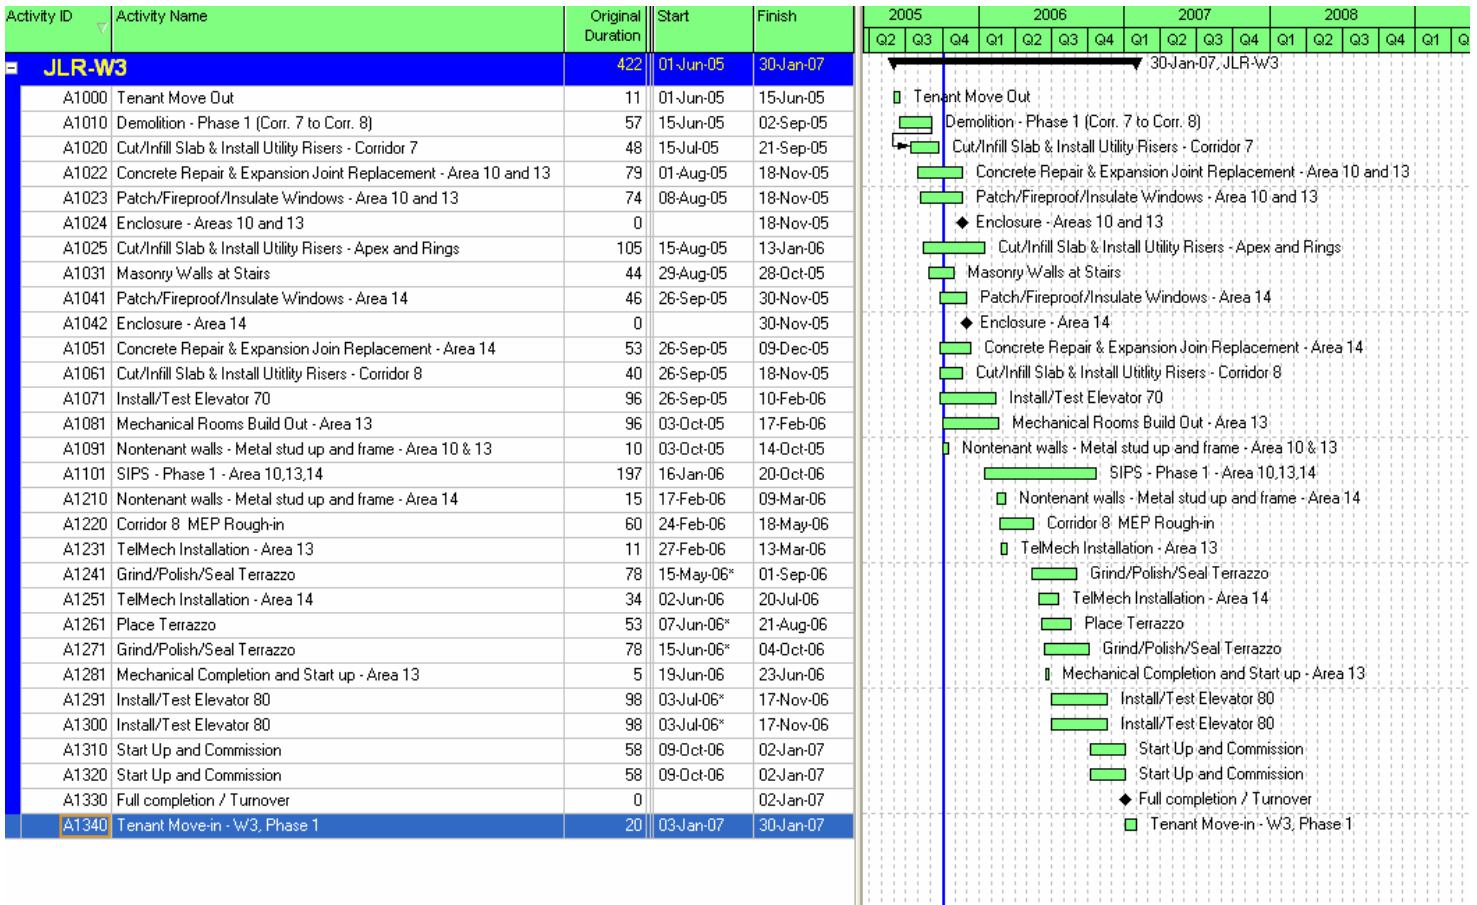
This Schedule Summary applies only to the first phase of Wedge 3 construction, which covers the area from corridor 7 to corridor 8 of the Pentagon. Phase 2 has not yet been scheduled by the general contractor. Completed in Primavera Project Manager, this schedule shows the flow of work, with tenants moving out of the existing space preceding all construction activities. The commencement of demolition is the first construction step, then structural and concrete repairs are performed, slabs are filled with concrete, and new utility penetrations will be cut. During this time, masonry walls are being set around existing stairwells and elevator shafts which did not exist previously are installed.

The large time designated to SIPS for Areas 10, 13 and 14 refer to the tenant fit out for all interior spaces, which includes the installation of sprinkler lines, duct, induction units, conduit and wires, drywall, ceiling grid and tile, doors, blinds, and more. A much more detailed schedule is necessary to show each of these steps in detail.

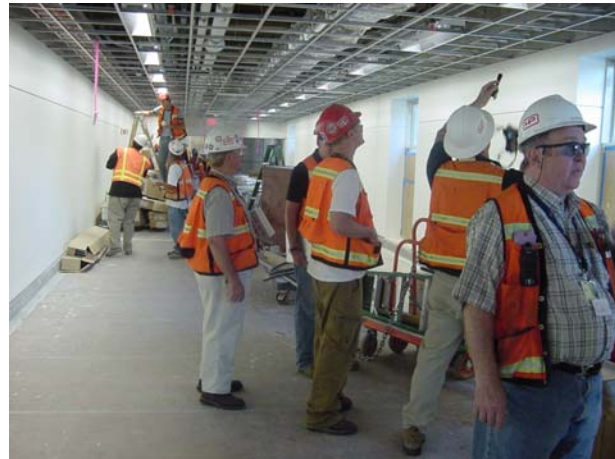
Figure 1 – The quality control team performs a ceiling close-in inspection.

PenRen has established extremely high expectations for a quality product. To ensure that work is performed to the fifty year specification plan, the owner has implemented their own quality control team. This quality control team works closely with the general contractor's quality control team. They have developed a method of four phases of quality control. Daily inspections are a large part of this plan. Some of these inspections include the Initial, In-house, Pre-final, and Final. All items are listed and tracked through a system called Prolog, which ensures that punch list items are not overlooked.

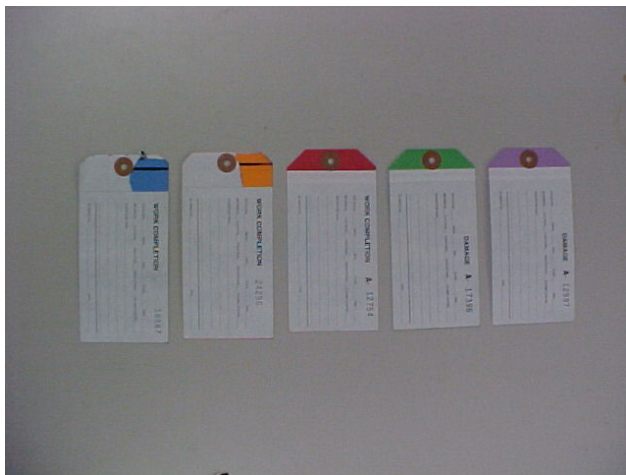
Figure 2 – The five color coded tracking tags

A system of tagging is used during inspections. The tags are color coded, so that various subcontractors recognize the tags hanging from objects and identify the color as their own to know if they are involved in addressing the issue. The color coding works as follows:

- Blue – Drywall / Carpentry
- Red – Mechanical
- Green – Electrical
- Orange – Caulk
- Purple – Other / Miscellaneous

All tagged items are entered into prolog by the QC administrators and tracked daily by PenRen and Hensel Phelps inspectors.
