Brandon M Tezak
Construction Management Option
Faculty Advisor: Dr. Anumba
April 3, 2013

[SENIOR THESIS FINAL REPORT]

North Hall – American University
Washington, D.C.

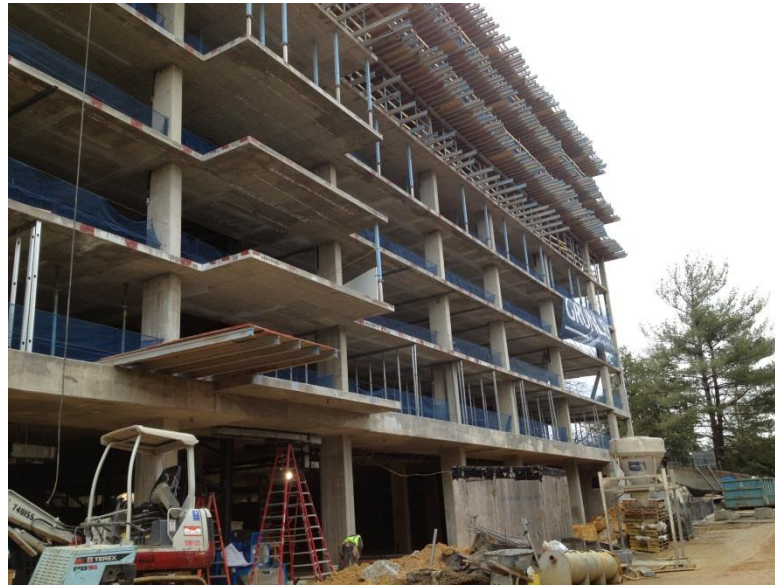
Figure 1: North Hall South Façade
Photo Taken By: Brandon Tezak

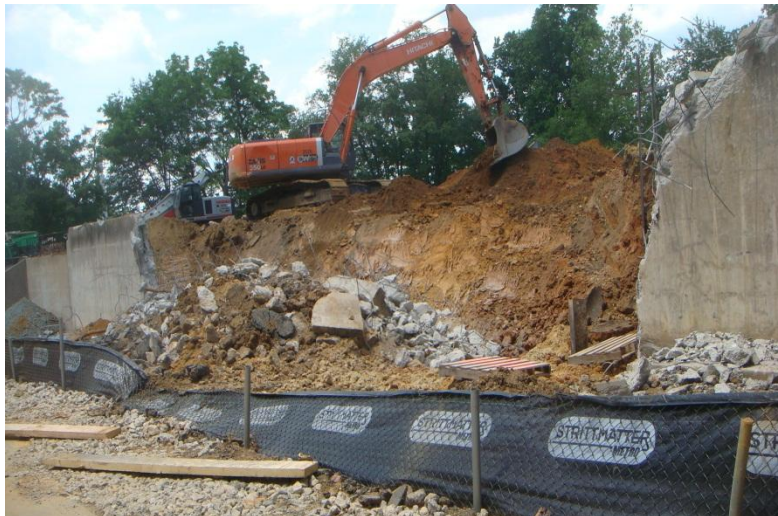
North Hall required only some minor demolition of two retaining walls and a parking lot. One of the retaining walls was only 6 feet tall at its highest point and sloping to a height of 6 inches at its lowest point. This wall was approximately 30 linear feet in length. The other retaining wall was much bigger this wall was 20 feet tall and 80 linear feet in long. This wall can be seen in Figure 5 during the demolition process. There was parking lot that needed demolished to before the site could be excavated to subgrade. There was approximately 6,100 square feet of asphalt parking lot that had to be removed.

Figure 5: Large Retaining Wall Demolition
Photo Taken By: Brandon Tezak

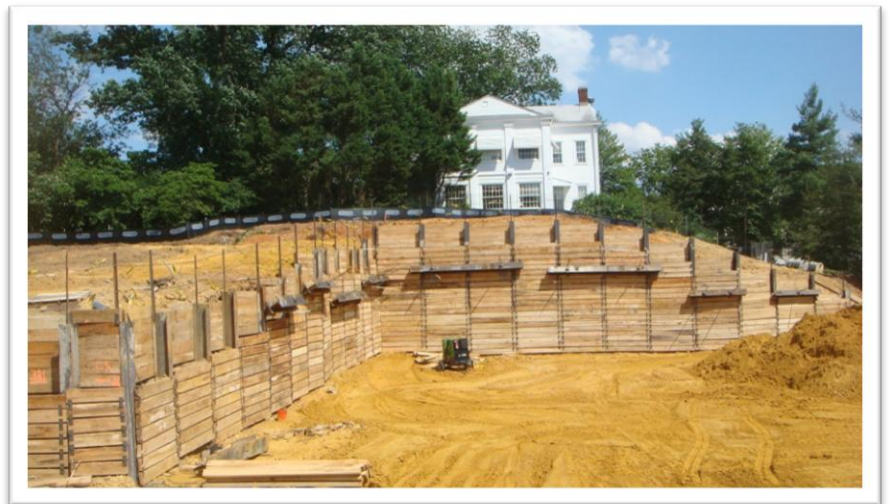
A portion of North Hall's first floor will be underground. To avoid having to over excavate as well as the small site would not allow for it, soldier beams and lagging with tiebacks were used to hold back the earth. The project required 46 soldier beams with 11 tiebacks. The support of excavation can be seen in Figure 6. The support of excavation is four feet from the exterior face of the first floor wall.

Figure 6: North Hall Soldier Beams, Lagging and Tiebacks
Photo Taken By: Brandon Tezak

When the building is complete, the top four feet will be cut off and the rest will be abandoned and buried.

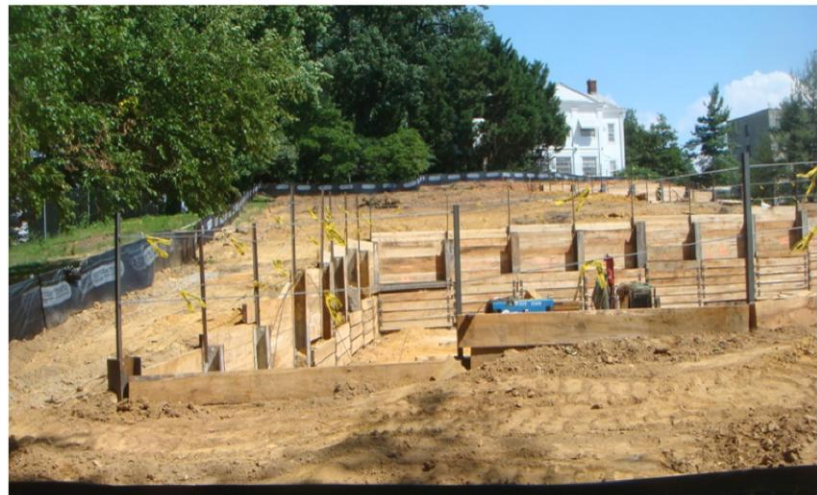
The same issue was a problem for the caisson subcontractor when their concrete trucks would arrive and leave only not on the scale of the site work subcontractor. North Hall's footprint is in the shape of the letter "L". The part of the site that was not occupied with the footprint was utilized for material storage and staging. This area shown in Figure 8 was used to store the caisson's rebar cages so that the crawler crane and the two drill rigs had full access to the site during the installation of the caissons.

Figure 8: Material Storage/ Staging Area
Photo Taken By: Brandon Tezak

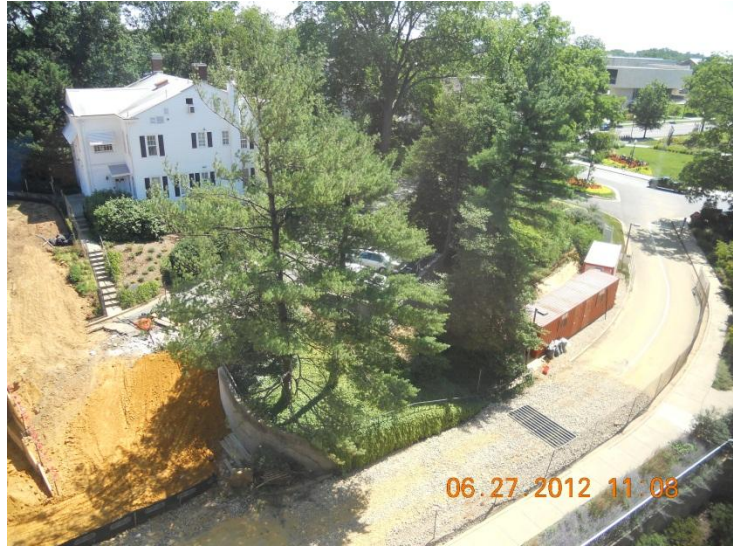
Figure 9: Site Office Trailers, Photo Taken by Brandon Tezak

North Hall's General Conditions can be broken down into two distinct categories, Site Expenses and the Project Team Staffing costs. The General Conditions Costs are relatively low for a few reasons. Grunley is expanding into a new market sector, Higher Education Construction, and to get their foot in the door they needed to be as competitive as possible and keep their costs down. Due to the very small site, Grunley decided to use a very small office trailer compared to the typical construction office trailer. Grunley's office trailer is an 8' by 40' sea container, which converted to an office. All of the onsite project staff is located in the trailer. A smaller trailer is also located on site as an office space of the American University Representative, which also serves as a meeting space for the project. Both trailers can be seen on the right side of Figure 9. The General Conditions was estimated at \$1,093,102.55.

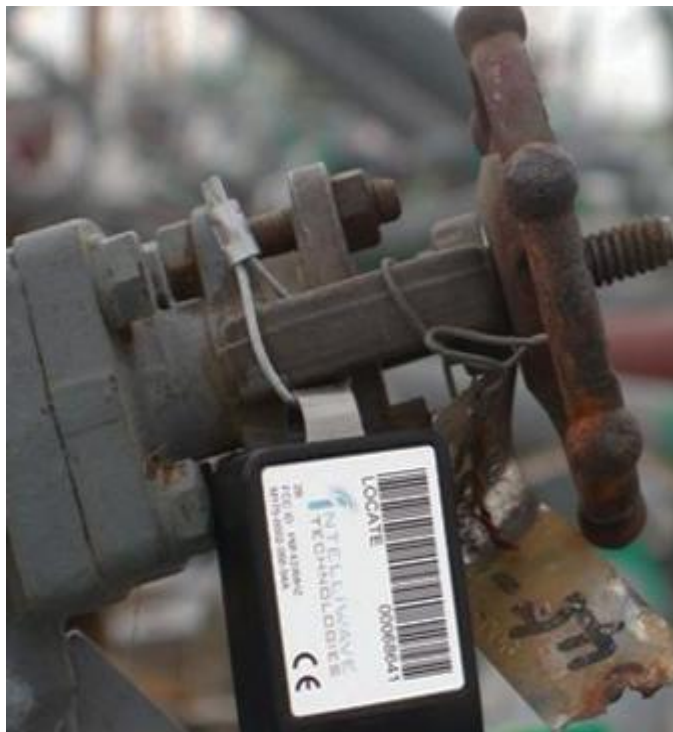
There are a number of GPS tacking programs available on the market today. Many of the systems are similar to ones that are used by trucking and transportation companies to track their vehicles such as the one used by many students at The Pennsylvania State University's main campus to track the location of the CATA buses. The great thing about a system like this is that these systems are all web based GPS tracking systems. The tracking system can then be viewed on any computer or mobile device such as a smart phone or tablet.

Figure 23: Tracking Tag, Photo Source: www.intelliwavetechnologies.com

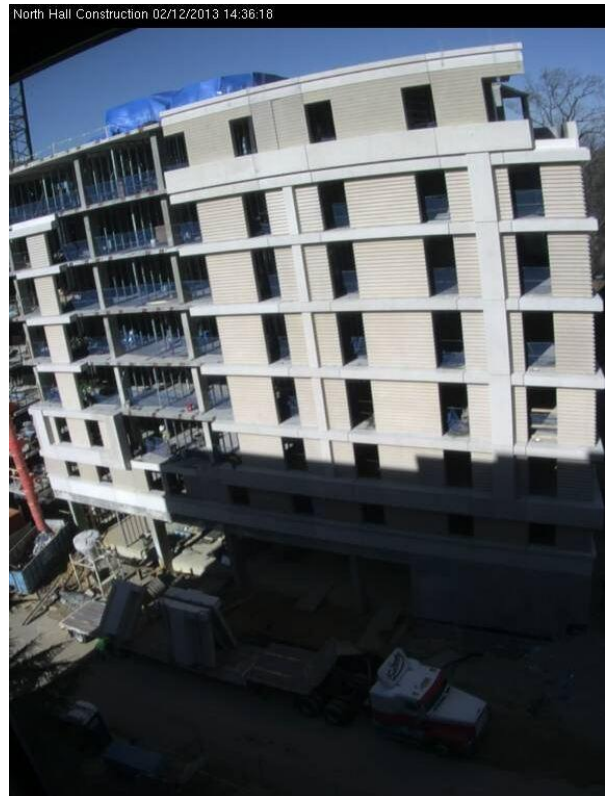
Figure 24: Precast Panel Delivery, Photo Courtesy of Grunley Construction Company

The most important feature of the *SiteSense* tracking system is that the project team can track each panel's location in real time. This is important since the site entrance as discussed previously is only big enough for one truck to enter and park on the road to be unloaded at one as can be seen in Figure 24 during the installation of the precast panels. Since there is a lot of other work going on during this phase of construction such as the framing and rough in work on each floor there will be other construction vehicles in and out of the site. The project team can be alerted to when a delivery truck carrying the precast panels is nearby so that the road can be clear of other vehicles to allow the truck unobstructed access of the site. This will help eliminate any delays by the delivery trucks not being able to get into the site.

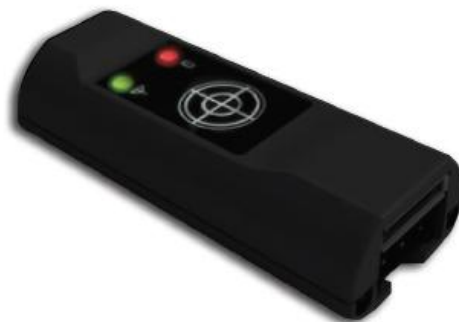
Another system that has potential to be used for tracking the precast panels it produced by GPS Insight. GPS Insight's system is similar to Intelwave Technologies' system in the web based software aspect. The major difference is that GPS Insight is more geared toward tracking a fleet of vehicles however they do make a GPS tracking product that is designed for tracking materials and assets, the FT-1000 as shown in Figure 25. This unit would be mounted directly to the precast panel. The FT-1000 is battery operated. The unit is designed to be able to work anywhere such as inside of buildings due to its strong signal strength. Also included in the FT-1000 is a #D accelerometer to track the speed the unit is moving at. The FT-1000 is small and very light weight, measuring at 2.5" x 1" x .625" and weighing on .8 ounces (FT-1000, 2012).

Figure 25: FT-1000 GPS Tracking Unit, Photo Source: www.gpsinsight.com

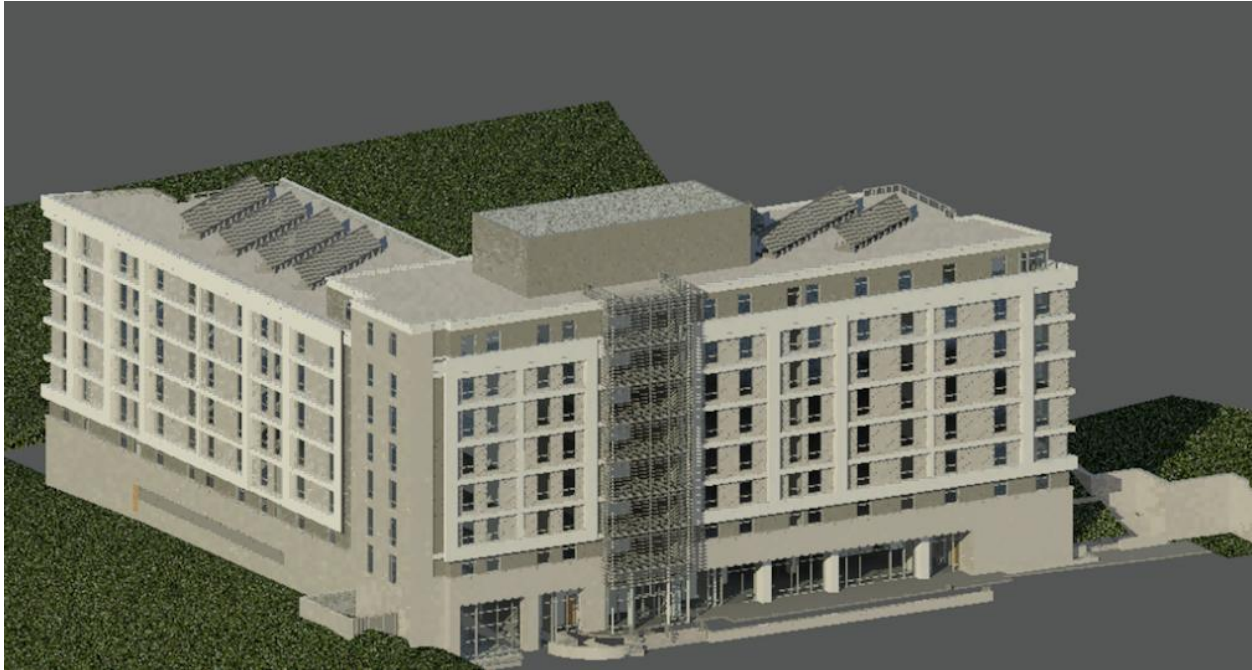
water panels on the seventh and eighth floor roofs as can be seen in Figure 26.

Figure 26: Hall Solar Panels, Model Courtesy of Grunley Construction Company

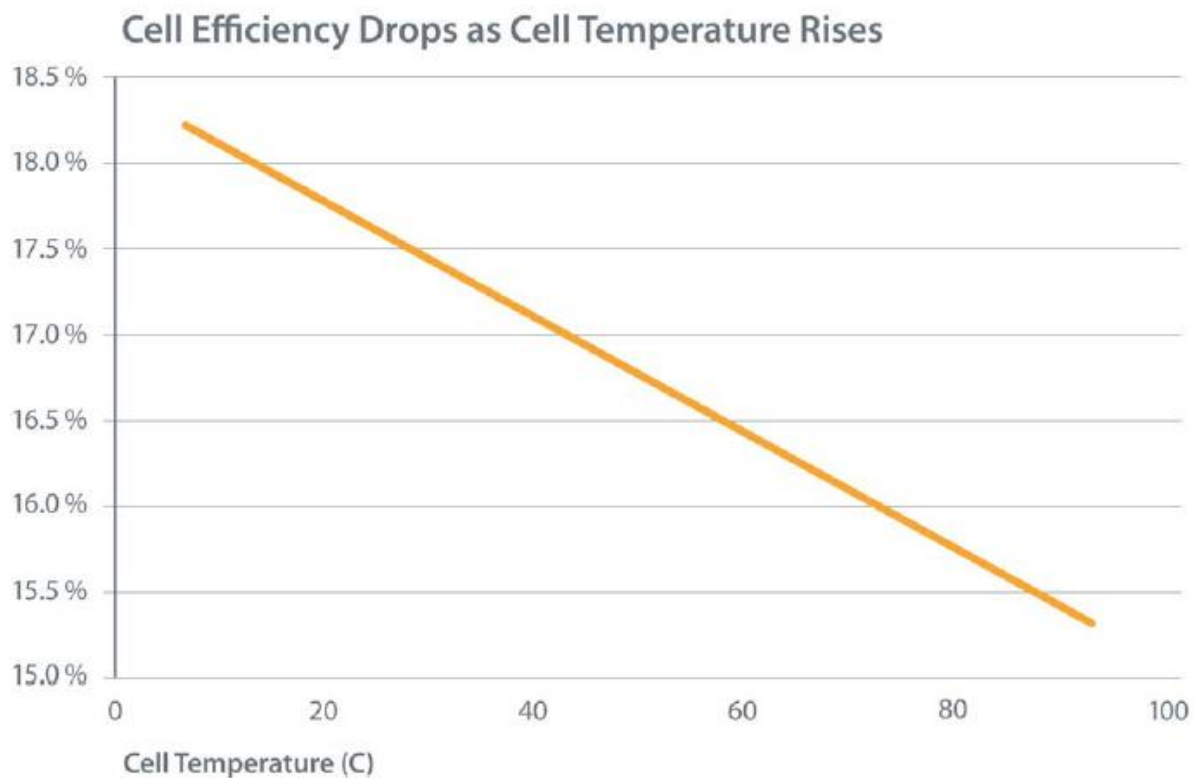
A hybrid solar panel has the ability to both heat water and generate electricity. Typically one of the two applications is attainable since the excess heat creates a problem when the panel is used for generating electricity. Solar cells decrease in efficiency when the temperatures rise. This is due to the increase of the conductivity of the semiconductor and the balancing that occurs in the material to the charge. Thus the magnitude of the electric field is reduced causing a lower voltage across the solar cell (den Haan, 2009). This decrease in efficiency is outlined in Figure 28, a graph developed by manufacturer, Cogenra Solar.

Figure 28: PV Cell Efficiency vs Temperature (typical 15-17% efficiency cell), Source: Cogenra Solar

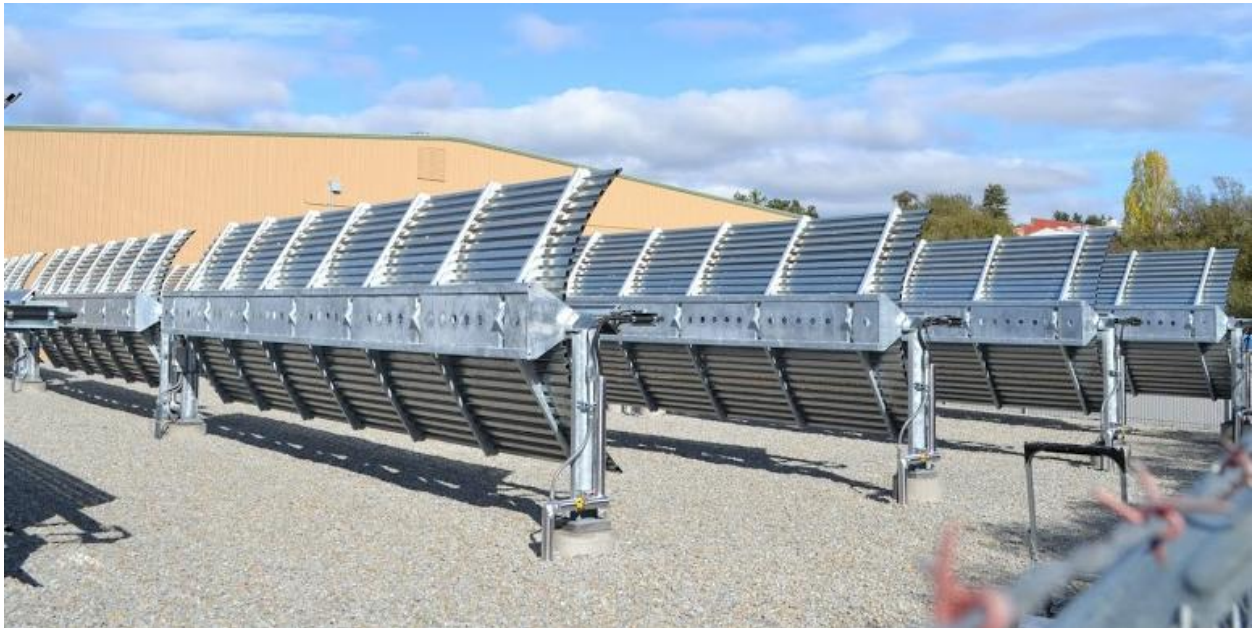
The Sonoma Wine Company, needed a way to limit its energy expenses for electricity and natural gas used to heat the water needed in for the production of its wine. Cogenra designed a system to meet the need of the owner. The design used 15 *SunBase* modules which are shown in Figure 30.

Figure 30: Sonoma Wine Company's Cogenra Solar Panels, Source: <http://guntherportfolio.com/2010/11/in-search-of-cogenra-solar/>

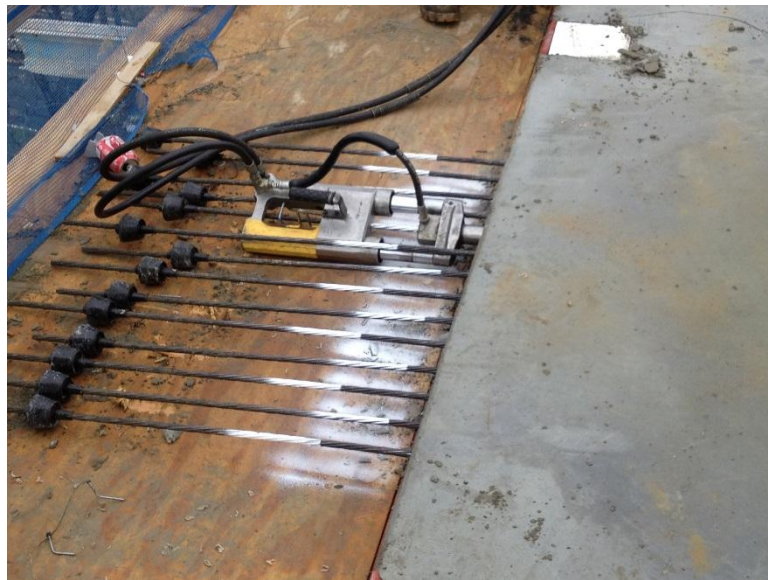
Once the slab formwork was completed the sleeves for slab penetrations were placed. Next the reinforcing steel was placed by the rodmen. The rodmen then placed the post-tensioning tendons so they could be woven in and out of the rebar. All the activities up to this point have a duration of 8 working days. The final 2 days were used to pour and finish the slab. The process this then repeated on each floor. The stressing of the tendons shown in Figure 36 are done once

Figure 6: Post-Tensioned Tendon Stressing, Photo Taken by Brandon Tezak

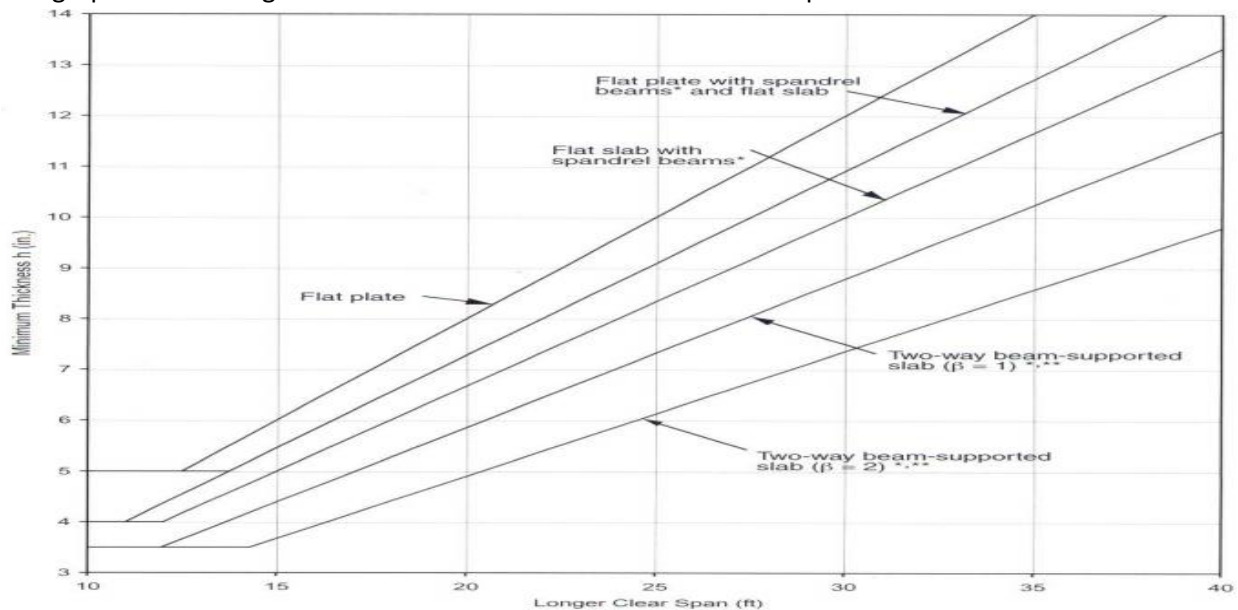
The graph shown in Figure 37 can also be used to determine the required thickness for the slab.

Figure 37: Minimum Slab Thickness for Two-Way Slab System, Source: http://www.inti.gob.ar/cirsoc/pdf/estructuras_hormigon/ACI_318_05.pdf
