Boll Family YMCA
Detroit, MI

The Pennsylvania State University
Department of Architectural Engineering
Spring 2005 Thesis

The Downtown Family YMCA

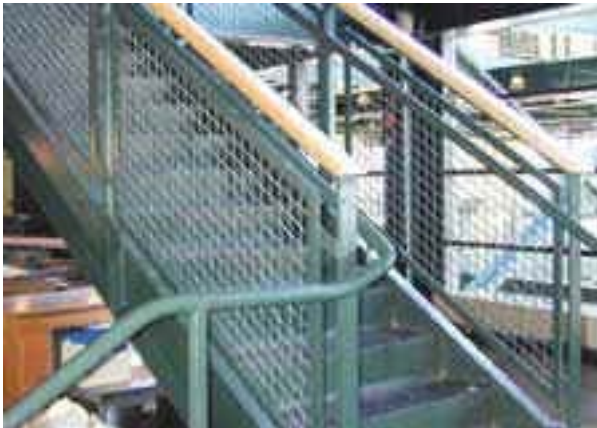
(Woven wire mesh in-fill panels)

The handrail system at the YMCA is not your conventional stainless steel or aluminum that you would expect in most office buildings, or recreation centers for that matter. There is 1,130 linear feet of railing in the YMCA which consists of approximately 4'-3" high woven wire mesh in-fill panels. These panels can be found lining the running track on the 3rd floor and they can also found in the main stairwell areas. The owner and the architect had a goal of achieving aesthetic consistency throughout the building; this is why the panels are found in areas outside of the running track. The main downside to this system is that the cost per linear foot is expensive and so is the maintenance of the panels.

In terms of initial cost and maintenance over a 20 year period, there are other alternatives that can be used that cost less than the woven wire mesh in-fill panels. There was originally a plan to use stainless steel, but the owner felt that this option was out of the price range of the budget. This is why I propose that an aluminum anodized handrail system be incorporated. Aluminum on its own may not be as durable as a stainless steel system, but if the handrails are anodized, it could perform just as well without a heavy price increase. Having the aluminum rails anodized gives them high corrosion, stain, and scratch resistance. Besides this it also gives the aluminum a better cosmetic appearance and increases its durability.

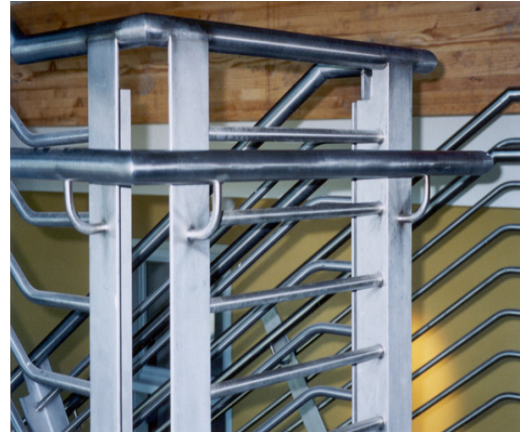
(Anodized aluminum handrails)

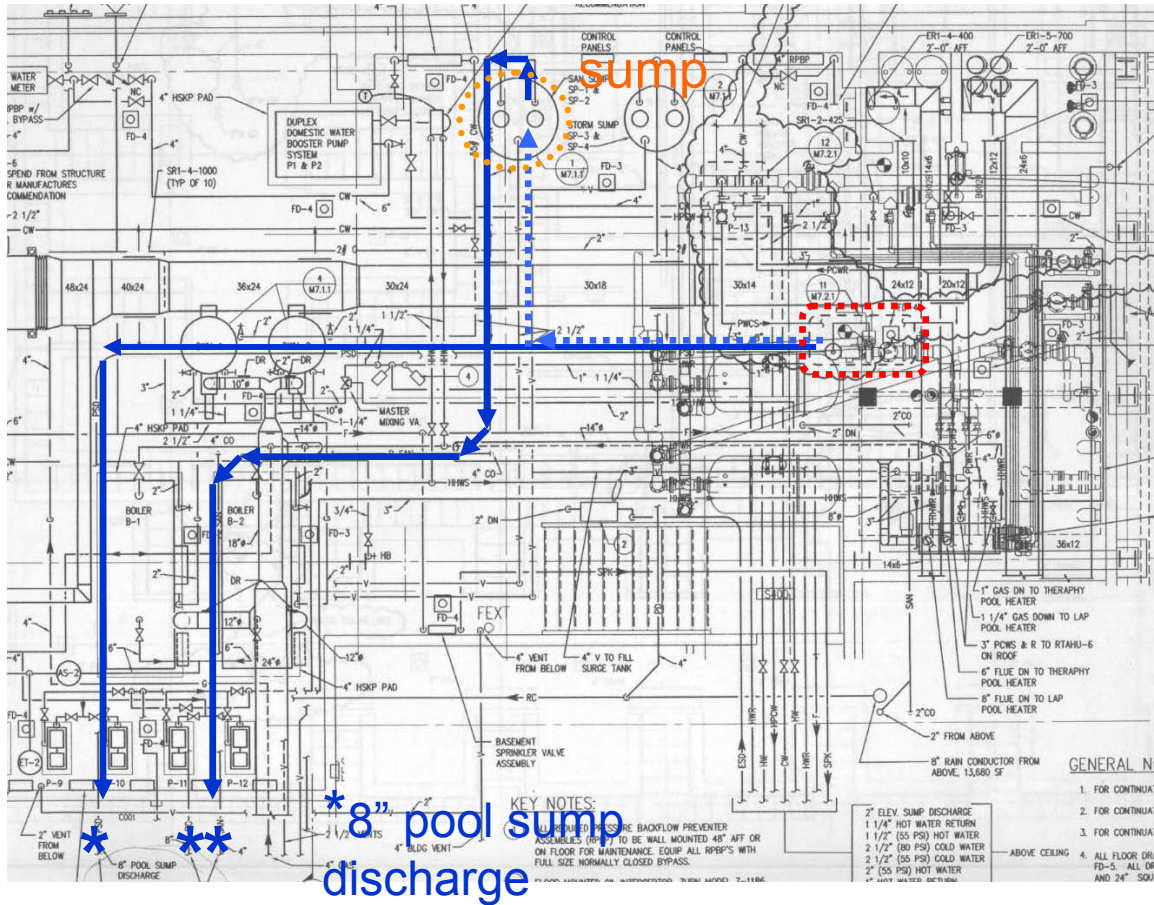
- EXISTING LINE
- PROPOSED LINE

The layout of the mechanical room is more complicated than it needs to be. In the middle of the room you will find a 12' tall propylene retention tank with electric switches, infrared beams, and a 1.5 HP (80 gal/min) pump installed. Due to an improper analysis of the mechanical room drawings, this tank had to be installed to regulate the flow of backwash water from the pool. The reason the tank was installed was because the 6" line that carries backwash water away from the pool had a fast flow rate and an improper amount of vertical rise when connecting to the 8" sanitary line. Combining the factors of having an improper amount of vertical rise, the flow rate of the 6" pipe being too fast, and the 8" pipe being a gravity line, problems came up. The resulting problem that occurred was at the air gap connecting the 6" line to the 8" line; because the rate was too fast for the amount of rise given, splashing would occur at the connection and it would cover the mechanical room floor with backwashed pool water. The cost associated with bringing in the tank and installing it came out to about \$35K. The pool backwash line (6") pumps out 430 gal/min and is now directly fed to the retention tank, from there it is indirectly tied to the 8" line. This solution is creative, but not cost effective.

I believe that a more cost effective solution would have been to run the backwash piping to the sanitary sump. From the sanitary sump, it would already be indirectly tied into an 8" sanitary line and carries away the waste water from the building. The trap line should go into the sanitary sump and have enough vertical rise to prevent any splashing. This process calls for the floor to be broken up to install the line. However, if another line is going to be added to the sump that is bringing in 430 GPM, a need for a new, bigger

sump will be necessary (since the current sump can only handle 400 GPM). As a result, this would mean that the current 5HP sump be replaced with a 10HP sump.

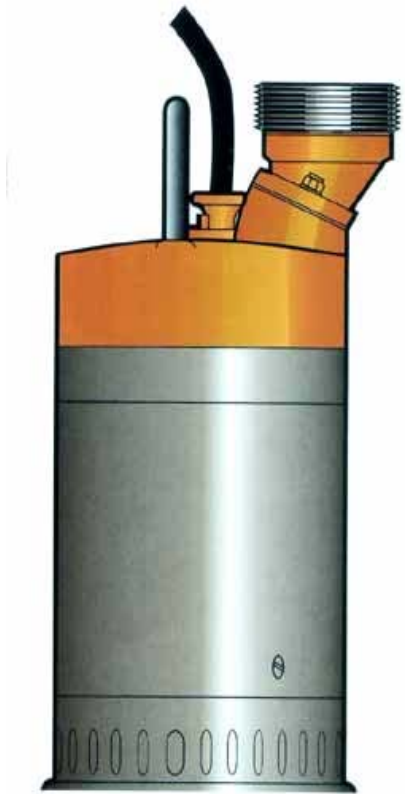
Sump Pump Illustrations (Not to scale)

MLS750
Performance Curve
5 HP Sump Pump

The specifications of the current sump are shown below. The price estimate of the current was provided by a manufacturer to be in the neighborhood of \$2,080 and \$4,800 for a 10HP sump. The data tables and cost of the sumps can be found in appendix D.

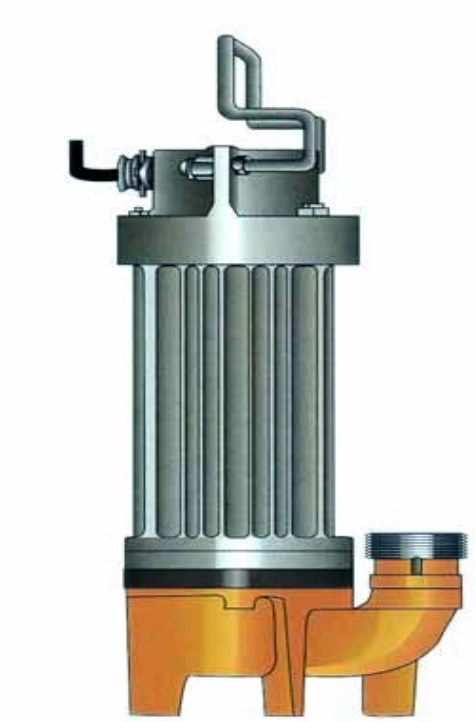
MLSW 1000
Performance Curve
MLP50CSE*
10 HP Sump Pump

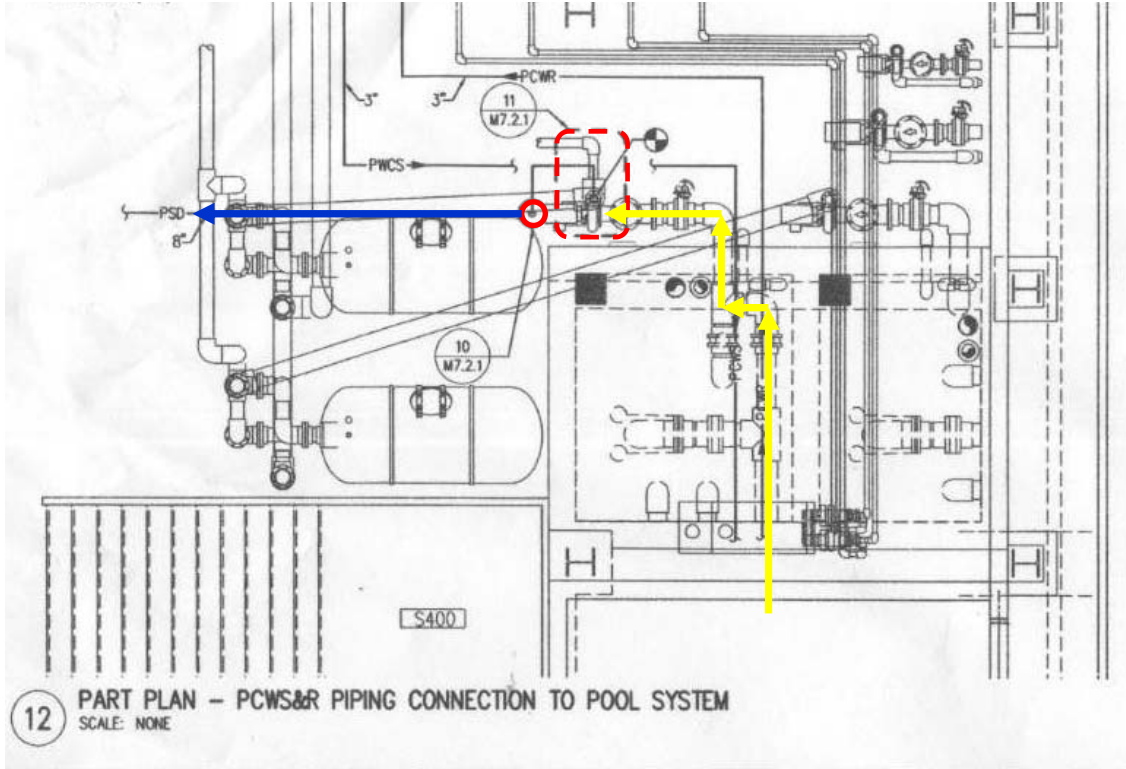
Additional Mechanical Room Illustrations

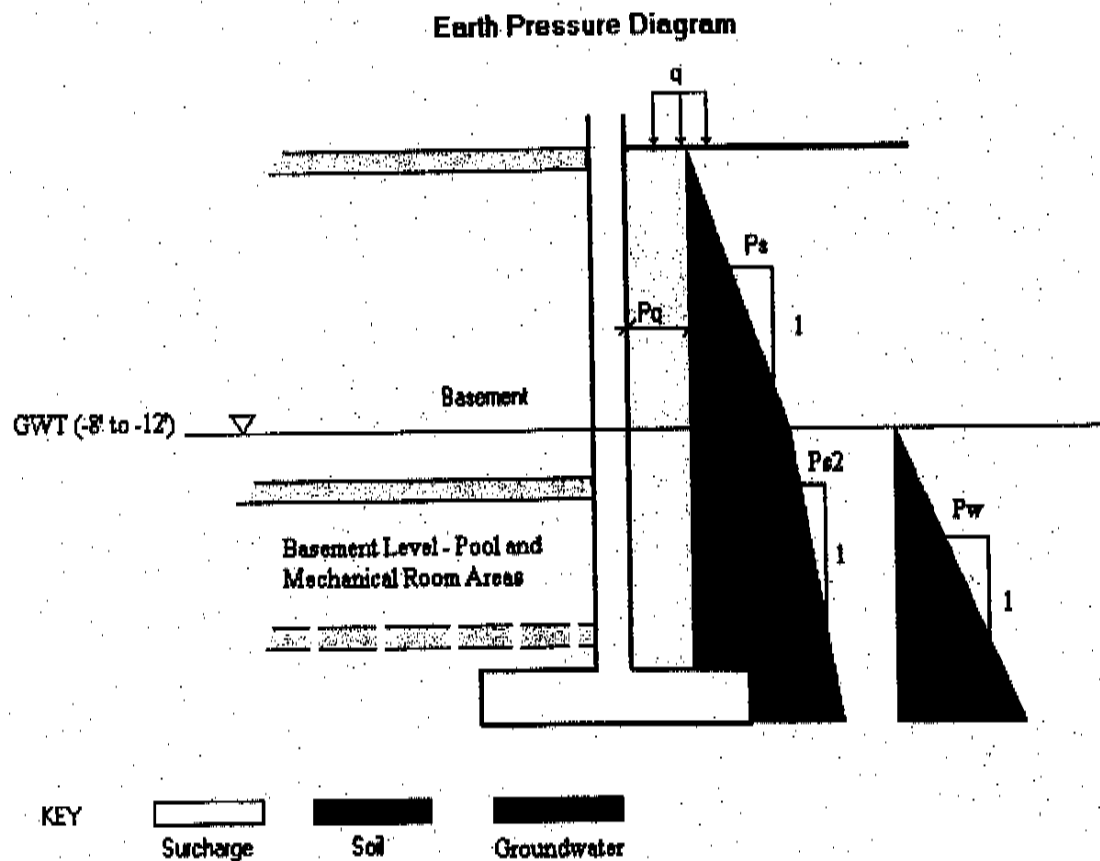
Where:

Backfill is MDOT Class II sand
 Unit weight (γ) = 120 pcf
 Unit weight of water (γ_w) = 62.4 pcf
 Effective unit weight of soil below groundwater level (γ') = $\gamma - \gamma_w$
 q = Surcharge loads from pavements, sidewalks, and/or streets
 P_q = Lateral pressure due to surcharge = $K \cdot q$
 P_s = Lateral pressure from soil above water level = γK
 P_{s2} = Lateral pressure from soil below water level = $\gamma' K$
 P_w = Hydrostatic pressure = γ_w
 K = Earth pressure coefficients:
 K_0 = At-rest earth pressure coefficient = 0.47
 K_a = Active earth pressure coefficient = 0.31
 K_p = Passive earth pressure coefficient = 3.25
 Earth pressure coefficients based on friction angle (ϕ) of 32 degrees

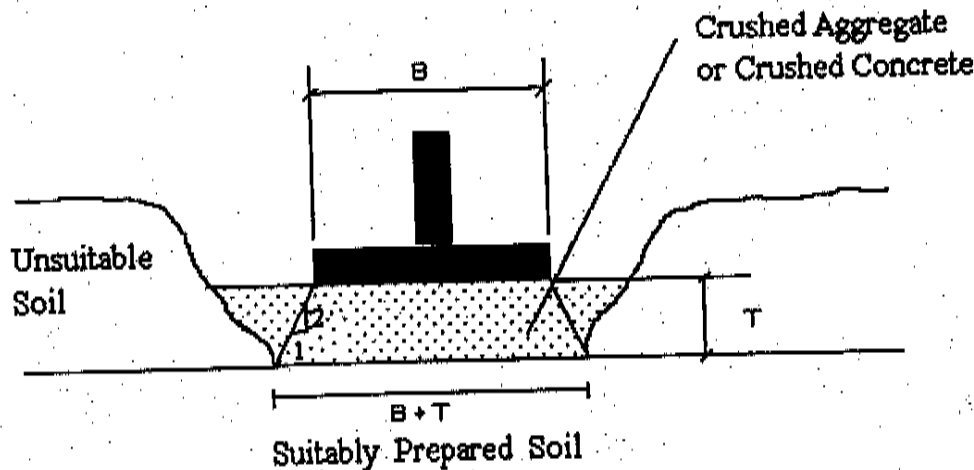
Undercuts should extend outward from the edge of the foundation at a minimum rate of 2V:1H, as indicated in the following diagram:

Shallow foundations should bear at as high an elevation as feasible. Where undocumented fill is encountered at proposed foundation bearing levels, the fill should be removed and replaced with 1-to-3-inch crushed aggregate or crushed concrete "choked" with a thin layer of dense-graded aggregate, such as MDOT 21AA. The foundations should then bear on the crushed material at the design bearing elevation. Foundations should not extend below design bearing levels, nor should engineered fill other than the crushed materials described above be used as engineered fill beneath foundations without first obtaining written authorization from the geotechnical and structural engineers.
