North Shore at Canton

Baltimore, MD

Final Report

Problem Statement

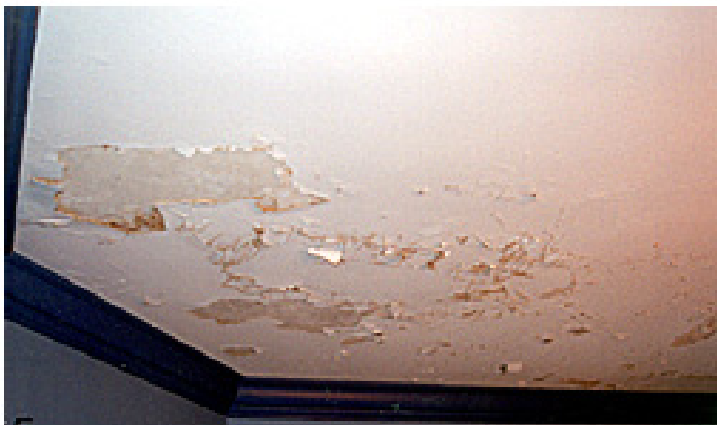
Example of moisture damage to gypsum.

This quote was taken directly from an article written by the Gypsum Association, in regards to moisture related problems with gypsum board. Since the structure of the top three floors are dependent on the stability of the gypsum sheathing, the effects of water damage should be of great consideration. There are also issues that arise from the buildings constant exposure to moisture, since the building is built over Baltimore harbor.

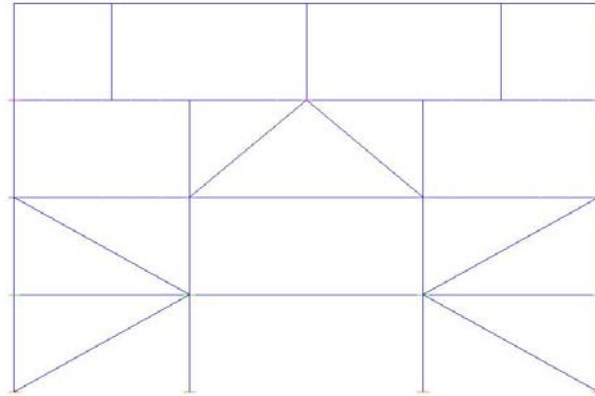
Steel frame short span

The rigid steel frame will consist of four stories of steel columns and girders, , affixed to the pier bents. Each story height is approximately 10 feet. The floor system will be comprised of open web steel joists, maximum span of 25', topped with metal decking and light weight concrete. The frame will contain braced members along shared interior walls. The effects on the foundation will be addressed, given that the lateral loads will transfer differently than the original system. The design of the steel frame shall be in accordance with the AISC (LRFD) 3rd edition. Members will be analyzed by hand and checked against a computer model.
