Section 4 - Design and Construction Overview

4 - 1 Building Architecture/Enclosure

Pearland Recreation Center and Natatorium – Final Report

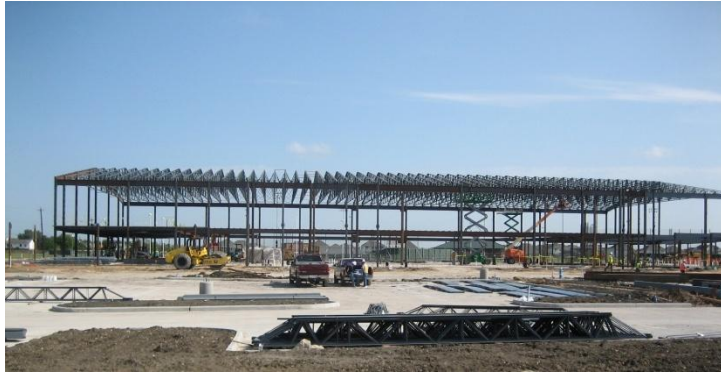
Figure 4-2.6 - Construction photo of roof trusses at recreation center

The roof in the recreation center is a steel truss system (shown in **Figure 4-2.6 - Construction photo of roof trusses at recreation center**) while the roof in the natatorium is a glulam truss system. The roofing system throughout the recreation center and natatorium consists of a standing seam metal roof on a fully adhered waterproof membrane. The roofing system over the main entrance to the building on the south side, a small strip between the recreation area and natatorium, and a small portion of the north side of the natatorium is modified bitumen.
