# FINAL REPORT

Alec Hanley

Construction Management

Cardinal Wuerl North Catholic High School

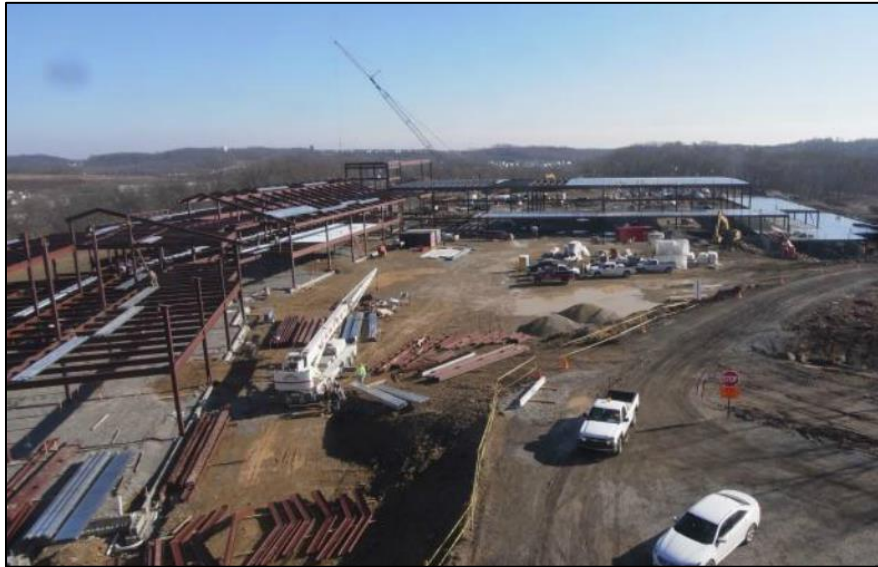
Figure 4: Steel Erection Phase (Property of Mascaro Construction)

The primary structure of CWNCHS is its steel frame. The building reaches vertically by utilizing a system of W10, W12 & various HSS columns, and is either covered by TPO or standing seam metal roofing. The frame utilizes shear walls in the stairwells and elevator shafts as well as moment connections on beams throughout the structure for lateral strength. Mobile cranes were used since a lot of horizontal distance needed to be covered during the erection phase. Two mobile boom & jib cranes navigated the perimeter for 1.5 months in order to put the steel skeleton in place. 5.5" thick composite slabs were used in the few areas that required a second floor, while most of the slab construction was on-grade.

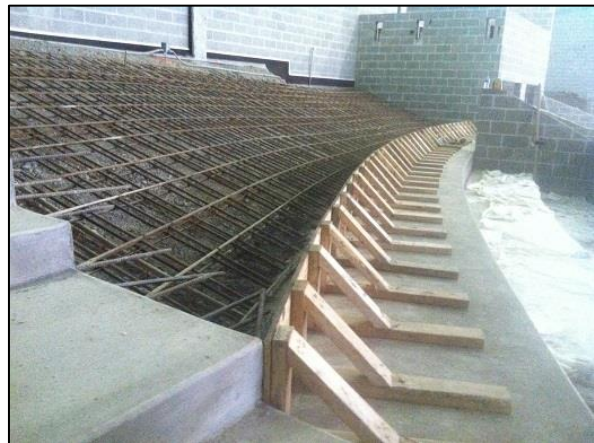
Figure 5: Auditorium Risers (Property of Mascaro Construction)

Perhaps the biggest undertaking at CWNCHS was the cast-in-place concrete. It took approximately 9 months to complete from the first pour in November 2012 to the last in August 2013. Since most of the school is on one level, a majority of the concrete flooring was poured on grade at 1203'-0". Mascaro self-performed all concrete, which included footers, retaining walls, slab-on-grade, slab-on-deck, cast-in-place stairs, prefabricated steel pan stair cast-in-place concrete, etc. Where it was necessary, the primary formwork used was lumber. In a lot of

places, formwork was not necessary due to the two courses of CMU on the footers, which shaped the outer edge of the cast-in-place slab on grade. Power buggies were used for all 1st level concrete placements while a concrete pump truck was necessary for composite slab-on-deck pours at higher elevations.

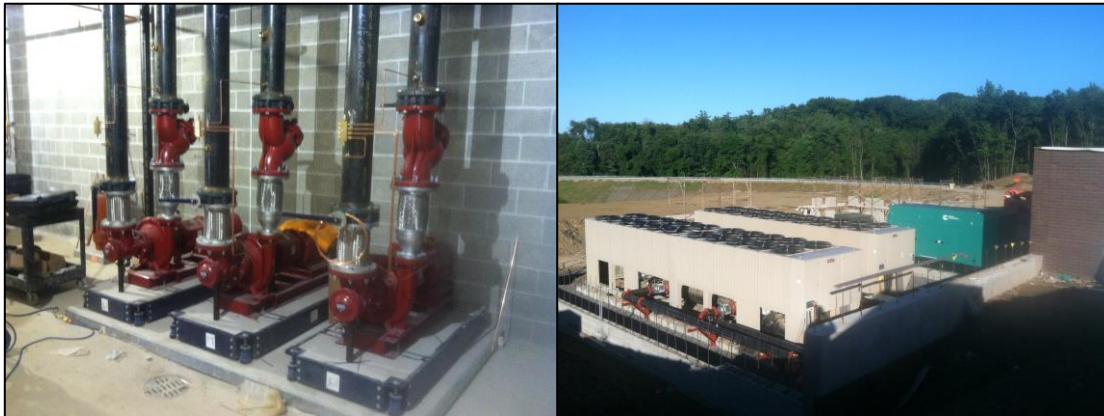
**Figure 6: CHWPs & Chiller Yard (Mascaro Property)**

wings, auditorium & gymnasium. All chilled water to these units is returned to the three B&G 1510 36 Model chilled water pumps located in Room A006 (MEP) and are rated at 450 GPM (25-HP; one of these CHWPs must be on standby at all times). From here, the 30% propylene glycol chilled water passes through a glycol fill station and recirculate through one of the two 350-ton chillers in the mechanical yard on the south side of the building. The majority of the chilled water supply feeds the rooftop AHUs but a small portion is delivered to the two fan-coil units for the purposes of providing conditioned air to the academic wing stairwells. Aside from the water-to-air system described, thirteen split system air conditioners are installed at roof level to serve MEP/MDF/machine rooms on lower level A, electrical/IDF rooms through Areas B, E, & F, and the auxiliary/storage rooms (D103/D104) in the auditorium. The SSACs used in CWNCHS supply either 240, 345, or 640 CFM and are necessary to provide constant volume air conditioning to these critical spaces. The rooftop air-handling units also provide heated air through means of natural gas and deliver conditioned air through overhead ducts at traditional grille, register & diffuser terminals. The natural gas service enters North Catholic at the south end of the building in the chiller yard from a 3" pipe at 2-psig/8,702 CFH. The service feeds the ten air-handling units and the three water heaters through branch piping from this single entrance. The natural gas is used as fuel for the AHU's at a max gas inlet pressure of 14 in-wg in each unit and the natural gas burner shall be fully modulating with a minimum turndown ratio of 10:1. Mechanical space is designated in the southeast corner of Area A.

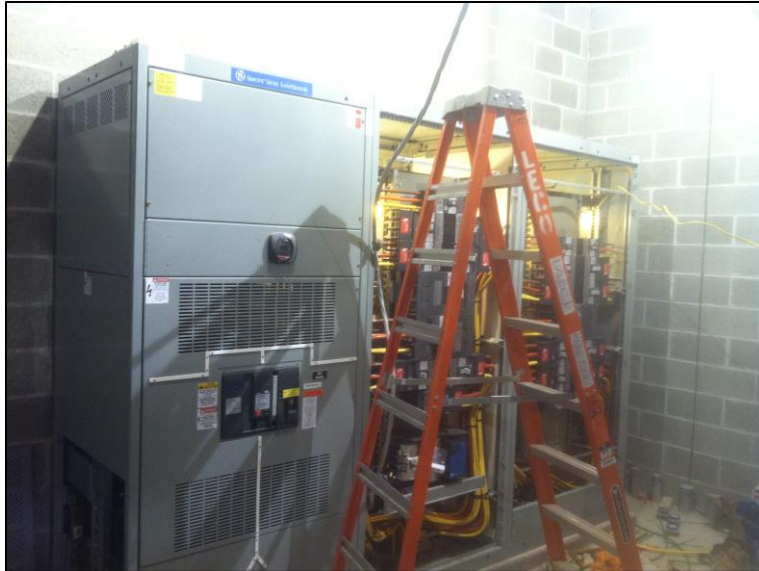
**Figure 7: 3,000A Main Switchboard (Mascaro Property)**

The underground electrical utility service enters the building at the south side in the mechanical yard into the utility transformer. The primary service power then travels to an exterior current transformer cabinet and inside the building to the main switchboard (3,000 Amps). Power is distributed from here to the 41-208/120V & 30-480/277V panel boards. EMT conduit runs the length of the building from here, feeding power to the entire complex. Classrooms utilize pendant linear fluorescent lighting while the auditorium utilized 6" pendant LED down lights. There is also a diesel generator in the mechanical yard of the building, which serves emergency power and has an optional standby power. Branch electrical and IDF rooms are located in many

areas throughout the school. The main electrical rooms are located in the southeast corner of lower Level A.

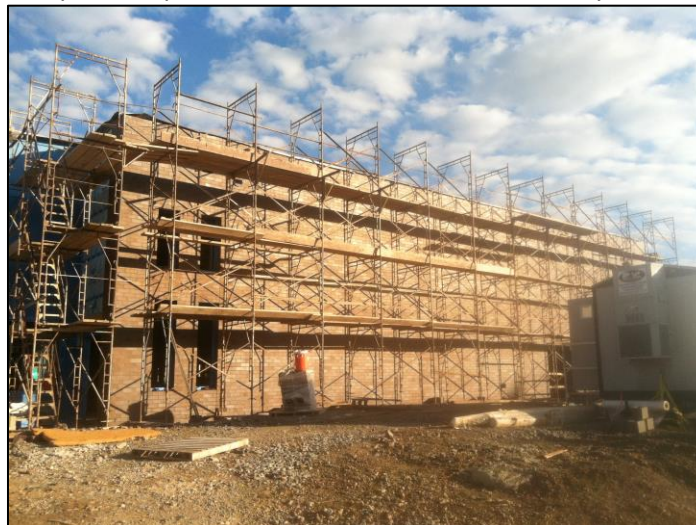
**Figure 8: Brick Masonry Construction on Area E East (Mascaro Property)**

CMUs were used to construct shear walls in the staircases & elevators. They were also used in areas such as the locker rooms, kitchen, MEP rooms etc. as the finished wall material. A brick veneer is used on almost 65% of the exterior. Traditional scaffolding was used on most elevations other than the Area E north elevation. A hydraulic scaffolding lift was used here since it was the largest & simplest scope of brick veneer work for efficiency's sake.

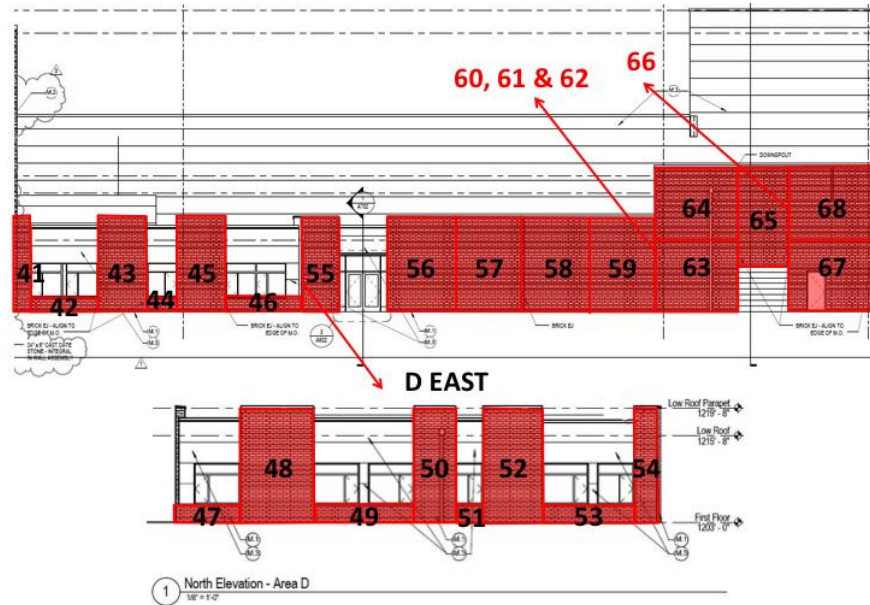
Figure 25: Area D East Elevation - Panel Design and Erection Sequence (Astorino Property)

D East - Panel Design Sequence					
Panel No.	Height (ft)	Width (ft)	Area	Punch-Out Area	Total Panel Area
41	17.25	5.5	95		95
42	3	12.5	38		38
43	17.25	9	155		155
44	3	5.5	17		17
45	17.25	9	155		155
46	3	13.5	41		41
47	3	10	30		30
48	17.25	12	207		207
49	3	15	45		45
50	17.25	6	104		104
51	3	15	45		45
52	17.25	9	155		155
53	3	13.5	41		41
54	17.25	3	52		52
55	17.25	7	121		121
56	17.25	12.25	211		211
57	17.25	12.25	211		211
58	17.25	12.25	211		211
59	17.25	12.25	211		211
60	8.83	26.5	234		234
61	8.83	26.5	234		234
62	8.83	26.5	234		234
63	13.25	16	212		212
64	13.25	16	212		212
65	18.17	9	164		164
66	26.5	10	265		265
67	13.25	15.5	205	25	180
68	13.25	15.5	205		205
		<b>Total SF</b>	<b>4109</b>	<b>Total Gross SF</b>	<b>4084</b>
		<b>AVG Panel Size</b>	<b>147</b>	<b>AVG Gross Panel Size</b>	<b>146</b>

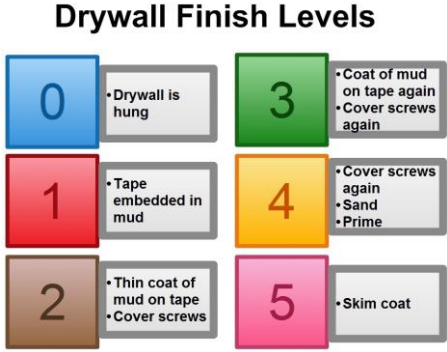
Figure 47: Drywall Finish Levels

Line Item #1 describes the skim-coat method of finishing interior GWB joints. This method is much more expensive than a Level 4 GWB finish and has no bearing on lifecycle costs. Level 5 is an extreme measure of finishing ensuring that joints are not visible after finishing, and the project team determined that Level 4 was more than sufficient. A drywall finish map is shown below to the right. For the purposes of this analysis, it was determined that this was a good VE decision and will be disregarded from this point.

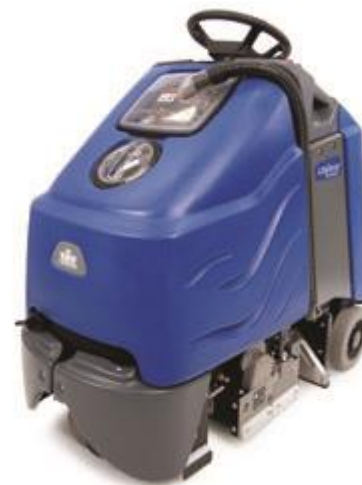
Figure 48: iChariot Floor Scrubber (Windsor Property)

After speaking with the facility manager at CWNCHS, he was able to shed some light on how they clean and maintain polished concrete. They use two iChariot scrubbing machines, shown to the right, that have two diamond pads on the bottom. These pads supposedly will last up to one year and cost \$600/pad. So, pads alone cost \$2,400/year. He also informed me that they use a Hillyard® product called Super Shine-All in the iChariot to clean the floors. This product costs \$36.09/gallon when it's bought in a pack of four. Based on filling up the 25 gallon tank on each iChariot once/day at a dilution rate of 1:128 every week day of the year, this should cost \$3,681.18/year in floor cleaning

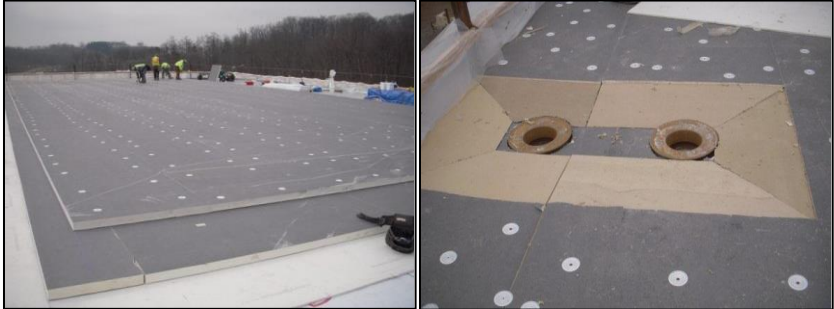
**Figure 65: CWNCHS TPO Installation (Florida Consulting Property)**

Finally, the single-ply, 60-mil TPO membrane is installed (Firestone UltraPly TPO). The Firestone low-VOC adhesive that fully-adheres the TPO membrane to the insulation should be stored in a climate controlled room and stirred to ensure consistency prior to being rolled onto the deck. Also, the TPO should be rolled out in place prior to rolling the adhesive on the insulation so it can relax. Next the TPO should be folded to the side so the adhesive can be applied and the bottom of the TPO can be mopped clean and dried. The heat-weld of the lap seam between TPO rolls is the final step in the process. A test-weld should be done first to that ensure conditions are good for installation. If any voids are present in the test weld, the TPO should not be heat-welded and the installers should wait for better conditions. Also, prior to the weld the seam lap should be cleaned with a splice wash (low-VOC) Firestone product. The pictures below show the application of the TPO adhesive, cleaning of the seam lap with splice wash, and the heat-welder closing the seam between two rolls of TPO, respectively:

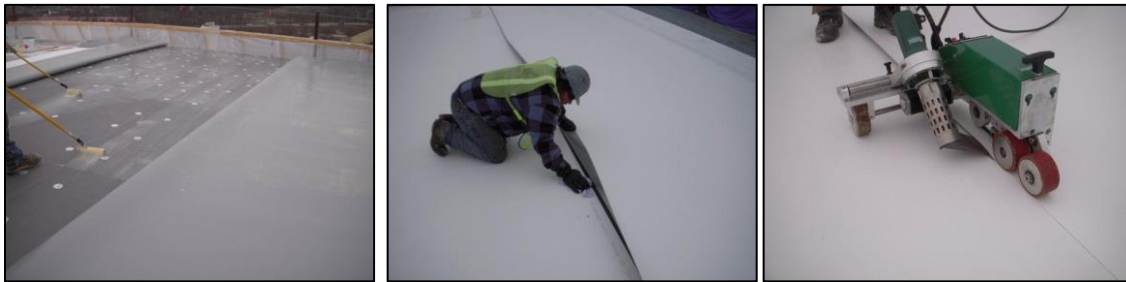
**Figure 66: CWNCHS TPO Installation (Florida Consulting Property)**

- Clean deck of debris, frost, ice
- Install V-Force vapor barrier (flute insulation if acoustic roof)
- Install 5/8" Dens Deck fireguard roof board
- Install (2) layers of 3" thick Firestone Resista™ with necessary detailing for MEP
- Roll out TPO, clean bottom, apply adhesive to insulation, broom surface of TPO, clean seam lap with splice wash, heat-weld seam
- Clear TPO surface of all debris, materials, and sharp objects

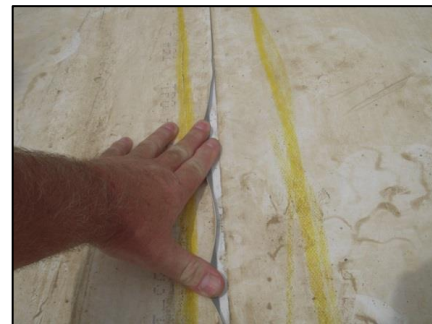
**Figure 67: TPO Failure at CWNCHS (Florida Consulting Property)**

All of the above steps should be taken very cautiously when around the threshold temperature of 25°F. Installing TPO systems at this temperature is very risky because TPO has a reputation of shrinking and pulling away from seams, curbs, and parapet walls. Some systems have a lot of issues with rapid deterioration, but the industry consensus is that Firestone products have the right chemical formula to counteract this issue (Firestone used at CWNCHS). The rigidity of this system is often accredited to the laminated white material that is exposed to the elements, called the "wearing surface." The wearing surface is a different material than what is on the bottom, or the "filler material." Another disadvantage to TPO systems is that it comes in relatively small rolls, which means there are more seams, which ultimately sacrifices the waterproofing integrity. A seamless roof is ideally the best circumstance. An example of where the heat-weld failed and caused a void at one of the seams at CWNCHS is shown to the upper-right. This shows why it is risky to heat-weld in cold weather.

issue is worse. This is clearly demonstrated by the failure seen on-site and in Chapter 7.5 of this analysis. Florida Consulting, LLC provided this photograph and was able to show several other areas of the TPO membrane where it failed and needed to be reworked. Other constructability issues such as the integrity of the alternative systems as well as cold weather installation of said systems were outlined and discussed in previous chapters of this analysis.
