TECHNICAL REPORT II

A Campus Project
Northeastern US

Garrett Schwier

Oct. 16, 2013

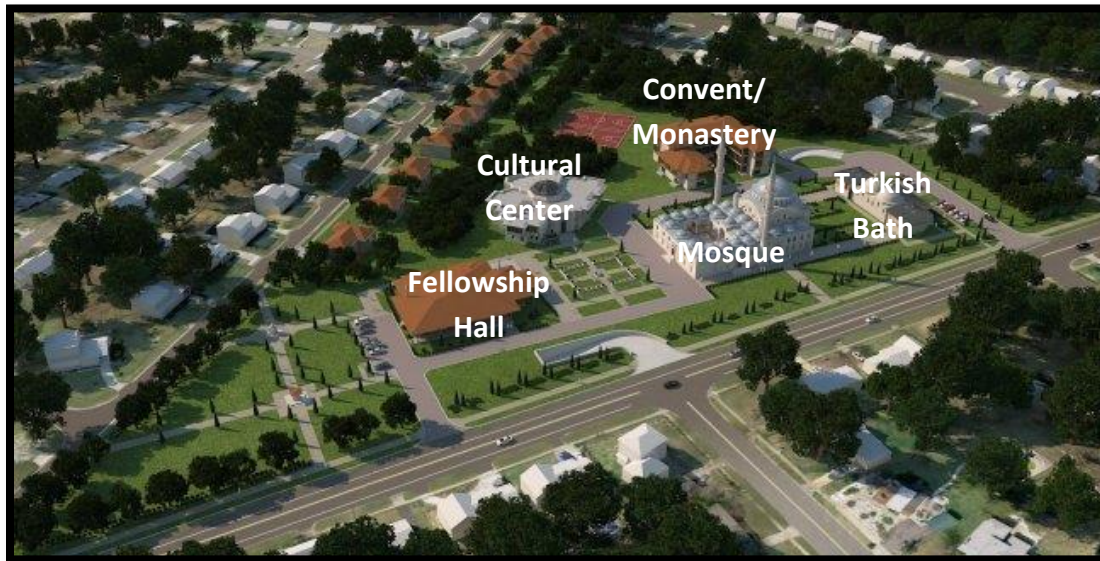
Figure 1. Overall Site (courtesy of Balfour Beatty)

This Campus Project, located in the northeastern US, is a multi-building, multi-use project, built to serve as a community and cultural gathering place. It consists of five unique buildings, an underground parking garage, and a geothermal well field. The five buildings are the Turkish Bath, Convent/Monastery, Mosque, Cultural Center, and Fellowship Hall, as labeled in the image below.

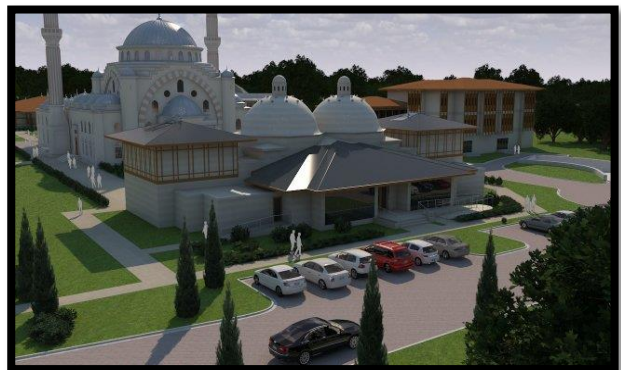
Figure 3. *Turkish Bath*

The second schedule, starting on page A-2, is a detailed look at the construction process for the Turkish Bath, shown in **Figure 3**. The Turkish Bath is a recreational facility totaling approximately 50,000 GSF. It consists of four total floors, two of which are below grade. The second basement is at a depth of 37', the deepest excavation on the project. An underground swimming pool and basketball court are located here, as well as a mechanical room to service those areas. The basement is at a depth of 15', with a mezzanine overlooking the pool that is at a depth of 20'. This floor contains fitness and gym areas as well as an additional mechanical room. Domestic water service enters the mechanical room

from the utility line before distribution to the rest of the project. Electrical service enters the electrical and generator rooms between the north wall and the entrance ramp to the garage. Several switchboards distribute the power throughout the site. The two above ground floors consist of spas, lounges, and warm rooms featuring radiant floor heating systems. Those spaces serve a purpose of spiritual connection and relaxation.

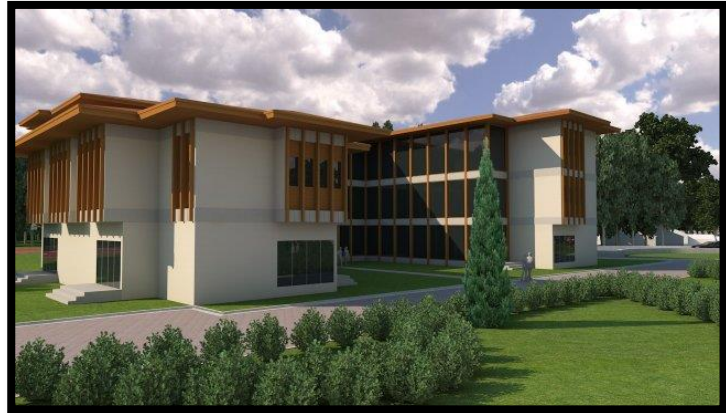
Figure 4. *Convent/Monastery*

For this report, estimates were only conducted for the Convent/Monastery. It is a U-shaped building, four story building, shown in **Figure 4** to the right, and is used as a guest house for visitors and other individuals. The basement level is exclusively reinforced concrete foundations, slabs, walls, and piers. These support the steel structure that forms the three above grade levels. On the basement level are laundry, mechanical, and electrical rooms. Access directly to and from the garage is also possible from this level. The ground floor contains a library, a lounge, space for club meetings and other guest accommodations. The second and third floors contain a total of 16 living spaces.

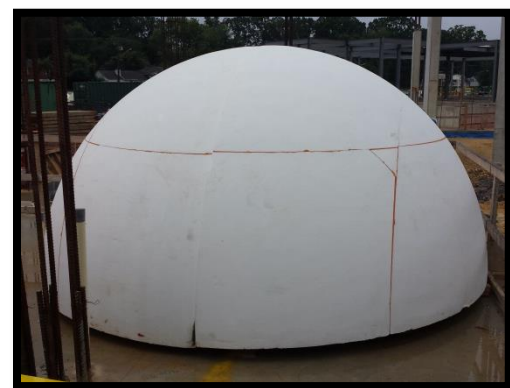
Figure 8. *Styrofoam Form*

A Styrofoam hemisphere is used to form the shape of each dome. They vary in size according to the corresponding dome and its shape. The hemisphere is brought on site in two pieces that are then attached together. A strip of tape is used to cover the joint between the pieces to keep the concrete from forming a ridge in the joint. One of these Styrofoam forms can be seen in **Figure 8**. The red lines across the form are glue joints where separate pieces of

Styrofoam were glued together. This was done by the manufacturer prior to shipping the forms on site. The first constructability issue in this process is developing a method of finishing the domes to a smooth surface. Typically, concrete is poured to a flat surface, such as a slab or wall. Horizontal faces can be smoothed with screeds, and finished with various floats. Vertical surfaces are given a smooth surface by the material that is used as formwork. With a dome, the curvature of the surface makes it very difficult to give the surface a clean finish. There is no typical equipment or technique to this situation, as it is not very common. In addition, the surface of the dome is fairly steep, particularly at the edges. Until it has set, the concrete falls off of the dome and will need to be repeatedly lifted and pushed back into position, requiring the attention of several workers.

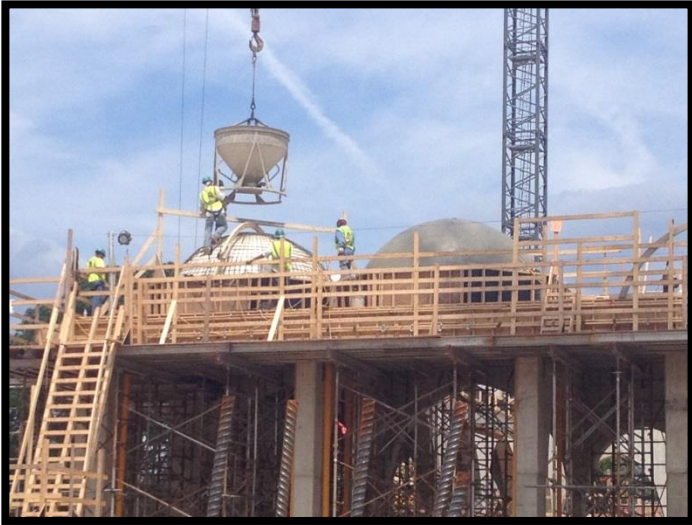
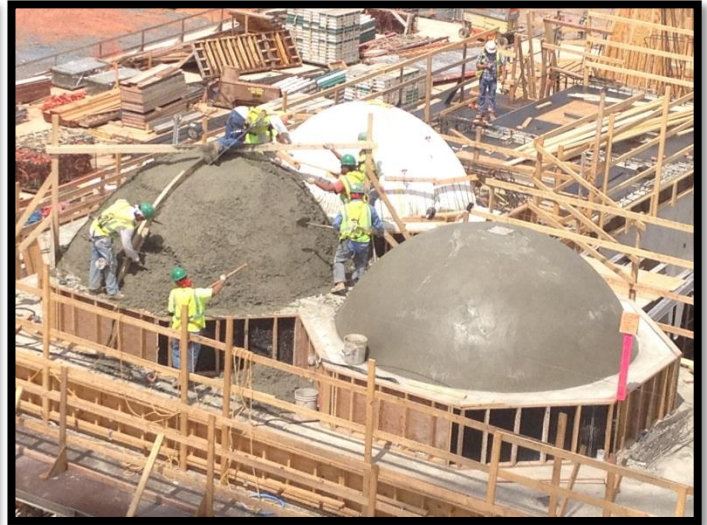
Facchina, the concrete subcontractor, was faced with this dilemma. They have vast experience in cast-in-place concrete projects and came up with a unique solution that could be used for all of the domes. To give a smooth surface to the pour, they built their own screed. It was made of a semicircle arc of wood and shaped to the surface dimensions of each dome. At the peak, it connected to a large post and lintel frame via a pin, allowing the arc to rotate 360 degrees and smooth the surface of the concrete. The entire assembly was lifted into place over the dome by crane. As the screed was rotated and knocked concrete off the dome, workers lifted it back into place until it began to set and remain in place. Once completed, the custom screed could be lifted out of position and moved to the next dome. A picture of the screed in action can be seen in **Figure 9** and **10**, on the following page.

Figure 9. Dome Pour

Figure 10. Screenshot in Use

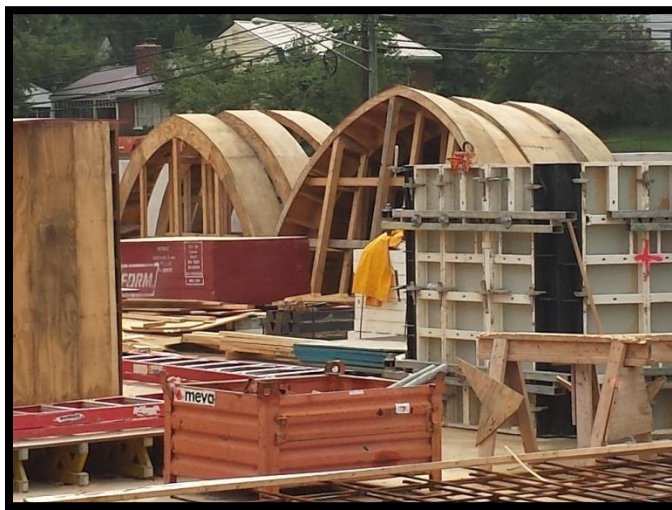
Figure 8 Custom Arch Formwork

Again, Facchina was tasked with developing a solution to this issue. Through consultation with the structural engineer, they developed a plan to form the arch in several lifts using wooden formwork. All of the formwork was custom built using plywood and 2x4 pieces. They were heavily braced underneath in order to support the heavy concrete loads. Each lift was carefully poured in order to ensure quality control. Facchina's formwork engineer was on duty to inspect the preparation work before any concrete was poured. This ensured the safety of the workers and an

assurance that the formwork would perform properly. Figure 8 shows a custom built arch frame. It is used for the many smaller arches throughout the Mosque. At approximately one fourth the size of the main arch, it is no comparison in size, but it does show the intensive custom design that Facchina underwent for each arch. Since the main arches are significantly larger in size, they would undergo even more extensive design.
