Corporate Headquarters

AE Senior Thesis
April 13th, 2015

Structural Option

Steel Joist System Roof Redesign

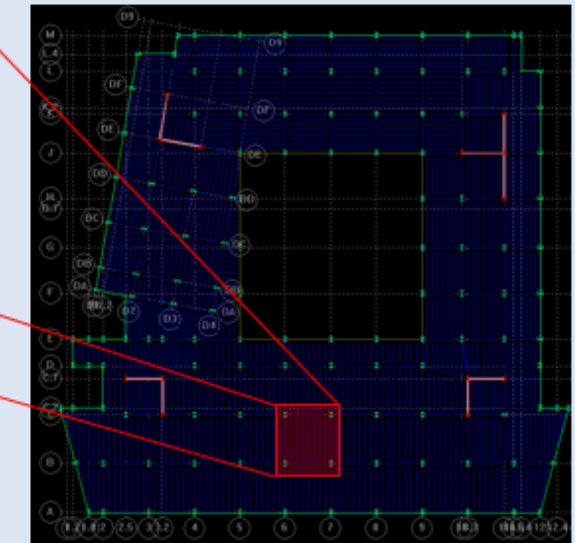
Typical Bay

- 1.5 VLR 18 gauge composite deck
 - 4" normal weight topping
 - Achieves two hour fire rating
- Unshored, 2 span construction
- Same deck type as floor deck for ease of constructability

Joists

- 28LH10

Joist Girders

- 36G8N26.2K

- Joists and girders to be fire proofed for a two hour fire rating
- Deflection controlled depths

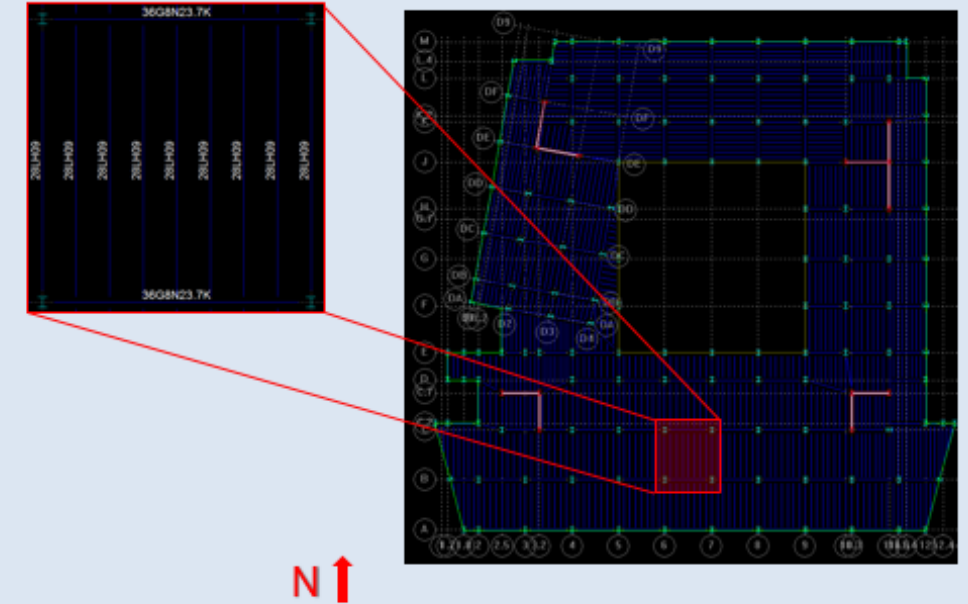
Steel Joist System Floor Redesign

Typical Bay

- 1.5 VLR 18 gauge composite deck
 - 3 ¼" lightweight topping
 - Achieves two hour fire rating
 - Unshored, 2 span construction

Joists

- 28LH09

Joist Girders

- 36G8N23.7K

Joists and girders to be fire proofed for a two hour fire rating

Deflection controlled depths

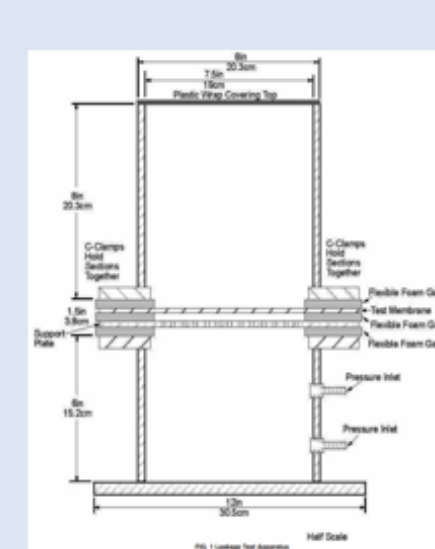
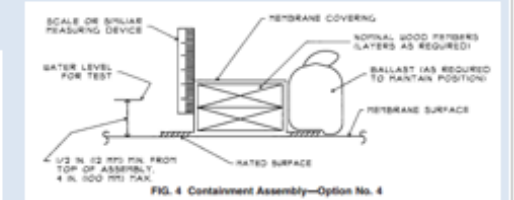
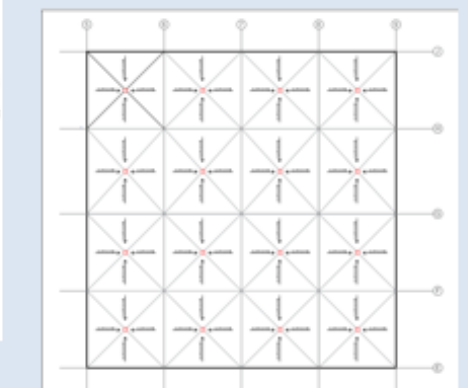
Water Testing and Drainage Plan

Flood Test- ASTM D5957-98

- Courtyard test
- Performed after membrane installation
- Requires drains to be plugged
- 24-72 hour test

Leakage Test- ASTM D7281-07

- Requires leakage test apparatus
- 7 day test procedure

New Drainage Plan

- one drain per bay
- 16 drains total
- 1520 sq ft of membrane area per drain
