North Shore at Canton

Final Report

Structural Depth

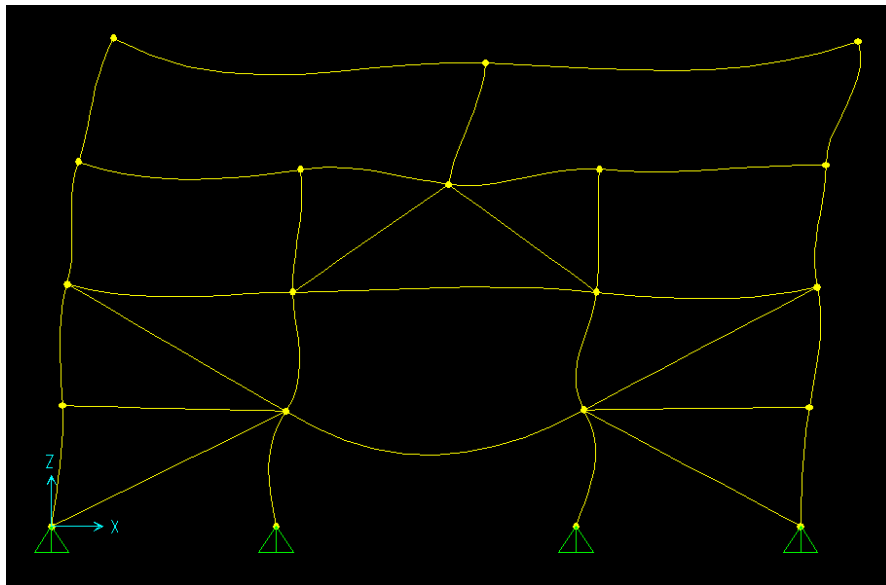
Lateral Displacement:

Story	Total Lateral Displacement (in)
1	.041
2	.079
3	.121
4	.276

The frame provides more than sufficient resistance to lateral displacements. The serviceability displacement requirement for the façade was $L/600$, and it is clear that the frame easily meets the recommended design displacement. Inter-story drift is not an issue either as it meets the displacement requirements.

The frame proved more than adequate in resisting lateral loads while staying within the serviceability limitations. The maximum building drift was only 0.27 inches while the maximum inter-story drift was only 0.15 inches. Also it was found that the foundation was more than adequate in resisting the base shear applied to them, through the distribution of the load through the batter piles.
