# Final Report

Construction Project Management Dec 7<sup>th</sup>, 2010

# 700 6th Street

# Washington, DC

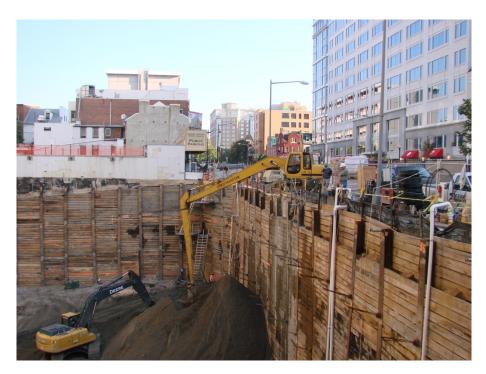
Picture 3.2-Extended Boom Excavator

There are 3 construction gates for the site. The gate closest to the restaurant building is the main gate for construction. This gate is where all the trucks are loaded with soil from the excavation. There are 2 excavators located in the pit. Once the excavation starts to get deep where trucks cannot get in the soil is piled on the perimeter of the pit. A third excavator with an extended boom is used to scoop that soil and load it in a truck. Please refer to the **Excavation Site Plan located in the Appendix** and the picture below for more information.

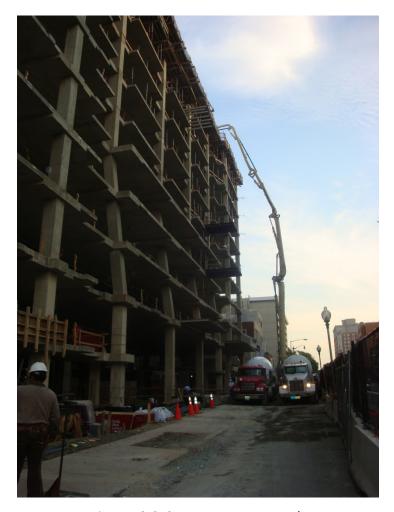
Picture 3.3-Concrete Pump Truck

While the structure goes up, the site starts to become very congested. Concrete trucks needs to have constant access to the concrete bucket, but deliveries also have to come in. For that reason it is very beneficial that the site has three entrances. The concrete trucks back into the alleyway in-between 700 6<sup>th</sup> Street and the Restaurant. There are wash down areas next to the exits for the concrete trucks to get cleaned off before returning to the roadways. The pump truck is mobile and stations itself around the building. The tower crane is located opposite the main construction entrance. It has a swing radius of 164'. The tower crane can cover every inch of the building and can unload trucks at any construction entrance. There isn't a lot of room for lay down areas so almost all of the deliveries have to be coordinated to come in when they are needed. There is one staging area located in-between the tower crane and the street. Please refer to the **Superstructure Site Plan located in the Appendix** and the picture below for more information.

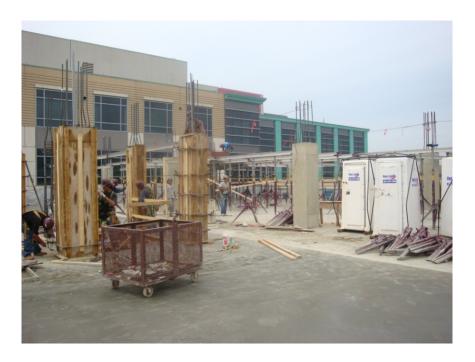
Picture 3.4-Column Formwork

- Cast –in-place concrete was used for building footings, foundation walls, grade beams, slabs-on-grade, suspended slabs, concrete toppings, and columns.
- All the above used normal weight concrete.
- All the formwork used typical wood framing. The formwork is removed, cleaned, and reused.
- A pump truck and crane bucket was used for all major pours.

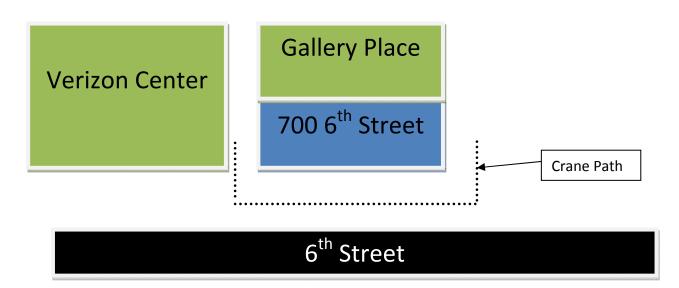
Diagram 3.6-Crane Path

- 2 types of precast on this job
  - Pre-cast with Alabama Limestone casted into pre-cast. Goes from 4<sup>th</sup> to 12<sup>th</sup> floor.
  - o Precast that has similar color to match Alabama limestone
- The stone to precast anchoring needs a minimum of 2 anchors per casted section.
- The precast units are bolted to the building structural frame. Clips and hangers are used to attach the precast units to the structural frame.
- Precast was used on all elevations
- The crane that was used to erect the precast pieces was a mobile crane.
- Refer to the attached map below for crane locations when erecting precast.

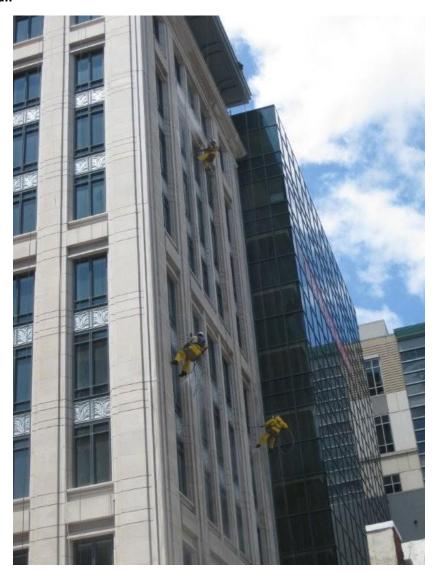
Picture 3.10-Curtain Wall

- The curtain wall is glazed aluminum
- The curtain wall is hung off the edge of a slab using metal brackets that are cast into the slab.
- The space between the slab and the curtain wall is filled with a fire caulking compound.

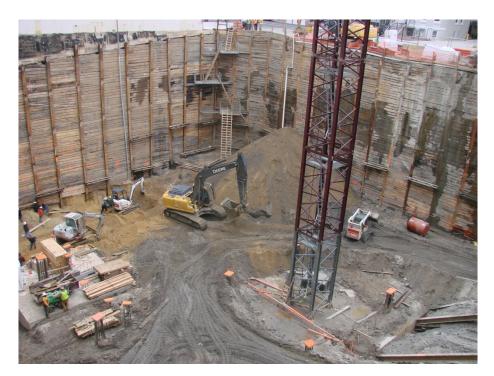
Picture 3.18-Excavation

The concrete foundation consists of spread footings at all columns, mat slab, and slab on grade at all other locations. The foundation is a driver to keep the schedule on time. Nothing can start till the foundation is done. Half of the concrete work was done during warm weather and the other was done during the colder months. Special care had to be taken to adjust the admixtures during the hot and cold months to ensure the concrete cures to its designed strength.

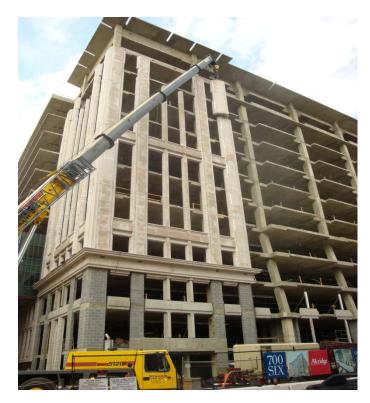
Picture 3.19-Concrete Superstructure

Once the foundation is complete the concrete superstructure starts construction. The estimated amount of days to complete all the levels is 115 days. Once a few floors are completed precast concrete will start to be hung. A tower crane will handle the concrete superstructure and mobile cranes will hang the precast on the lower levels.

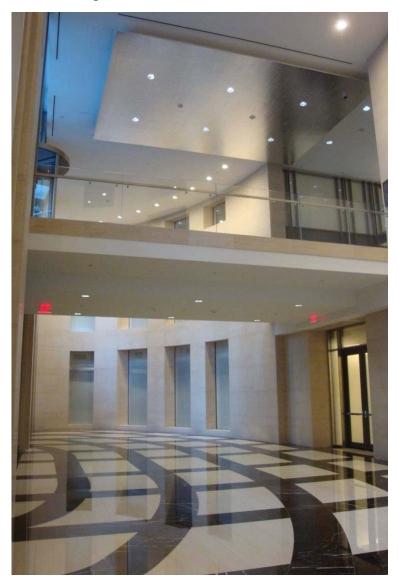
Picture-5.1 Main Lobby

700 6<sup>th</sup> Street has a beautiful lobby with a marble floor and limestone walls. The elevators also have matching marble floors.

This marble floor leads me into a value engineering analysis. Marble is a very porous stone and needs to be polished regularly and resealed every 9 months in a high traffic area. This lobby is a high traffic area and will require to be resealed every 9 months or less depending on the traffic. Marble is susceptible to staining if a watery or oily liquid is left on the surface. The sealer gives you 24 hours, versus 30 minutes, to wipe up spills before they lodge to deep for you to wipe them away. This is why it is so important to reseal and clean the marble floor regularly. Another issue is dulling, once dulling occurs it cannot be reversed. The only way to fix dulling is to sand down the area and repolish/reseal the marble. If a marble tile gets stained there are chemicals to help take out the stain but you may never be able to completely remove the stain. If the stain is beyond what your eye can take and cannot be completely removed that piece of marble will have to be removed. Another problem with marble is it is not a local material. The marble for this material was shipped in from Italy. The replacement of this material could be troublesome because of the long lead time.

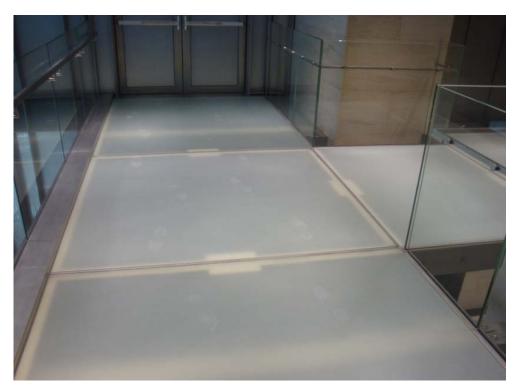
Picture 6.3-Glass Bridge

to replace. At the moment the owner is getting complaints about the glass panels being broke. Tenants are worried that the glass is not safe, because they have spider cracked completely across the top of the glass. The panels are actually still structurally safe because they are layered. The layers thickness from top to bottom is, ¼", ½", ½", and ¼". Refer to the picture for a section of the glass.

In the main lobby there is a glass bridge and glass floors. The problem with having a glass floor is it is very delicate. A week after the glass floor was installed a screw driver was dropped on the glass causing it to spider crack all the way through the glass. At the moment a total of 5 panels have been broke and replaced. Each glass panel is approximately 8 feet x 4 feet. These panels are approximately \$10,000 each to replace and install and are only produced by 2 manufacturers. The lead time for these panels is months and is not easy to replace. From my research I found that increasing the thickness of the glass will prevent the glass from breaking and also does not affect the structural system.

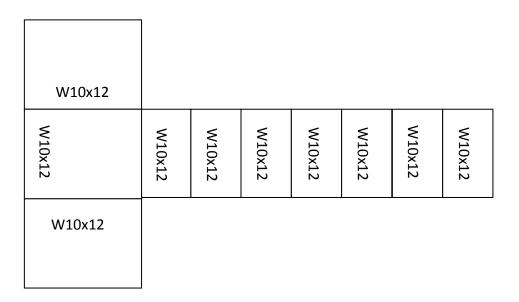
Figure 6.5-Existing System

The existing structural system is made up of W10x12 beams. The glass sits on the beams and then the load from the beams is transferred to a load bearing masonry wall. The horizontal W10x12 beams transfer their loads to the vertical beam on the left hand side of the figure. The long W10x12 beam then transfers those loads to a load bearing masonry wall. I checked to see if the existing system can support the extra dead load. **Refer to structural calculations in the appendix.** After checking each beam with the new dead load I came to the conclusion that the existing system can hold the new dead load. The extra 13.6 pounds per square foot did not add enough to up the beam size.

I would recommend to the owner to increase the thickness of the glass. The structural system does not need to be redesigned to accommodate the new glass. The new system will only cost an extra \$9,000 which is less than replacing one glass panel. This thickened glass will break less than the existing glass, but there isn't a guarantee that the thicker glass will never break. Glass can break if a heavy enough object lands in the right spot (especially the corners). The owner might want to consider a new material, possibly a granite/marble floor to match the lobby below.

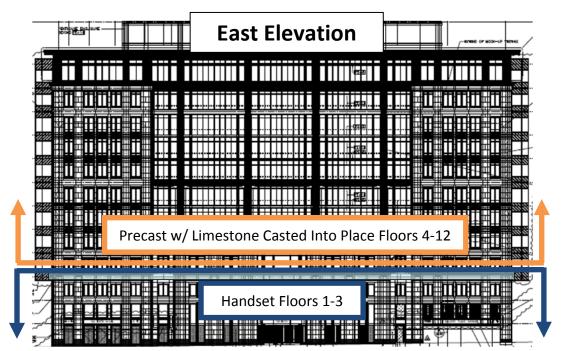
Picture 7.2-East Elevation

There is approximately 4,000 square feet of handset limestone and 7,340 square feet of precast with limestone casted in place on the East Elevation.

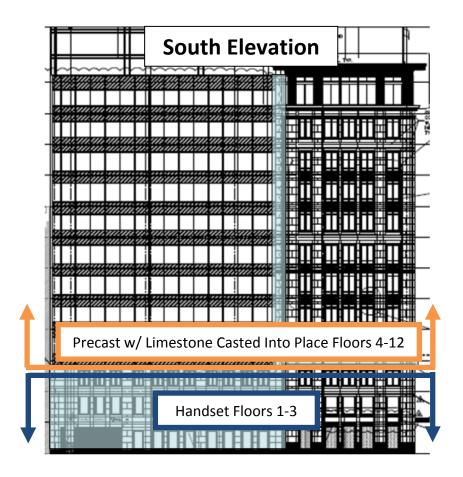
Picture 7.3-South Elevation

There is approximately 2,625 square feet of handset limestone and 2,418 square feet of precast with limestone casted in place on the South Elevation.

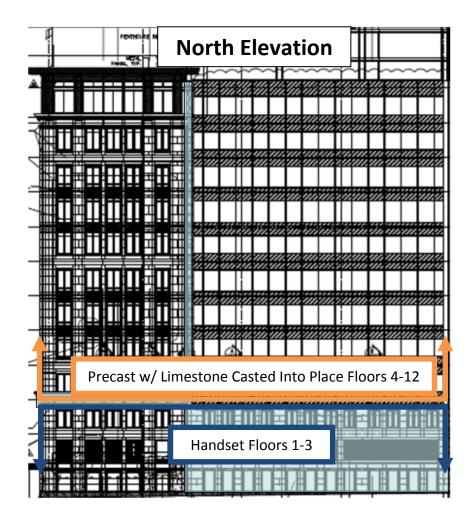
Picture 7.4-North Elevation

There is approximately 2,625 square feet of handset limestone and 2,418 square feet of precast with limestone casted in place on the North Elevation.

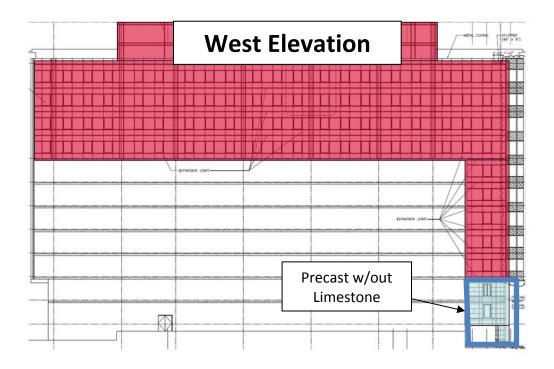
Picture 7.5-West Elevation

There is approximately 256 square feet of precast without limestone on the West Elevation, the rest is EIFS.

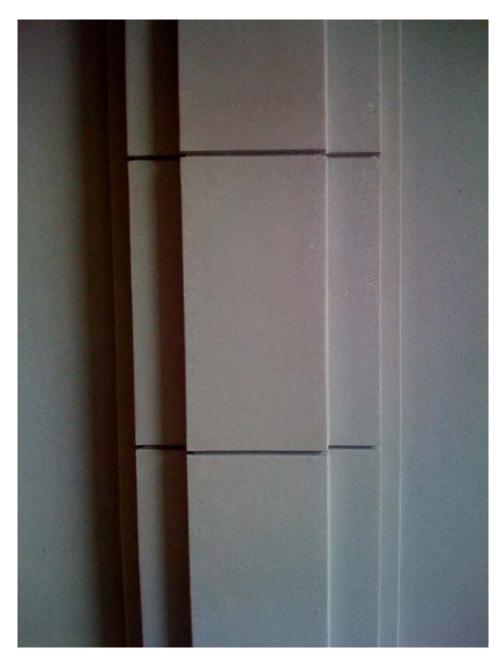
Picture 7.11-Precast

For the Architectural analysis I am going to show that Precast and limestone look almost identical. Architectural precast can be made to look like almost any façade material including Limestone. On the west face of the building there is a location where there is architectural precast made to look like limestone. The precast is located here because it's in an area with low traffic.

From these pictures it's obvious that the precast can and does look like limestone.

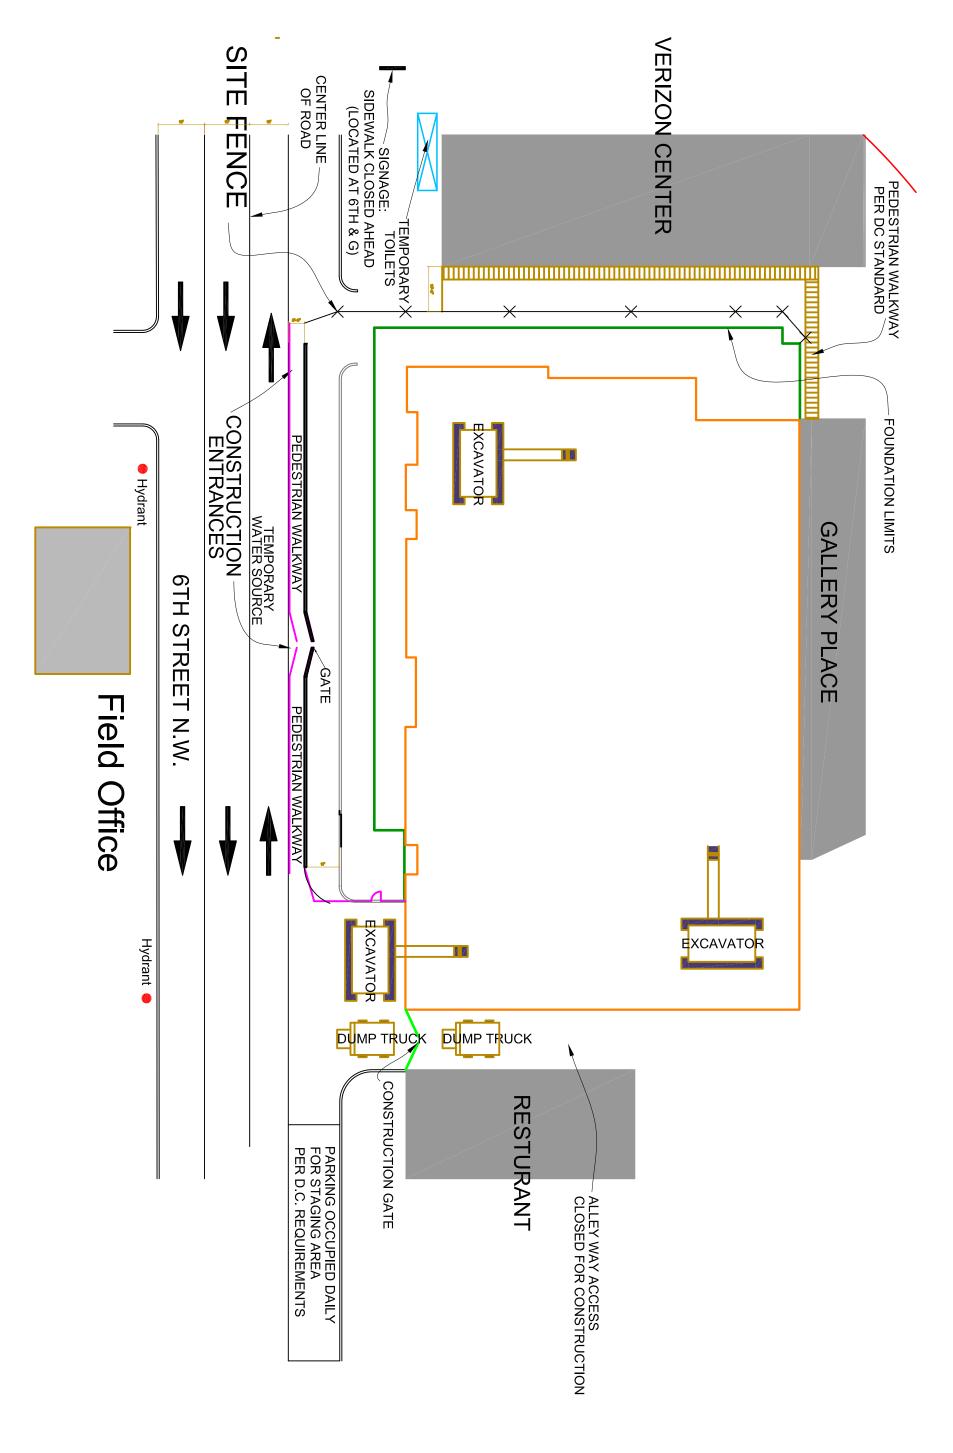
## Appendix B: Excavation Site Plan

# Site Plan For Excavation P

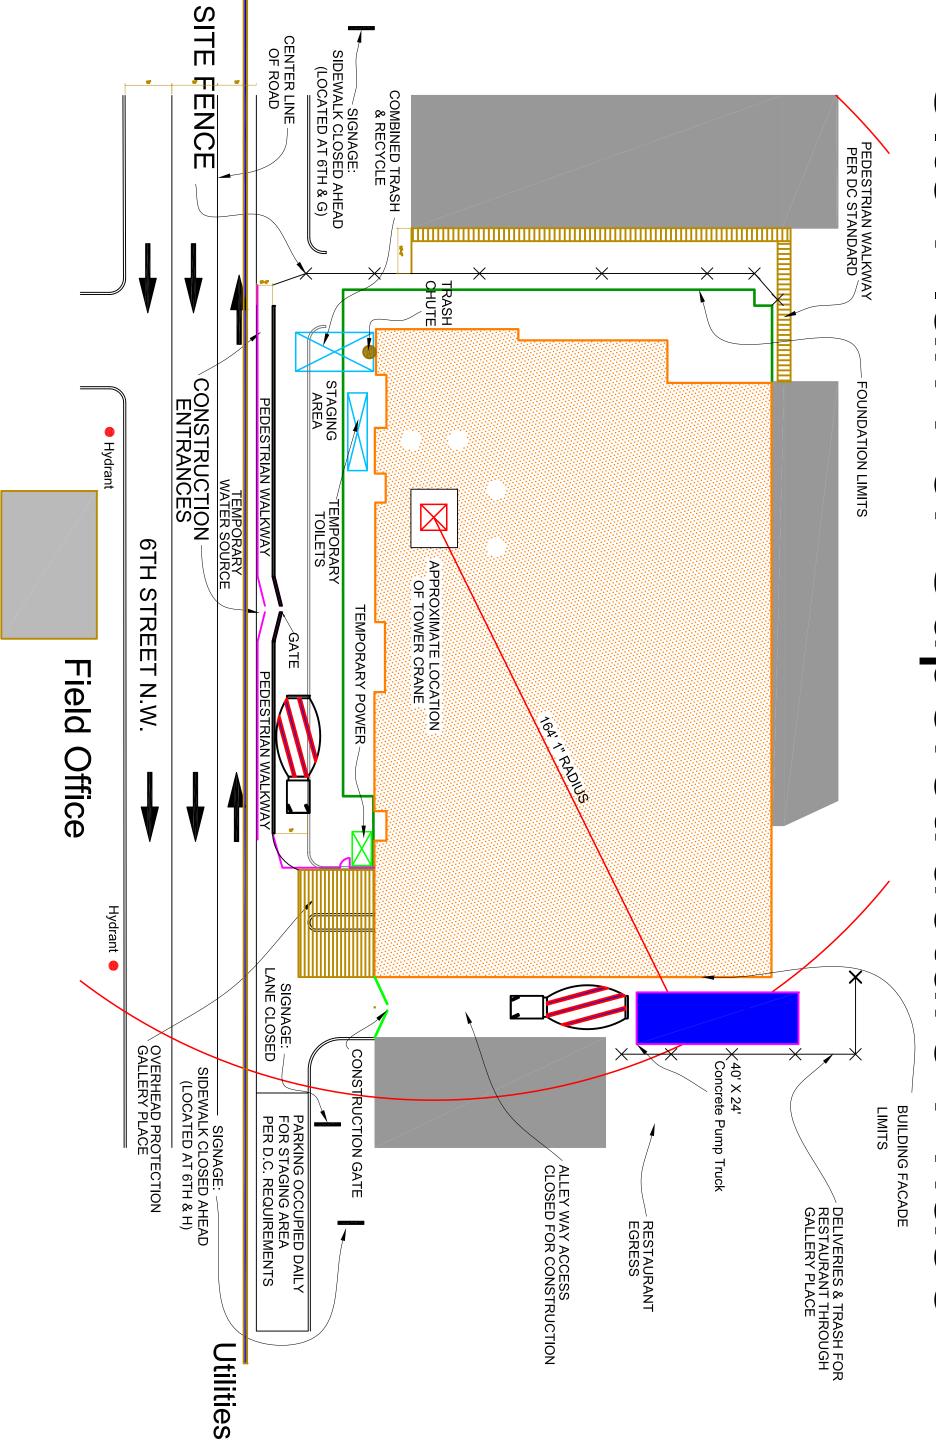
## Appendix C: Superstructure Site Plan

## Site Plan For Superstructure nase
