MONONGALIA GENERAL HOSPITAL

THESIS PROPOSAL: BLAST AND PROGRESSIVE COLLAPSE ANALYSIS

THE PENNSYLVANIA STATE UNIVERSITY
DEPARTMENT OF ARCHITECTURAL ENGINEERING
SENIOR THESIS 2008-2009

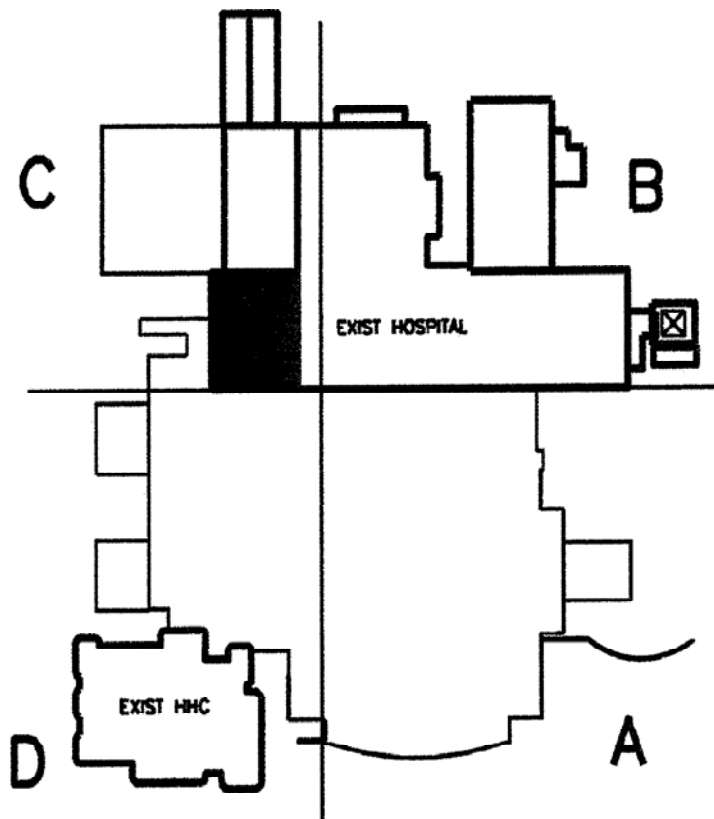
Figure 1: Hospital Divided in Four Quads

The Monongalia General Hospital's plan can be divided into four different quads, A, B, C, and D (Figure 1). The first floor of the Monongalia General Hospital occupies 92,086 square feet and houses a boiler/chiller room, electrical rooms, doctors' offices, labs, nurse stations, storage spaces, and a dining space equipped with a food services kitchen. The second floor follows a similar layout but provides more space for examination rooms as well as a gift shop and café on the southern face of Quad A. The third floor mainly consists of patient rooms with the central part of the plan dedicated to operation rooms. The third floor has a reduced square footage compared to those of the floors below with an area of 80,882 square feet; the western section of Quad D does not continue up to the third floor as patient room spaces but provides housing for two air handling units. The fourth floor sees an even less square footage on plan at 53,833 square feet, with the western section of Quad D no longer existing at this elevation. This floor only houses private patient rooms, each equipped with a private toilet and shower. The square footage

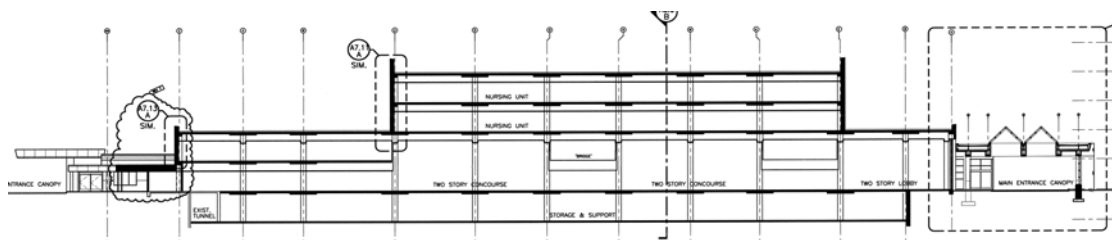
West Section

Figure 2: Cross Section of the Monongalia General Hospital

of the fourth floor continues up to the fifth, housing more private patient rooms as well as a Labor, Delivery, Recovery, and Postpartum (LDRP) rooms in Quad B and C. The sixth floor sees nearly a fifty percent reduction in square footage from the fifth floor with only Quads B and C serving rooms for private patients. The rooftop at Quad A is located at this elevation and houses five air handling units. Acoustic ceiling systems are utilized on each floor to provide acoustic insulation. The rooftop of the Monongalia General Hospital is used primarily to house mechanical equipment. Two different types of roof systems are utilized: an adhered roof system and a ballasted roof system. The ballasted roof system is only present on the rooftop of Quad A and all other roofs utilize the adhered roof system. (Refer to Figure 2 for building cross section)

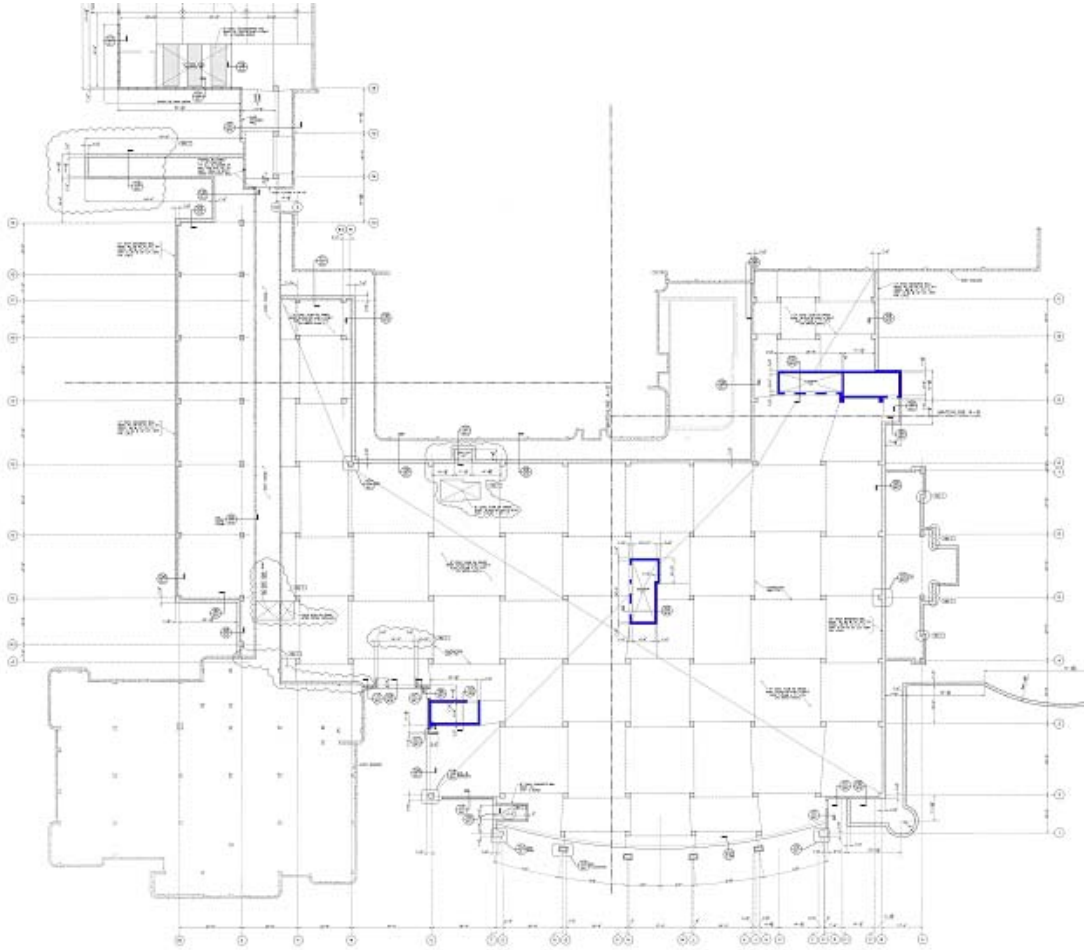
Figure 3: Location of Shear Walls (Colored in blue)

There are twelve lateral force resisting shear walls present in the Hospital (Figure 3). All of these are variable sizes ranging in height and width, the most representative shear wall being a 52'-9-1/8" x 70' wall with two sets of eight #5 bars used at each floor level.

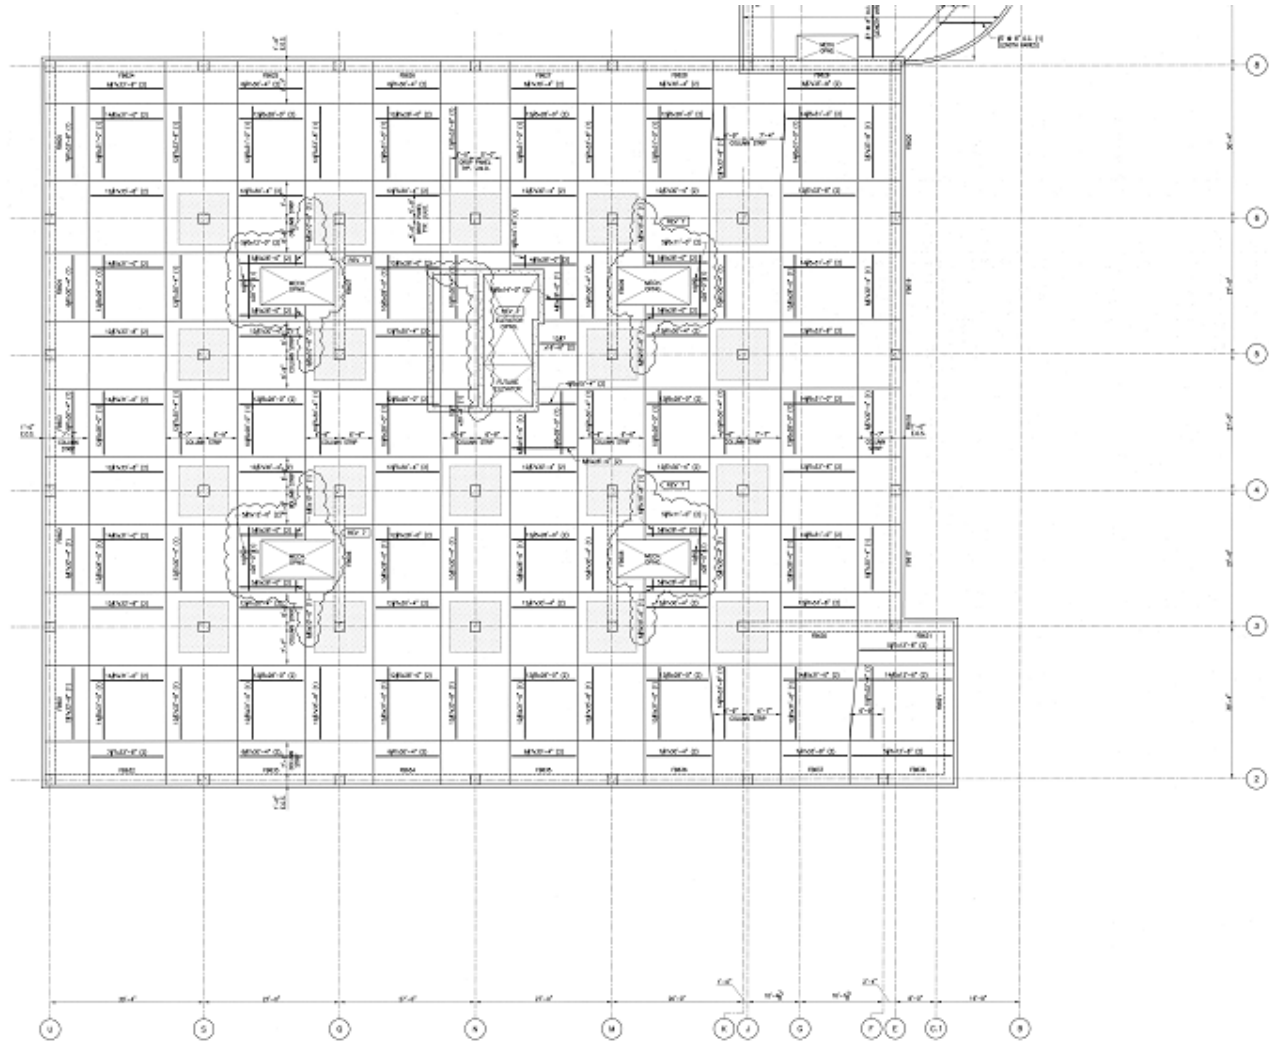
Figure 4: Typical Framing Plan (Taken from Quad A)

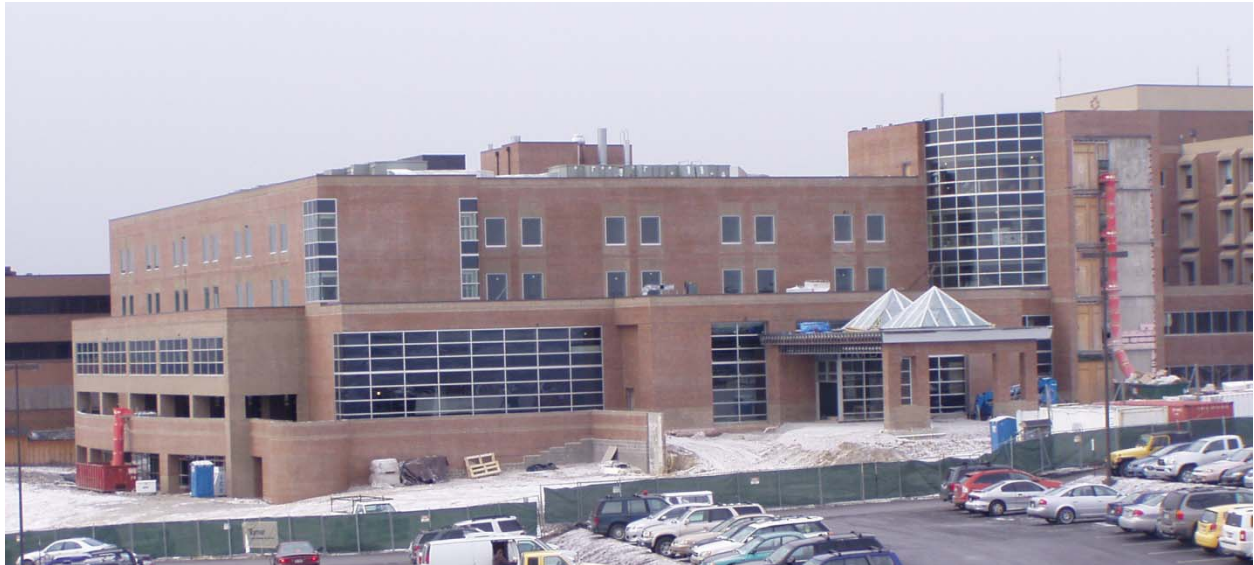
Photograph 3: View from South-East showing the brick façade and curtain walls

The exterior façade of the Monongalia General Hospital is a brick façade tied to 8” structural concrete walls with openings for punch windows and curtain wall systems. Windows are typically aluminum punch window units and located where there are offices and patient rooms, located on the third floor and up. Aluminum curtain wall systems can be seen all around the Hospital, oriented around lobbies and other major openings on plan (Photograph 1 and 3). The system consists of insulated tempered spandrel glass framed by aluminum mullions which is tied into the concrete structural system. Two inch rigid insulation is provided all around the building for insulation.
